# National Transportation Safety Board

## Marine Accident Brief

### Sinking of Fishing Vessel *Capt Richie Rich*

NTSB/MAB-16/14

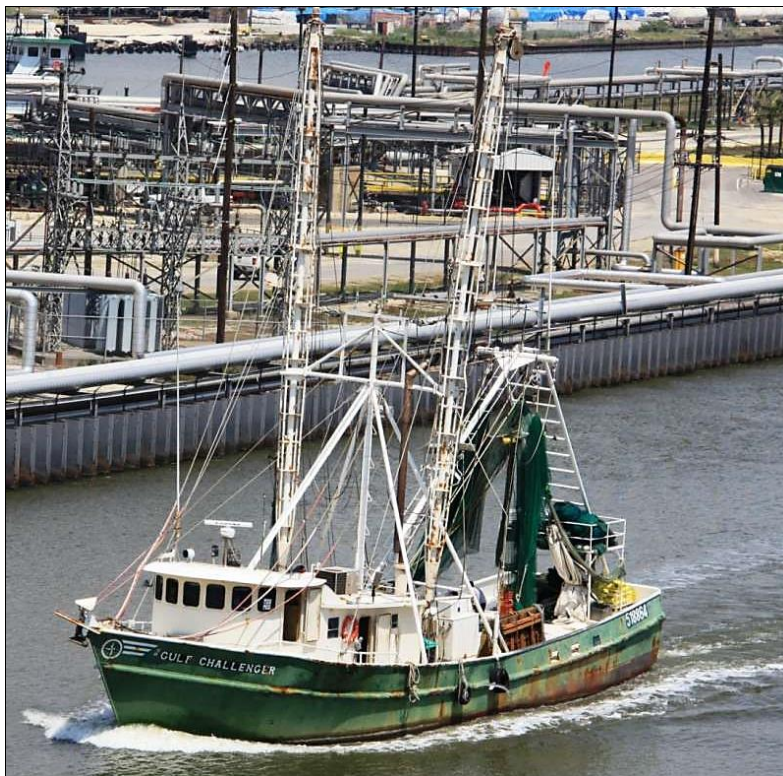
*Capt Richie Rich* while still named *Gulf Challenger*.  
(Photo by "Captain Ted" from [www.shipspotting.com](http://www.shipspotting.com))
