National Transportation Safety Board

Marine Accident Brief

Grounding of Fish-Processing Vessel *Gordon Jensen*

Accident no.	DCA16FM013
Accident type	Grounding
Vessel	<i>Gordon Jensen</i>
Location	Bella Bella, British Columbia, Canada, about 250 nautical miles (nm) northwest of Vancouver Approximately 52°10'12.91"N, 128°07'12.67"W
Date	December 19, 2015
Time	About 1810 Pacific standard time (coordinated universal time – 8 hours)
Damage	\$583,376
Injuries	None
Environmental damage	None reported
Weather and sea conditions	Darkness, light rain, visibility about 8 nm, winds 9–24 mph, air temperature 35°F
Waterway information	Channel in the Inside Passage (a coastal route for oceangoing vessels along a network of passages that weave through the islands on the Pacific coast of North America), Canada's southwest coast, east side of Campbell Island.

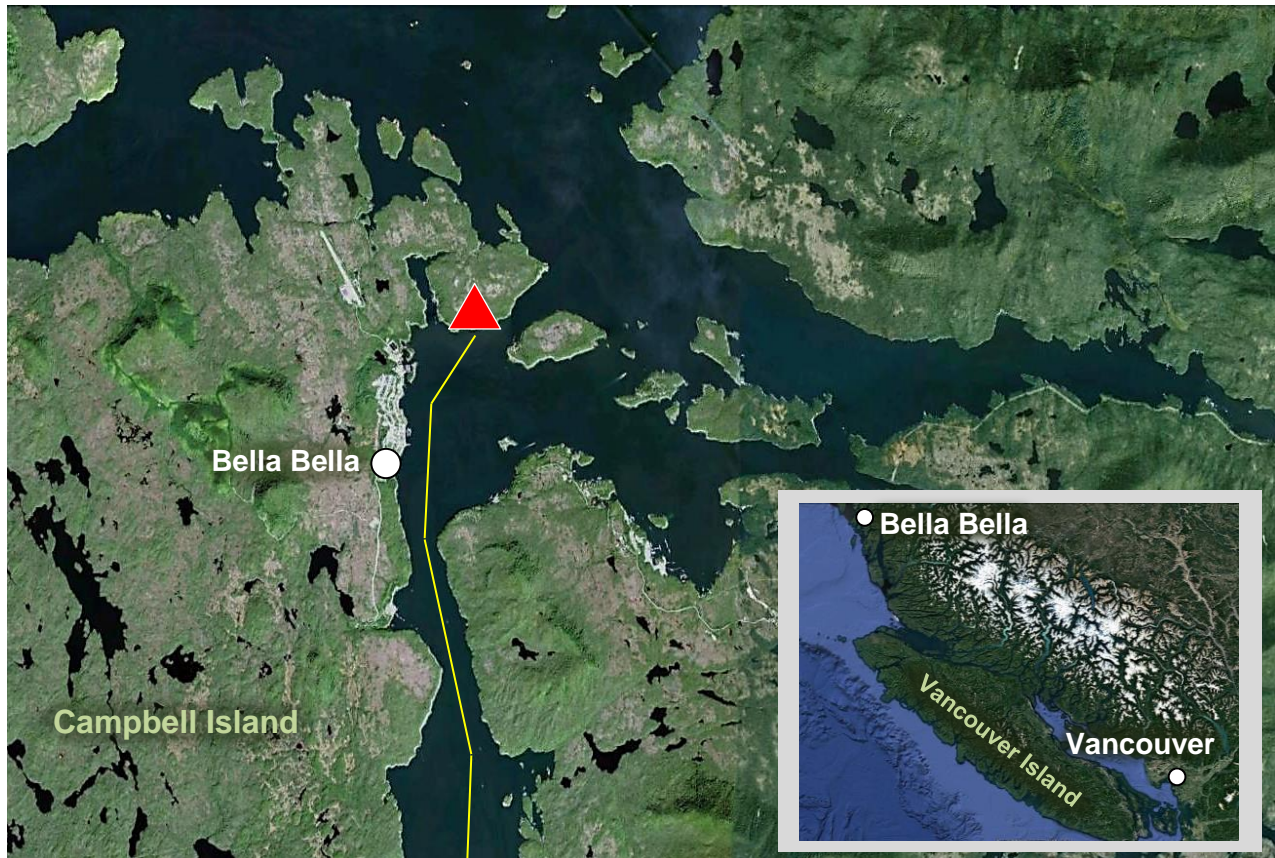
Satellite image of the waterway and islets near Bella Bella, where the *Gordon Jensen* grounded. Overlaid in yellow is the approximate trackline leading up to the grounding. The inset map shows the Canadian coast between the cities of Vancouver and Bella Bella.

The master told investigators that in the wintertime he typically took the accident route to avoid open water so as not to expose the people aboard to more adverse weather conditions. In the summertime, when weather conditions were typically calmer, the master would transit with the vessel in open seas to the west.

The master also believed that, because of the drill, the illumination of the deck lights outside the wheelhouse limited his ability to scan the external environment and restricted his navigation to radar. Had the master set the navigation alarms, they would have alerted him when the vessel veered off track into shallow water, thereby enabling him to correct the course.
