# National Transportation Safety Board

## Marine Accident Brief

### Flooding and Sinking of Fishing Vessel *Capt. David*

<b>Accident no.</b>	DCA16PM026
<b>Vessel name</b>	<i>Capt. David</i>
<b>Accident type</b>	Flooding and sinking
<b>Location</b>	Atlantic Ocean, about 40 miles* east of Oregon Inlet, North Carolina 35°44.2' N, 74°42.5' W
<b>Date</b>	February 15, 2016
<b>Time</b>	About 1440 eastern standard time (coordinated universal time – 5 hours)
<b>Injuries</b>	None
<b>Property damage</b>	Loss of vessel and catch, \$68,000 est.
<b>Environmental damage</b>	None reported
<b>Weather</b>	Broken to overcast cloud cover, fog with visibility of about 1.5 miles, south-southwest winds 20–30 knots with gusts to 35 knots, air temperature about 54°F, water temperature about 50°F, seas 8–10 feet
<b>Waterway information</b>	Atlantic Ocean along the western edge of the Gulf Stream above the continental shelf

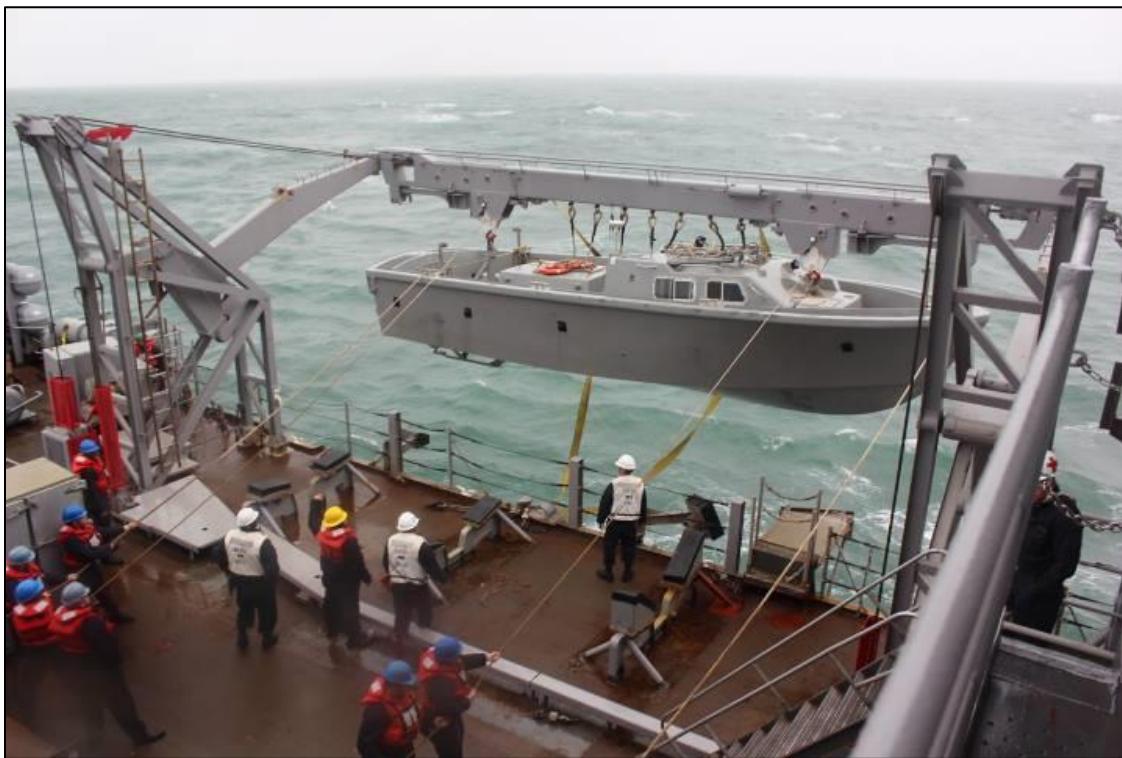
About 1524, the *Carter Hall* began the launch of the PL to lend assistance to the stricken boats. The 5-person crew consisted of the boat officer, the coxswain, a deckhand, an engineer, and a search and rescue swimmer. At 1546, the boat was in the water and away, but, according to the crew, launch difficulties resulted in damage to the boat davit and some fiberglass on the forward exterior of the PL cabin.

Navy 11MPL small boat being launched from *Carter Hall*, about 1530, prior to transiting to stricken fishing vessels *Capt. David* and *Miss Kaylee*. (Photo by USS *Carter Hall* crew)

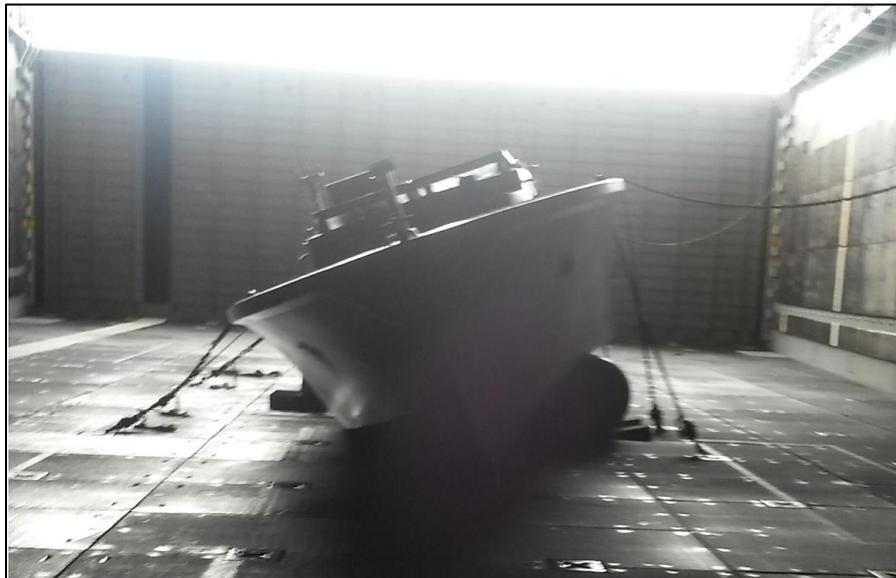
PL secured in drained well deck of *Carter Hall* after recovery. (Photo by USS *Carter Hall* crew)

Severe damage—a continuous fiberglass hull crack running from the outboard gunwale edge down to the inboard deck—was noted on the port side of the bow cockpit. Investigators were provided video footage of the PL re-entering the well deck upon return to the *Carter Hall* that showed the PL's port side impact against the ship's steel well deck bulkhead, accompanied by an audible bang. Interviews

of the boat crew indicate this heavy contact was the event that caused the portside hull damage, which subsequently required the PL to be removed from service for repair.
