National Transportation Safety Board

Marine Accident Brief

Allision of *Peter F Gellatly* Tow with IMTT Bayonne Pier A

Accident no.	DCA15LM030
Vessel names	<i>Peter F Gellatly</i> , Double Skin 501
Accident type	Allision
Location	New York Harbor, Kill Van Kull waterway at IMTT Bayonne Pier A, Bayonne, New Jersey
Date	August 1, 2015
Time	2147 eastern daylight time (coordinated universal time – 4 hours)
Injuries	None
Property damage	\$2.7 million est.
Environmental damage	630 gallons of no. 6 fuel oil released into the waterway
Weather	Partly cloudy, visibility 10 miles, winds west at 8.1 mph, air temperature 80°F
Waterway information	Kill Van Kull separates the southern shore of the city of Bayonne, New Jersey, from Staten Island, New York, and connects the Upper Bay of New York Harbor with Newark Bay and Arthur Kill. Kill Van Kull is a major channel for container, petroleum, and bulk cargo in New York Harbor and has extensive through-traffic.

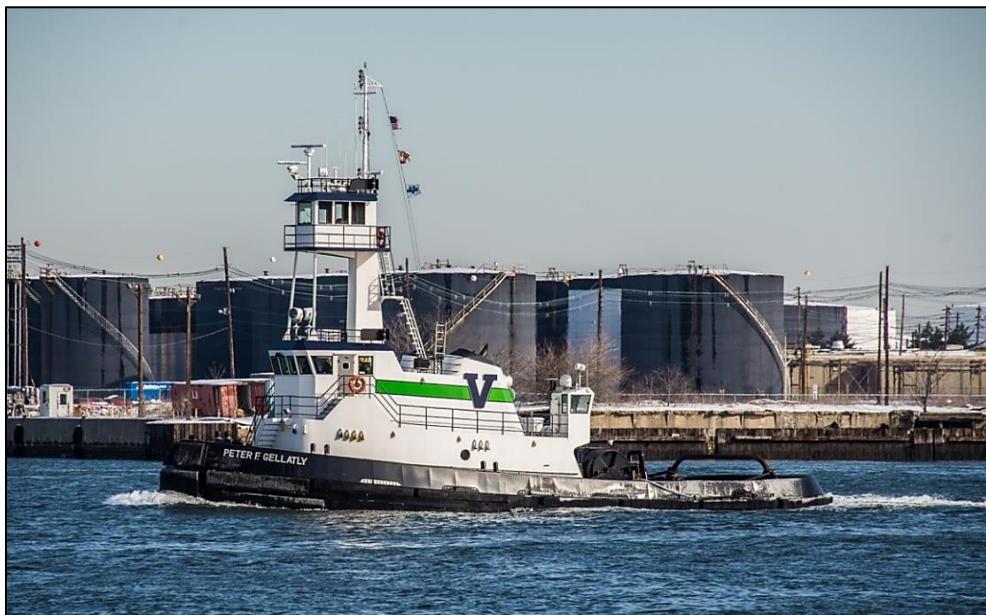
Towing vessel *Peter F Gellatly*. (Photo by Mr. John Skelson)

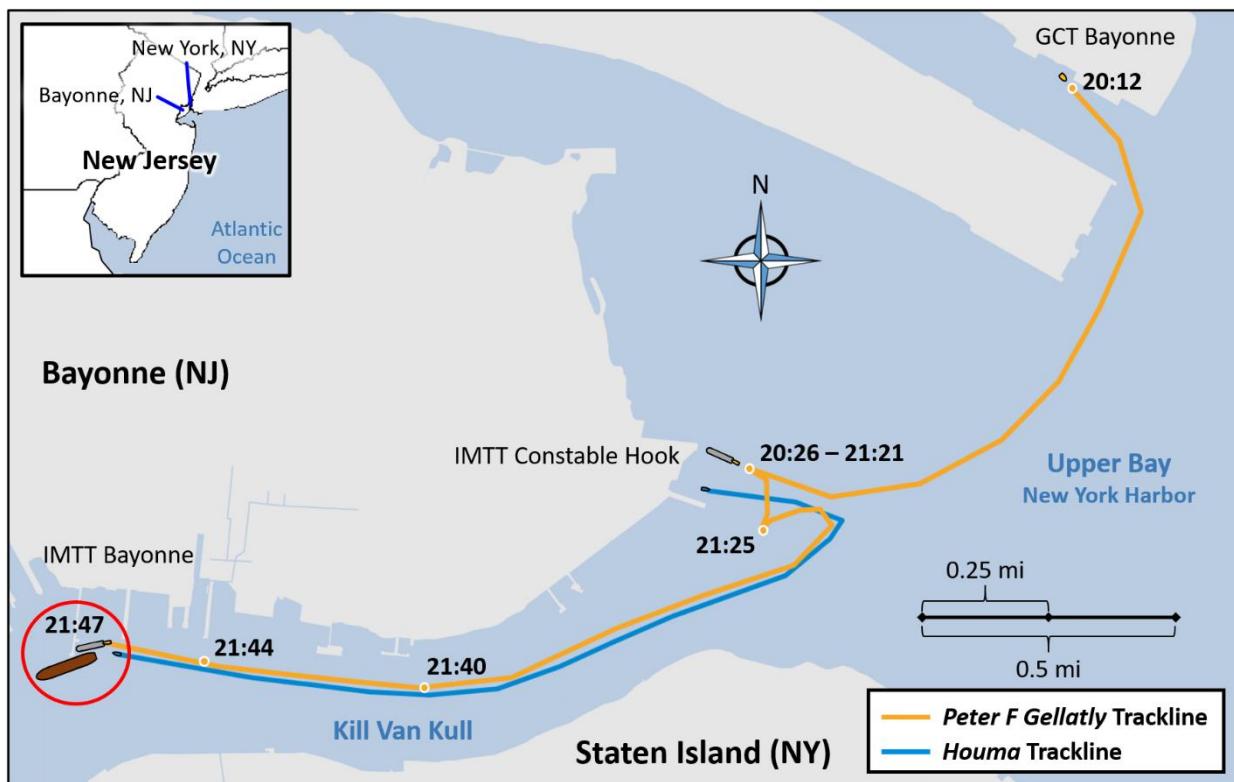
Automatic identification system (AIS) tracks of *Peter F Gellatly* and assist tugboat *Houma* leading up to the accident. The accident site is marked by a red circle. (Background by Google Maps)

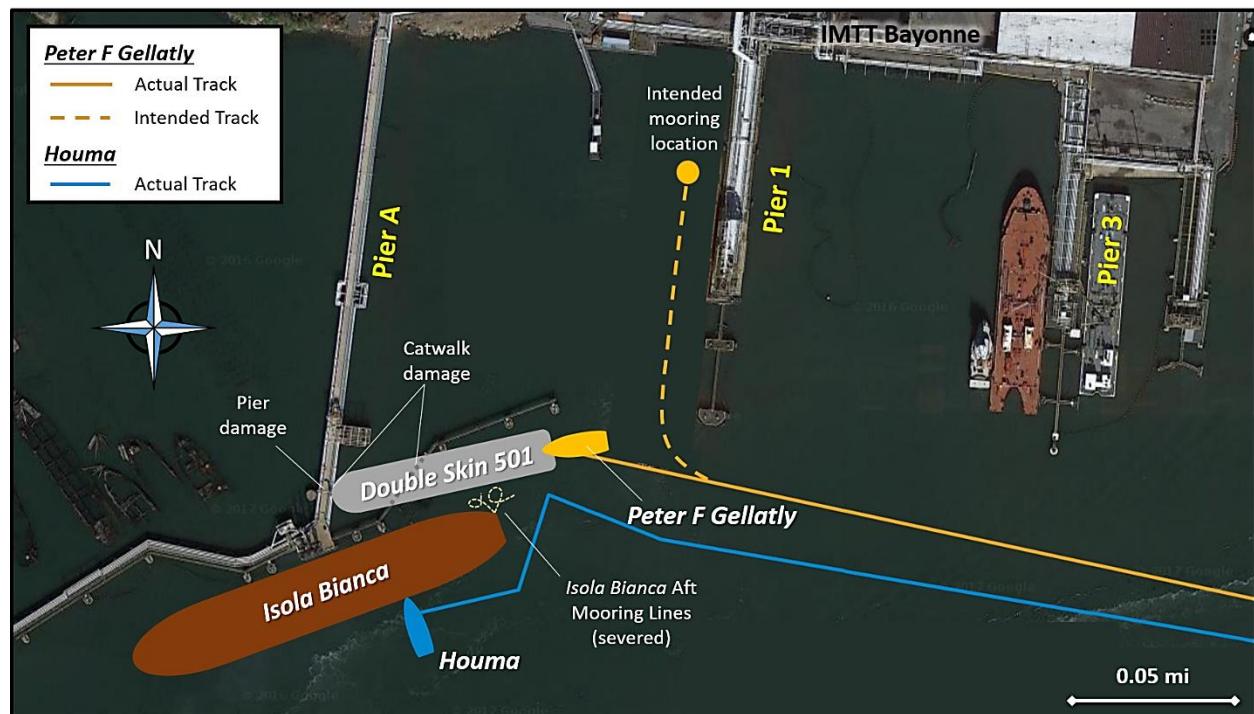
At 2140, as the *Peter F Gellatly* approached the terminal, the captain attempted to slow the tow for its approach to Pier 1. He moved both engine throttles astern, but the starboard engine did not disengage from forward propulsion. The captain told investigators that he did not look at instruments in the wheelhouse, such as the shaft tachometers, that would have showed him both the revolutions per minute of the propeller and the ahead, astern, or neutral position of the propeller
