# National Transportation Safety Board

## Marine Accident Brief

### Fire aboard Towing Vessel *Jaxon Aaron*

<b>Accident no.</b>	DCA16FM050
<b>Vessel name</b>	<i>Jaxon Aaron</i>
<b>Accident type</b>	Fire
<b>Location</b>	Lower Mississippi River, mile marker (mm) 770, north of Memphis, Tennessee 35°31.352' N, 089°56.654' W
<b>Date</b>	August 13, 2016
<b>Time</b>	About 1140 central daylight time (coordinated universal time – 5 hours)
<b>Injuries</b>	None
<b>Property damage</b>	\$10.2 million est.
<b>Environmental damage</b>	None
<b>Weather</b>	Mostly cloudy, visibility at 10 miles, winds south at 12.7 mph, air temperature 86°F
<b>Waterway information</b>	The river stage near mm 770 on the Lower Mississippi River was 8 feet and falling.

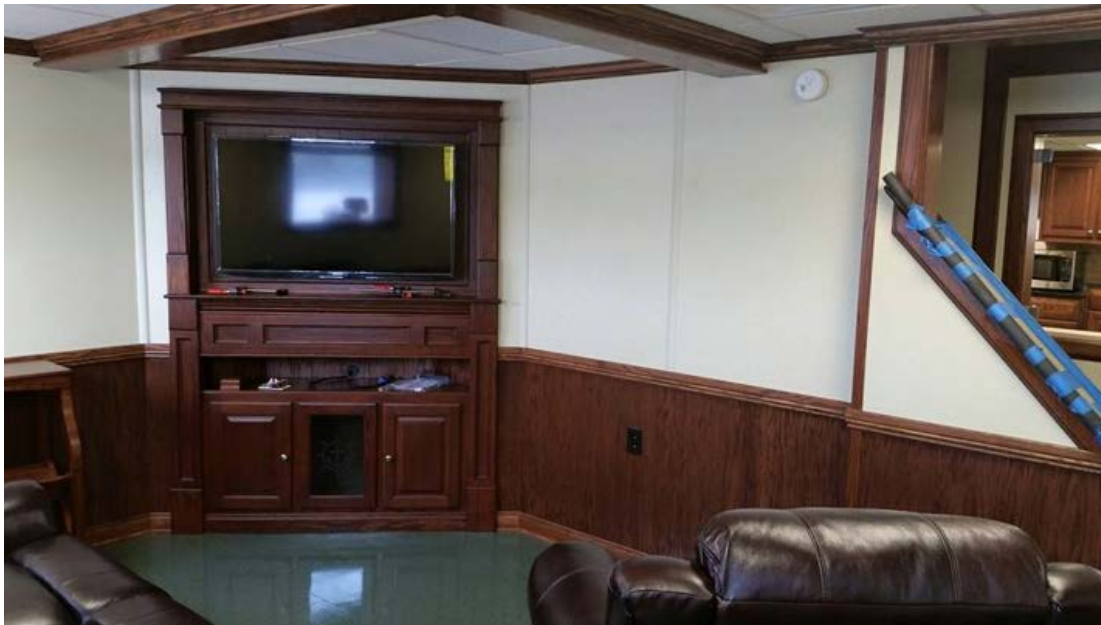
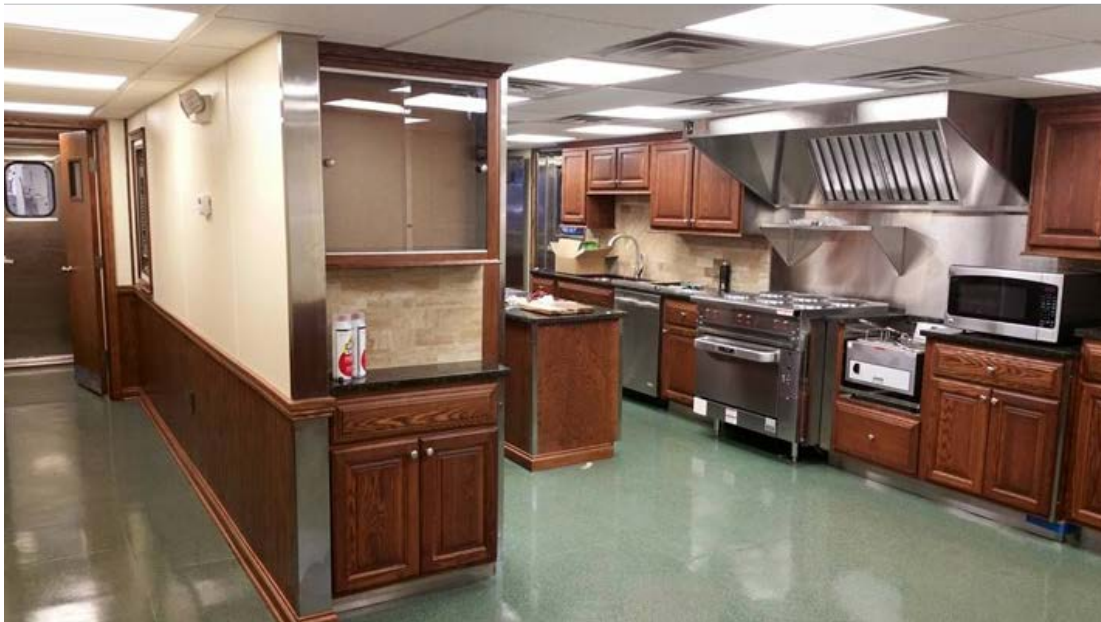
Crew lounge (at top) and adjacent galley area (at bottom) on the main deck of the *Jaxon Aaron* after renovations. The stainless-steel door (bottom, far left) is common with the upper engine room flat and located just aft of the chief engineer's stateroom. (Photo by Western Rivers Boat Management)
