National Transportation Safety Board

Marine Accident Brief

Grounding and Subsequent Breakup of Small Passenger Vessel *Spirit of Kona*

Accident no.	DCA16FM046
Vessel name	<i>Spirit of Kona</i>
Accident type	Grounding and breakup
Location	Kailua Bay, Island of Hawaii, Hawaii; 19°38.2' N, 156°00.0' W
Date	July 24, 2016
Time	About 0220 Hawaii-Aleutian standard time (coordinated universal time – 10 hours)
Injuries	None
Property damage	\$1.1 million est.
Environmental damage	About 275 gallons of diesel and lubricating oil in water
Weather	Overcast, rain squalls, southeast winds at 22 knots with gusts up to 27 knots, seas 8–10 feet, air and water temperature 80°F
Waterway information	Kailua-Kona is located on the west (dry) side of the Island of Hawaii and is a popular tourist destination. The port has a pier used by cruise and charter boats. There is no breakwater to protect this small exposed harbor. Many of the vessels home-ported in Kailua Bay use offshore moorings. The coastline is mostly black, jagged lava.

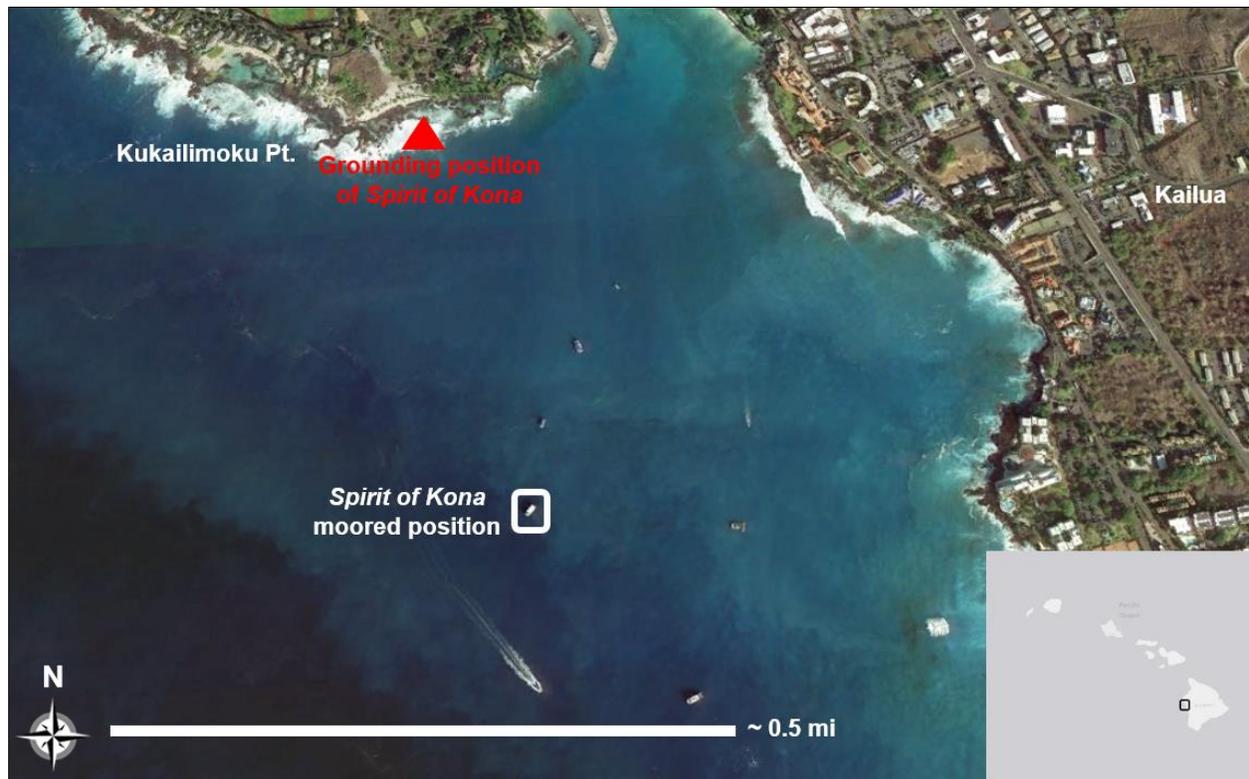
Aerial view of Kailua Bay. A white rectangle indicates the approximate location of the *Spirit of Kona*'s mooring, and a red triangle marks the approximate site of the vessel's grounding and breakup. (Background by Google Earth)

The *Spirit of Kona* was kept at an offshore mooring position about 0.4 nautical miles south of the Kailua pier. The privately owned mooring arrangement, as described by the vice president of Blue Sea Cruises, consisted of two anchors—one weighing 2,000 pounds; the other, 350 pounds—along with chains on the sea floor in about 90 feet of water. These anchors were attached to a block of concrete and positioned with the larger anchor in a southerly direction and the smaller anchor in a westerly direction from the block. A chain was suspended from the block by three subsurface floats and connected to a “surface ball” by a swivel and shackle. The *Spirit of Kona* used a mooring bridle consisting of two nylon lines, attached to the port- and starboard-bow mooring bits of the boat, that connected to the surface ball. At the ball, the lines were secured together by a shackle that connected to another swivel at the surface ball.
