National Transportation Safety Board

Marine Accident Brief

Flooding and Sinking of Small Passenger Vessel *Maximus*

Accident no.	DCA16FM039
Vessel name	<i>Maximus</i>
Accident type	Flooding and sinking
Location	Turtle Bay, Mexico, 27°29.5'N, 114°50.1'W
Date	May 12, 2016
Time	1655 Pacific daylight time (coordinated universal time – 7 hours)
Injuries	None
Damage	\$575,000 est.
Environmental damage	None reported
Weather	Clear, visibility 8 miles, winds north-northwest at 25 mph, 3–4-foot seas, air temperature 65°F, water temperature 60°F ¹
Waterway information	Turtle Bay is located on the west coast of Mexico's Baja California peninsula.

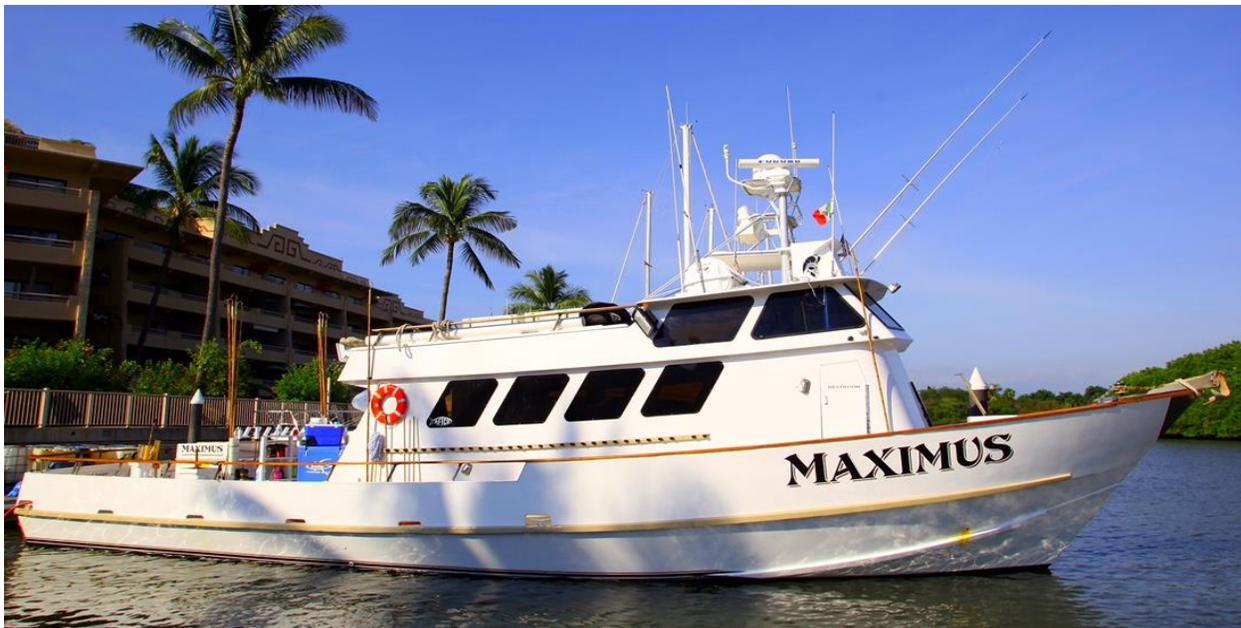
Maximus in Cabo San Lucas, Mexico, before the accident. (Photo by Maximus Sportfishing)

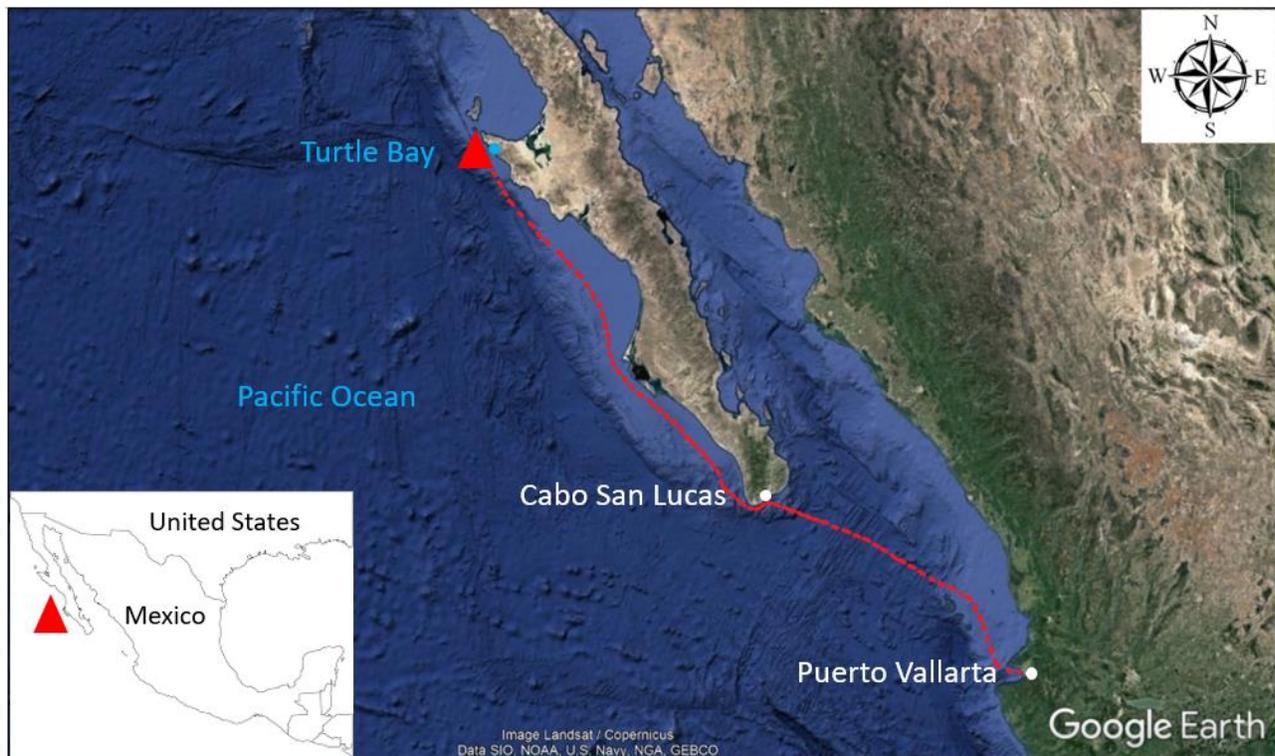
Overlaid symbols on an excerpt from Google Earth Pro depict the *Maximus* trackline and sinking location near Turtle Bay, Mexico.

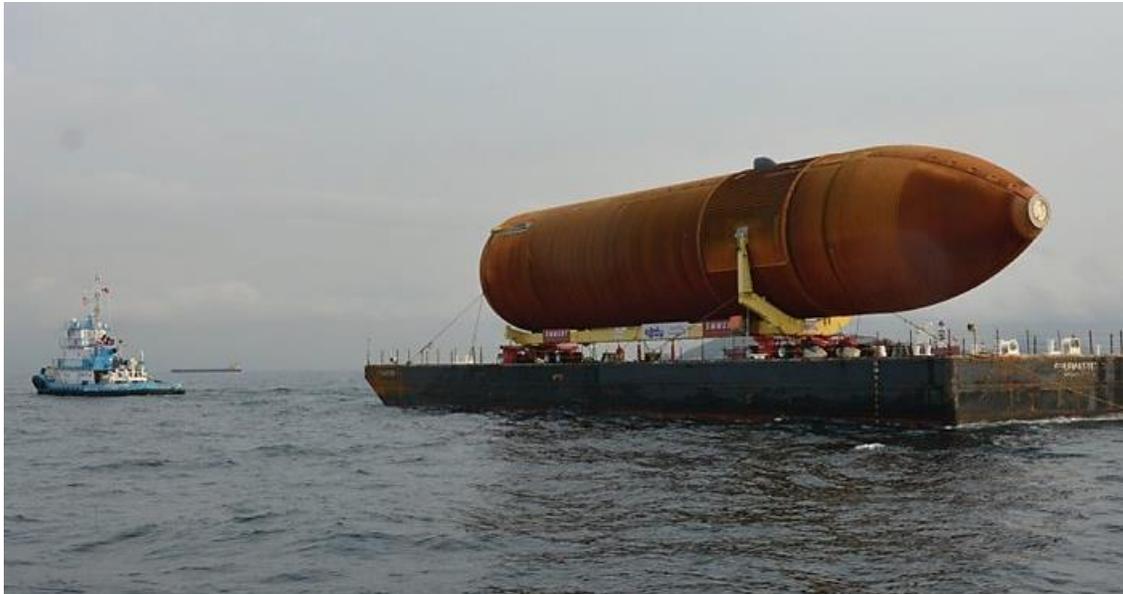
Towing vessel *Shannon Dann* with space shuttle *Endeavour's* external fuel tank (ET-94) under tow. (Image by Emmert International)

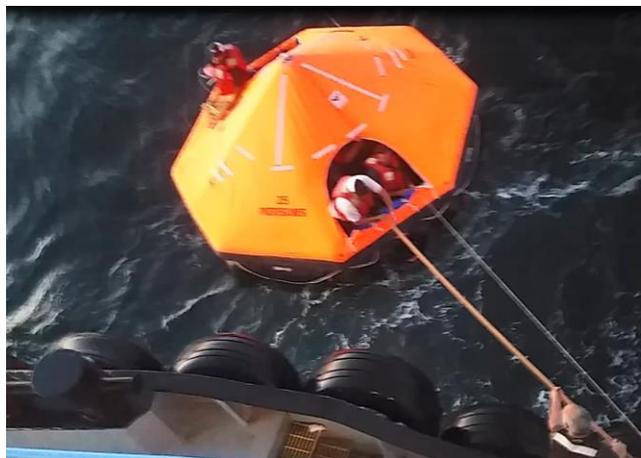
At left, *Maximus* and its liferaft. At right, the *Maximus* crewmembers about to be brought aboard *Shannon Dann*. (Photo by Shannon Dann crew)
