National Transportation Safety Board

Marine Accident Brief

Flooding of Towing Vessel *Atlantic Raider*

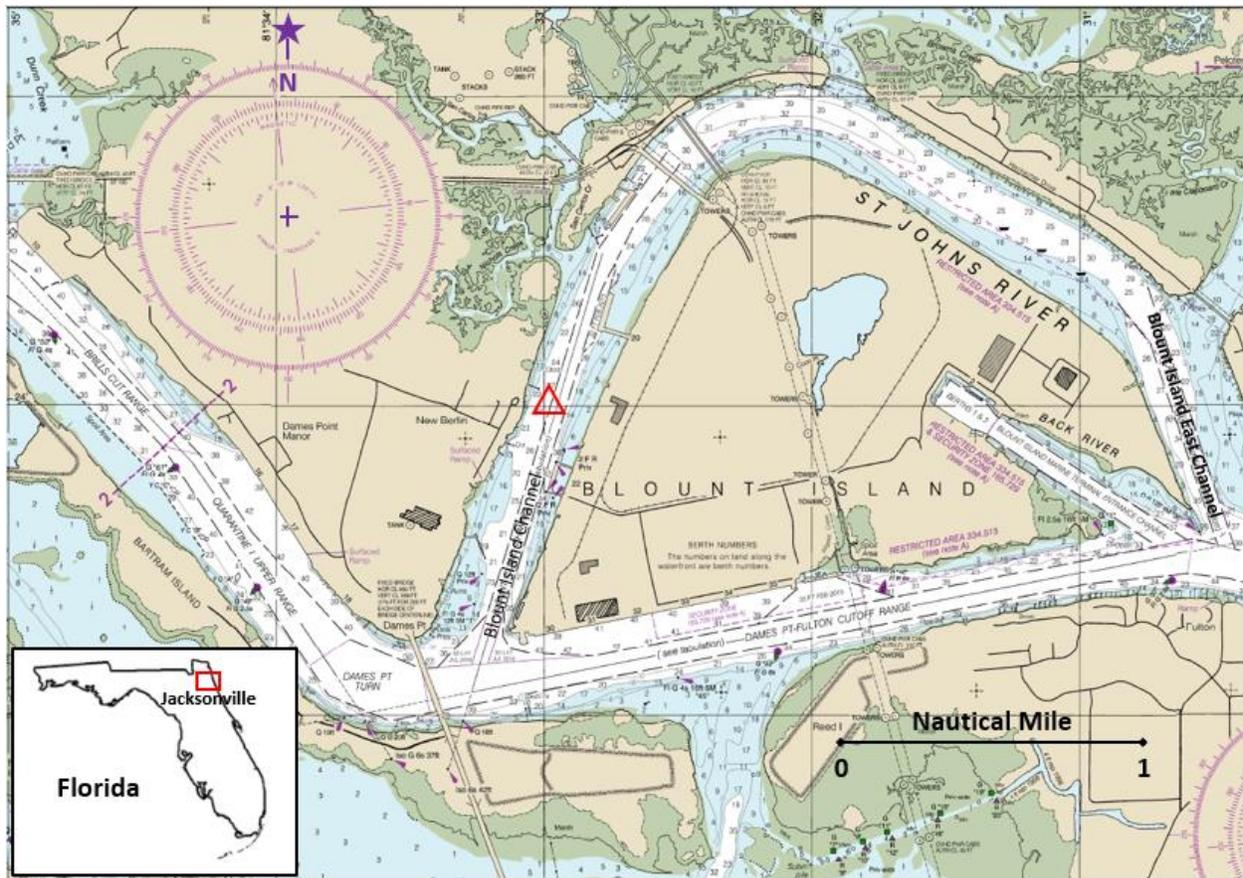
The *Atlantic Raider* was run aground beyond the west side of the Blount Island Channel, shown by the overlaid red triangle. (Background NOAA Chart 11491, *St. Johns River – Atlantic Ocean to Jacksonville*)

At 1545, the crew intentionally grounded the *Atlantic Raider* outside of the channel. The captain told investigators that the vessel rolled to port about 45 degrees as it grounded and came to rest down by the port quarter. Water continued to flood through open portholes on the port and starboard side of the main deck. In a short period of time, the engine room and most of the main deck were fully submerged. The other vessels in the staging area, the *Lady Theo* and the *Free State*, came to aid the *Atlantic Raider*, and all three crewmembers were able to disembark safely from the vessel without injuries. Samples were later taken from the three crewmembers for drug and alcohol testing; all results were negative.
