National Transportation Safety Board

Marine Accident Brief

Collision and Sinking of Towing Vessel *Todd Brown*

Accident no.	DCA17FM010
Vessel name	<i>Todd Brown</i>
Accident type	Collision and sinking
Location	Lower Mississippi River, mile marker 940, near Columbus, Kentucky 36°48.6' N, 89°08.6' W
Date	April 17, 2017
Time	1530 central daylight time (coordinated universal time – 5 hours)
Injuries	None reported
Property damage	\$1.5 million est.
Environmental damage	Approximately 100 gallons of diesel fuel (recovered during salvage operations)
Weather	Cloudy, winds north-northwest about 5 knots, air temperature 64°F
Waterway information	The accident occurred on the Lower Mississippi River about 20 miles south of the confluence with the Ohio River. At the time, the river gauge was about 36 feet (major flood stage) and the current flowing downstream was estimated at 8 mph (7 knots).

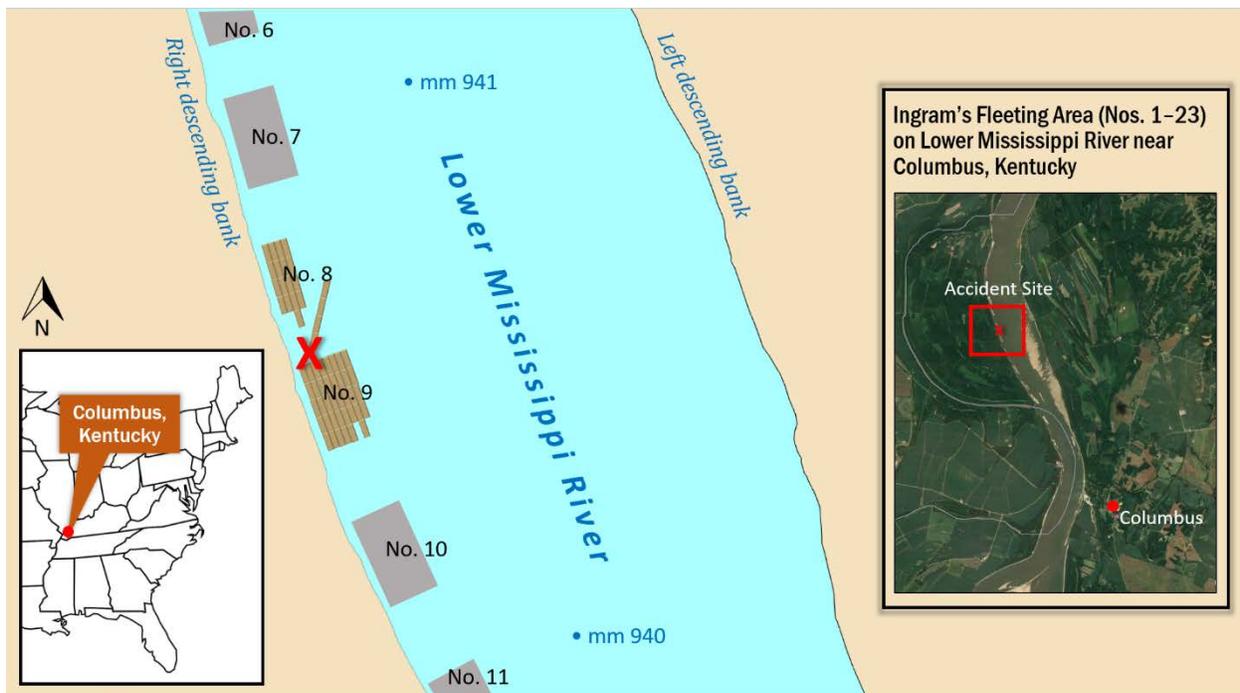
Map of the accident area where the *Todd Brown* collided with moored barges and sank. The locations and dimensions of the fleets nearby are approximate. (Background from Google Earth Pro).

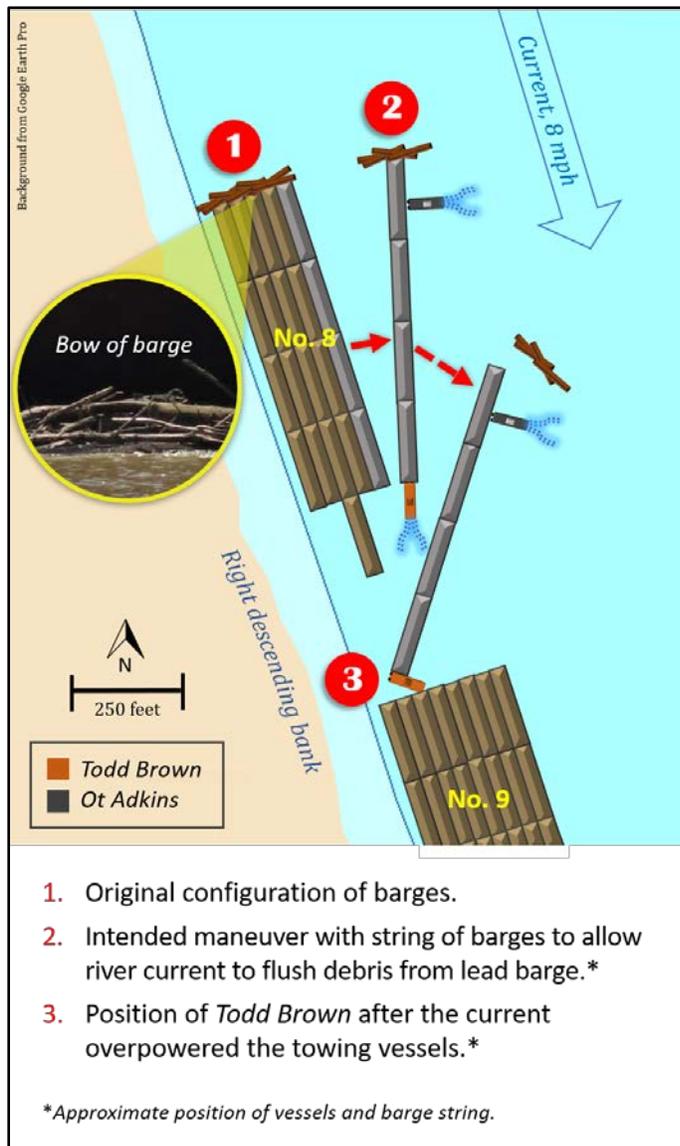
The barge string pinned the *Todd Brown*'s port side against the bow of one of the lead barges in the no. 9 fleet and the force of the river current pushed it under the barge's angled bow rake, causing the *Todd Brown* to list to starboard. After the pilot sounded the general alarm, the crew abandoned the vessel by climbing onto the moored barges. Swamped with water, the *Todd Brown* sank at about 1530 and came to rest in about 35 feet of water. The vessel was loaded with approximately 17,900 gallons of diesel fuel, along with 150 gallons of lube oil and 150 gallons of hydraulic fluid.

spaces, the vessel was refloated and drydocked for inspection. The hull was not damaged, but the wheelhouse structure was distorted, handrails and decks were bent, and all interior spaces were water-damaged, amounting to an estimated \$1.5 million in repairs. There was no damage to the *Ot Adkins* or to any of the barges in fleeting area nos. 8 and 9.
