National Transportation Safety Board

Marine Accident Brief

Capsizing and Sinking of Towing Vessel *Gracie Claire*

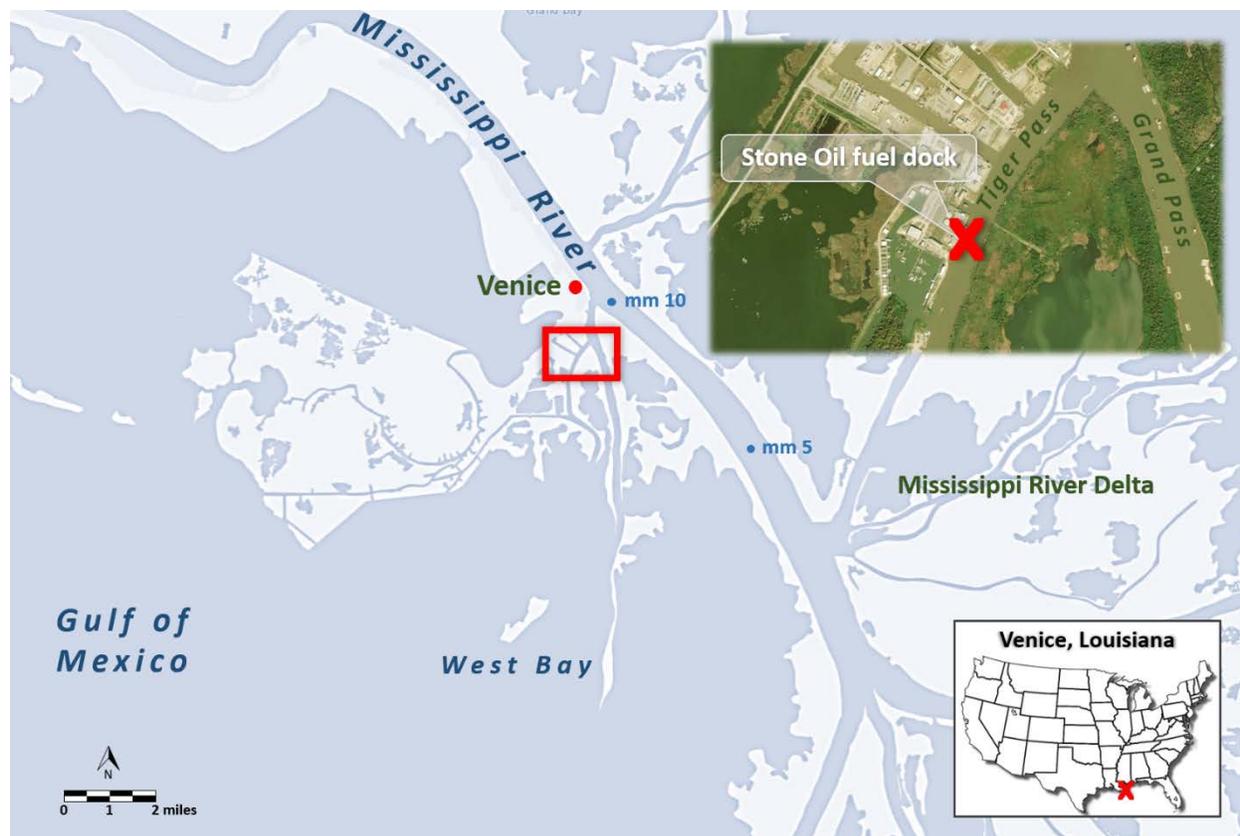
Location where *Gracie Claire* sank in Tiger Pass while vessel was refueling at John W. Stone Oil Distributor dock in Venice, Louisiana. (Base map and satellite image from NOAA ENC® Viewer)
