National Transportation Safety Board

Marine Accident Brief

Allision of *Cooperative Venture* Tow with St. Paul Union Pacific Rail Bridge

Accident no.	DCA18FM003
Vessel name	<i>Cooperative Venture</i>
Accident type	Allision
Location	Upper Mississippi River at mile 835.7, near St. Paul, Minnesota 44°55.13' N, 93°03.02' W
Date	October 26, 2017
Time	About 0230 central daylight time (coordinated universal time – 5 hours)
Injuries	None reported
Property damage	\$953,000 est.
Environmental damage	None
Weather	Visibility 10 miles, clear skies, winds north-northwest at approximately 15 mph, air temperature 45°F
Waterway information	The Upper Mississippi River has a controlling depth of 9 feet and a width of approximately 350 feet at the site of the accident. The current on the morning of the accident was estimated at 2 mph.

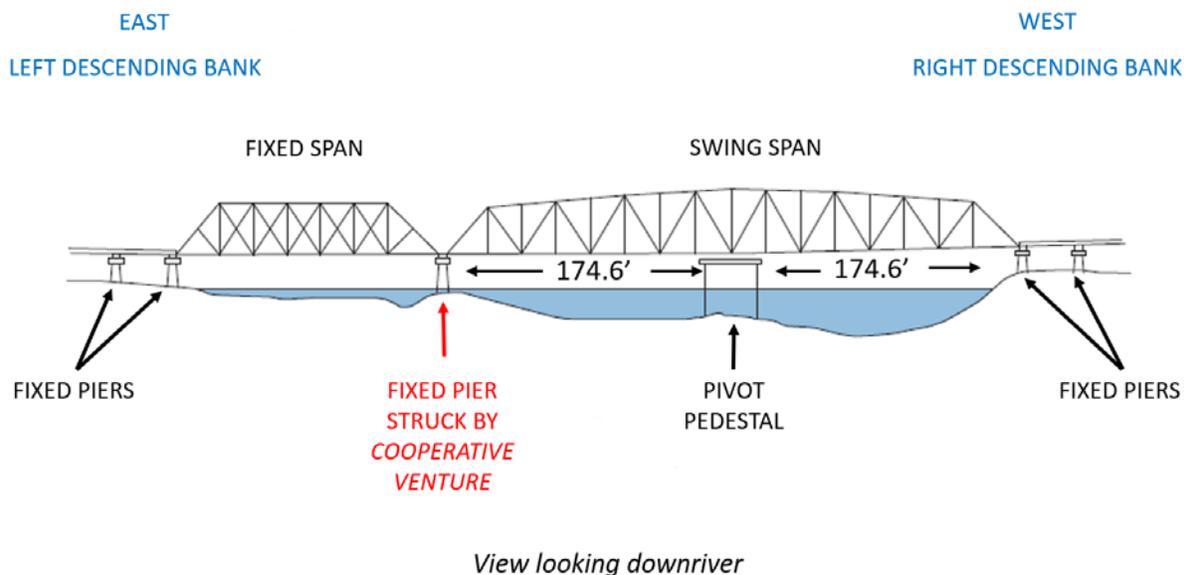
Built in 1910, the St. Paul Union Pacific Rail Bridge was a swing bridge located just south of a bend (referred to locally as “the chute”) and south of the St. Paul Downtown Airport.⁴ The swing span opened by rotating horizontally on a central axis, or pivot pedestal, in line with the navigable channel. When closed, the span rested on two piers: a west fixed pier on the right descending bank and an east fixed pier on the outside of the navigable channel near the left descending bank. The channels on both sides of the pivot pedestal, each measuring 174.6 feet wide, were navigable by downbound and upbound traffic.

St. Paul Union Pacific Rail Bridge in closed position, as approached by *Cooperative Venture*. (US Army Corps of Engineers)
