National Transportation Safety Board

Marine Accident Brief

Collision between Fishing Vessels *Got 'M On* and *Lady Toni*, and Subsequent Sinking of *Got 'M On*

Accident type	Collision	No. DCA18FM031
Vessel names	<i>Got 'M On</i> and <i>Lady Toni</i>	
Location	Gulf of Mexico, near Port O'Connor, Texas 27°53.3' N, 095°41.5' W	
Date	July 28, 2018	
Time	1548 central daylight time (coordinated universal time – 5 hours)	
Injuries	Minor	
Property damage	\$1.45 million est.	
Environmental damage	None reported	
Weather	Visibility 10 miles, winds calm, seas 1–2 feet, air temperature 90°F, water temperature 87°F	
Waterway information	Open waters of the Gulf of Mexico, at a water depth of about 200 feet, approximately 105 miles east of Corpus Christi, Texas

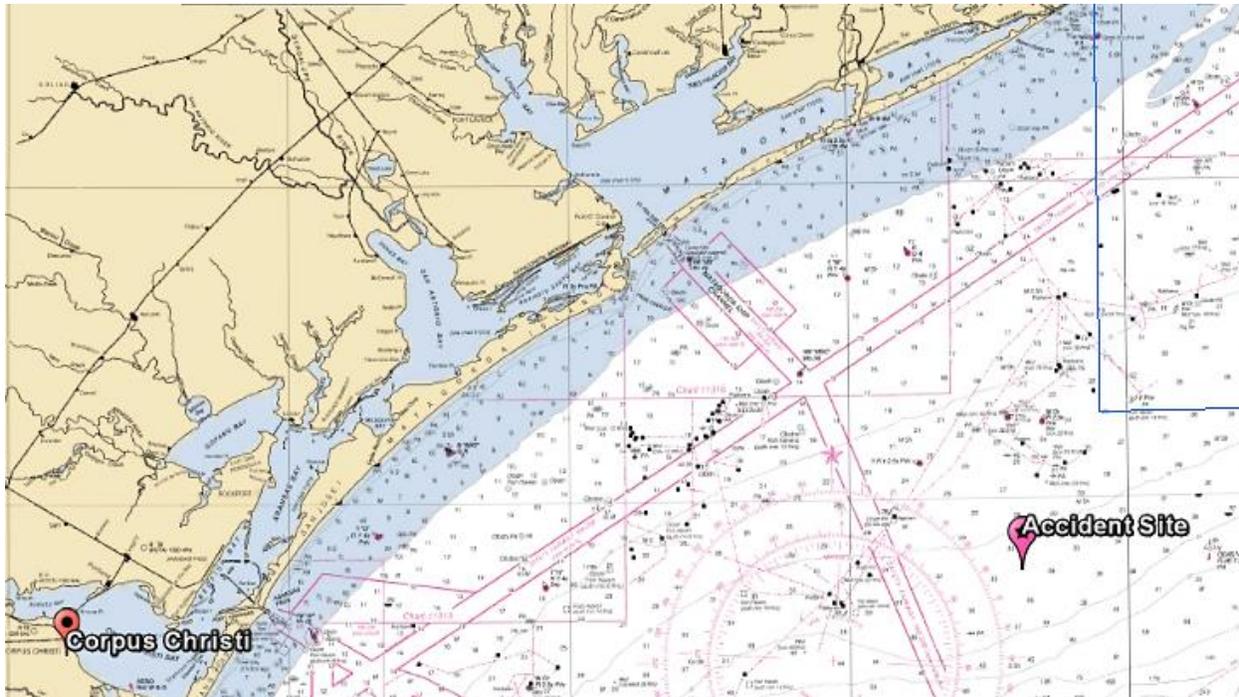
Section of NOAA navigation chart 11300. The accident location, about 105 miles east of Corpus Christi, Texas, is marked.
