National Transportation Safety Board

Marine Accident Brief

Grounding and Sinking of Fishing Vessel *Capt. M&M*

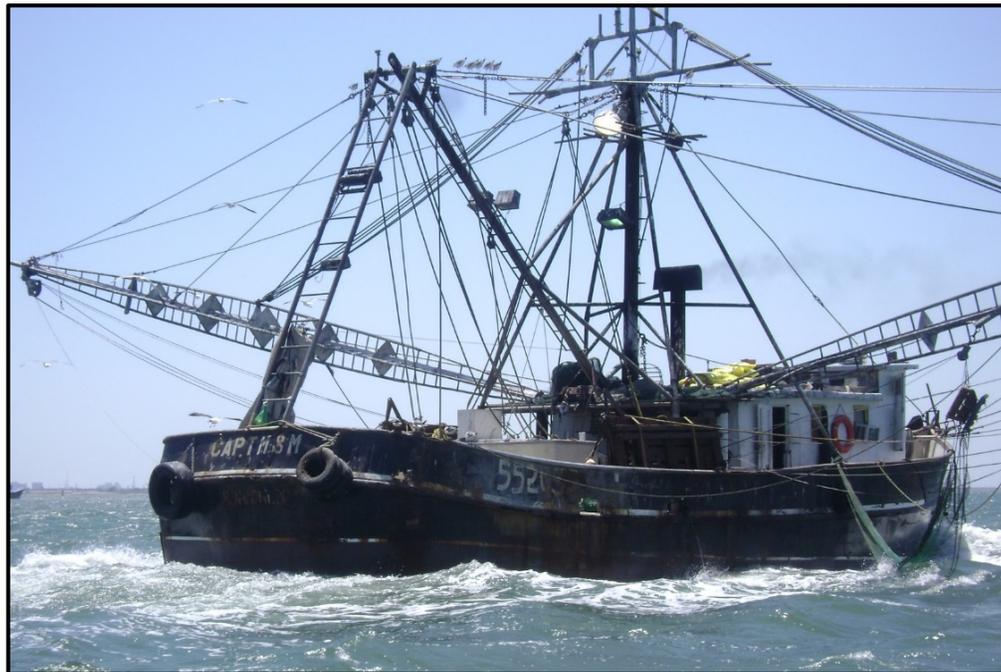
Fishing vessel *Capt. M&M* before the accident. (Source: Coast Guard)

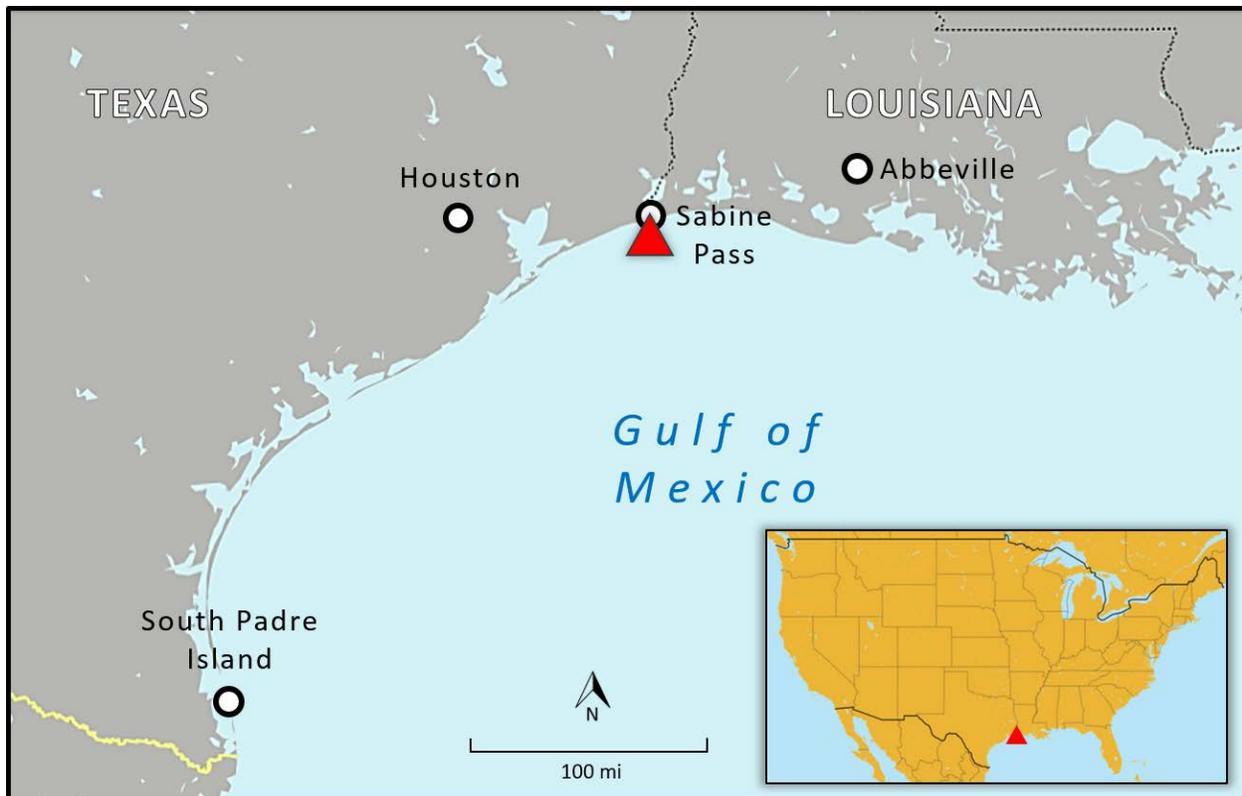
Area of accident where the *Capt. M&M* grounded and later sank, as indicated by the red triangle. (Background Source: Google Earth)
