Allision of Bahamas-Registered Tankship
M/V *Kition* with Interstate Highway 10 Bridge Pier
Baton Rouge, Louisiana
February 10, 2007

NTSB/MAR-08/03
PB2008-916403

Marine Accident Report

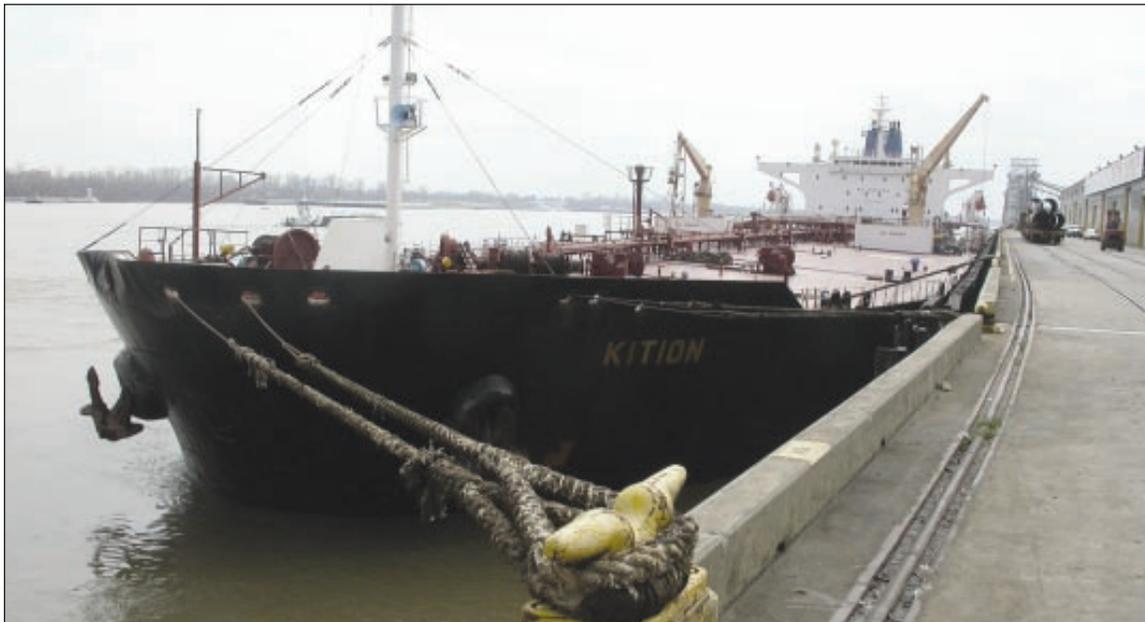
Figure 1. *Kition* docked downriver of the I-10 bridge after the accident. The vessel's draft (freshwater) on the day of the accident was 44 feet 7 inches.
