Allision of the Cargo Vessel M/V *Delta Mariner* with  
Eggner's Ferry Bridge, Tennessee River  
Near Aurora, Kentucky  
January 26, 2012

**Accident Report**  
NTSB/MAR-13/02  
PB2013-106636

# Marine Accident Report

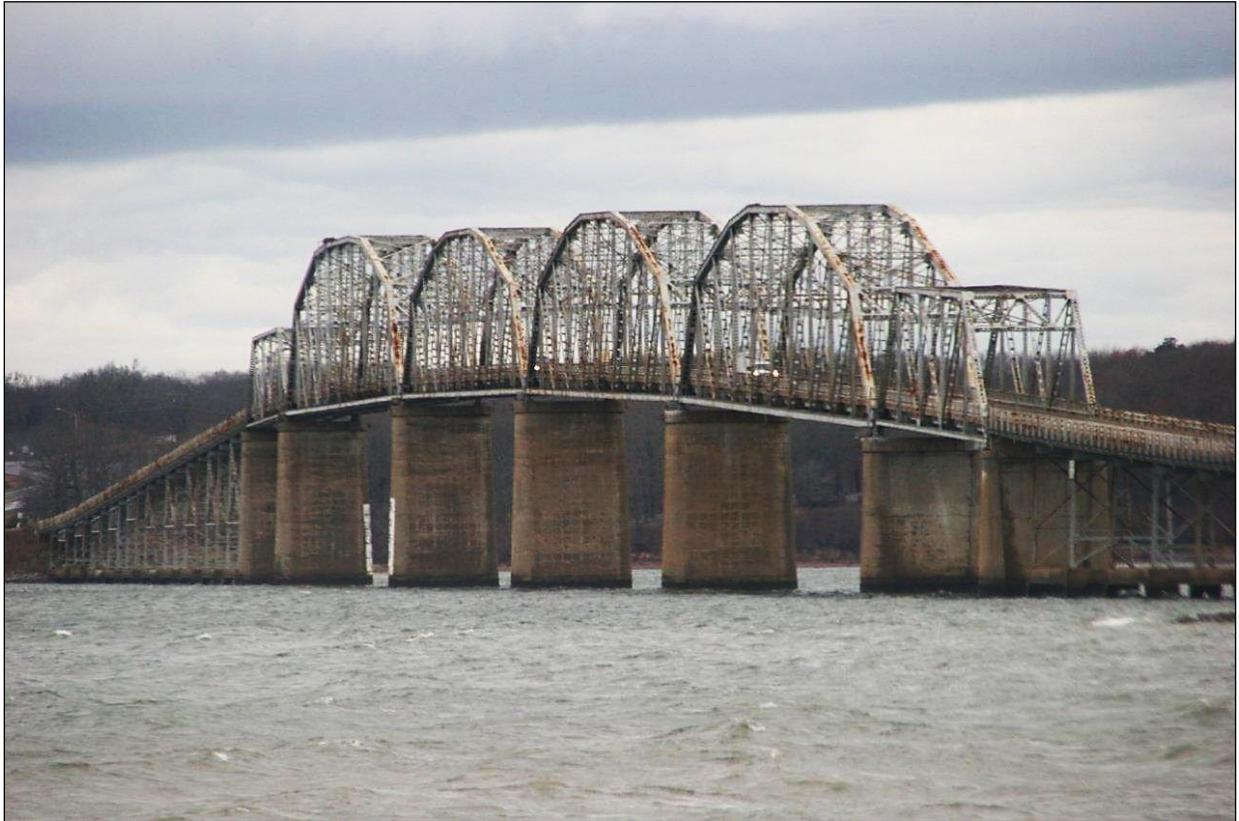
On the evening of the next day, January 26, the *Delta Mariner* approached Eggnor's Ferry Bridge at mile marker 41.7 on the Tennessee River (see figure 3). At 2001 central standard time, the vessel allided with a bridge span that provided insufficient vertical clearance for its passage (the lowest of four navigable spans). The *Delta Mariner* was traveling about 11.5 mph when it struck the bridge and tore away a 322-foot span, including a portion of US Highway 68.<sup>3</sup> Bridge debris lodged across the bow of the ship. The vessel sustained minor damage to its bow area, but its cargo was undamaged. Traffic was light on the bridge at the time of the accident, and vehicles traveling on the highway stopped before reaching the missing span. No injuries were reported on the vessel or on the highway, and no pollution was reported.

**Figure 3.** Eggner's Ferry Bridge, Tennessee River. Photo by US Coast Guard.

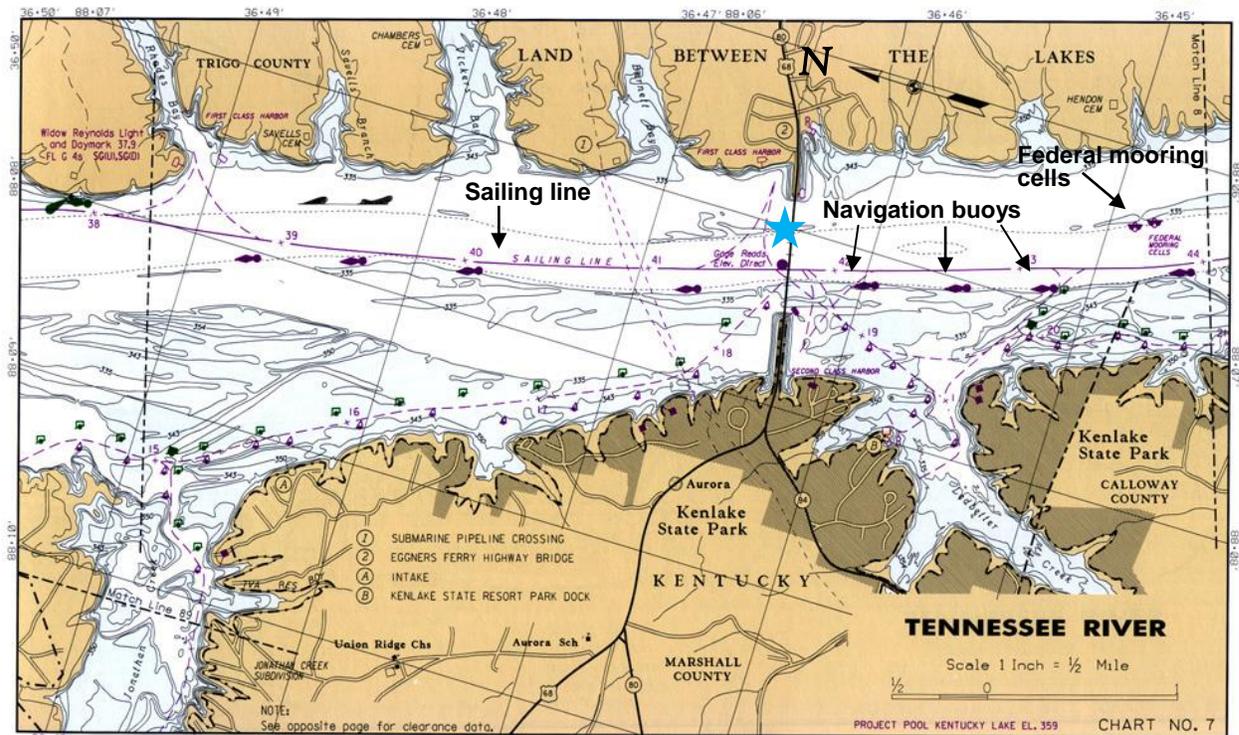
The audio recording revealed that about 1946, 15 minute before the allision, an unidentified voice in the pilothouse called out that the vessel was approaching a bridge (see chart of the accident location in figure 9). At this time, Eggner's Ferry Bridge was approximately 3 miles away. About a minute later, the pilot and chief mate discussed the vessel's heading and navigation aids in the vicinity.

**Figure 9.** Area of US Army Corps of Engineers chart 7 of the Tennessee River detailing the location of the *Delta Mariner* allision with Eggners Ferry Bridge, indicated by a blue star. The sailing line is clearly depicted and labeled in purple.

When the *Delta Mariner* was less than 2.6 miles south of the bridge, the vessel passed the towboat *Addi Belle* secured at the federal mooring cells to the east of the sailing line, indicated in figure 9.<sup>11,12</sup> The *Delta Mariner* master's voice was first heard on the VDR a few minutes later at 1951 when he came to the pilothouse for a routine visit. He told investigators he had woken early for his next watch and went up to "see where we were and . . . see how things were going. And then my intent was to make a quick visit, go back down to my room and get ready to go on watch." The chief mate briefed the master on the expected vertical clearance of the upcoming bridge. The *Delta Mariner* was about 1.8 miles from the bridge at this time.

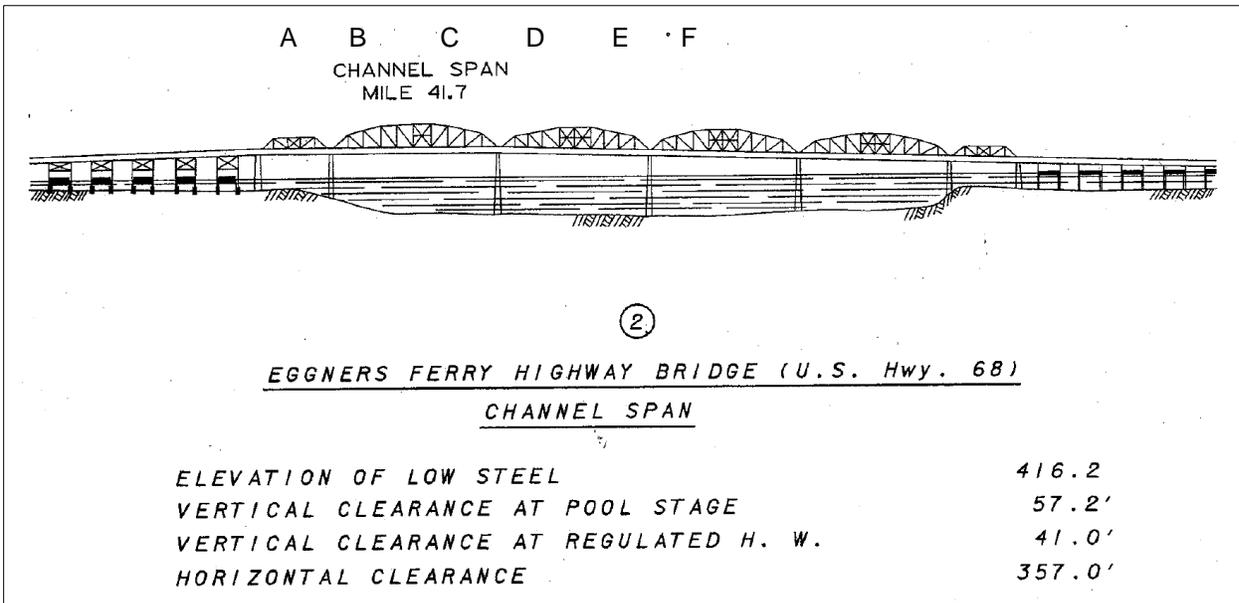
The main navigation span, or span B, and its vertical clearance were indicated in a diagram in the Army Corps of Engineers chart book (see figure 10).<sup>13</sup> The bridge lighting plan was not shown on the paper chart but was available from the vessel's ECS. According to the bridge lighting plan, this span should have been marked by a green light in the center, three

white lights arranged vertically above the green light, and a red light on the pier on each side of the span. Crewmembers in the pilothouse told investigators only three lights were visible on the entire bridge as they approached—two red lights marking bridge piers at each side of the span and one green light in between marking the middle of the span. The lighted span was span E, approximately 800 feet to the right of the sailing line and the center of the main navigation span.

**Figure 10.** Eggner's Ferry Bridge channel span elevation in the Army Corps of Engineers chart book, with labels added to identify spans A through F. This drawing depicts the bridge as viewed from upstream, the side the *Delta Mariner* was approaching.
