# **NATIONAL TRANSPORTATION SAFETY BOARD**

## **MARINE ACCIDENT REPORT**

**FIRE ABOARD THE  
BAHAMIAN PASSENGER SHIP  
M/V SCANDINAVIAN SUN  
PORT OF MIAMI  
MIAMI, FLORIDA  
AUGUST 20, 1984**

**NTSB/MAR-85/08**

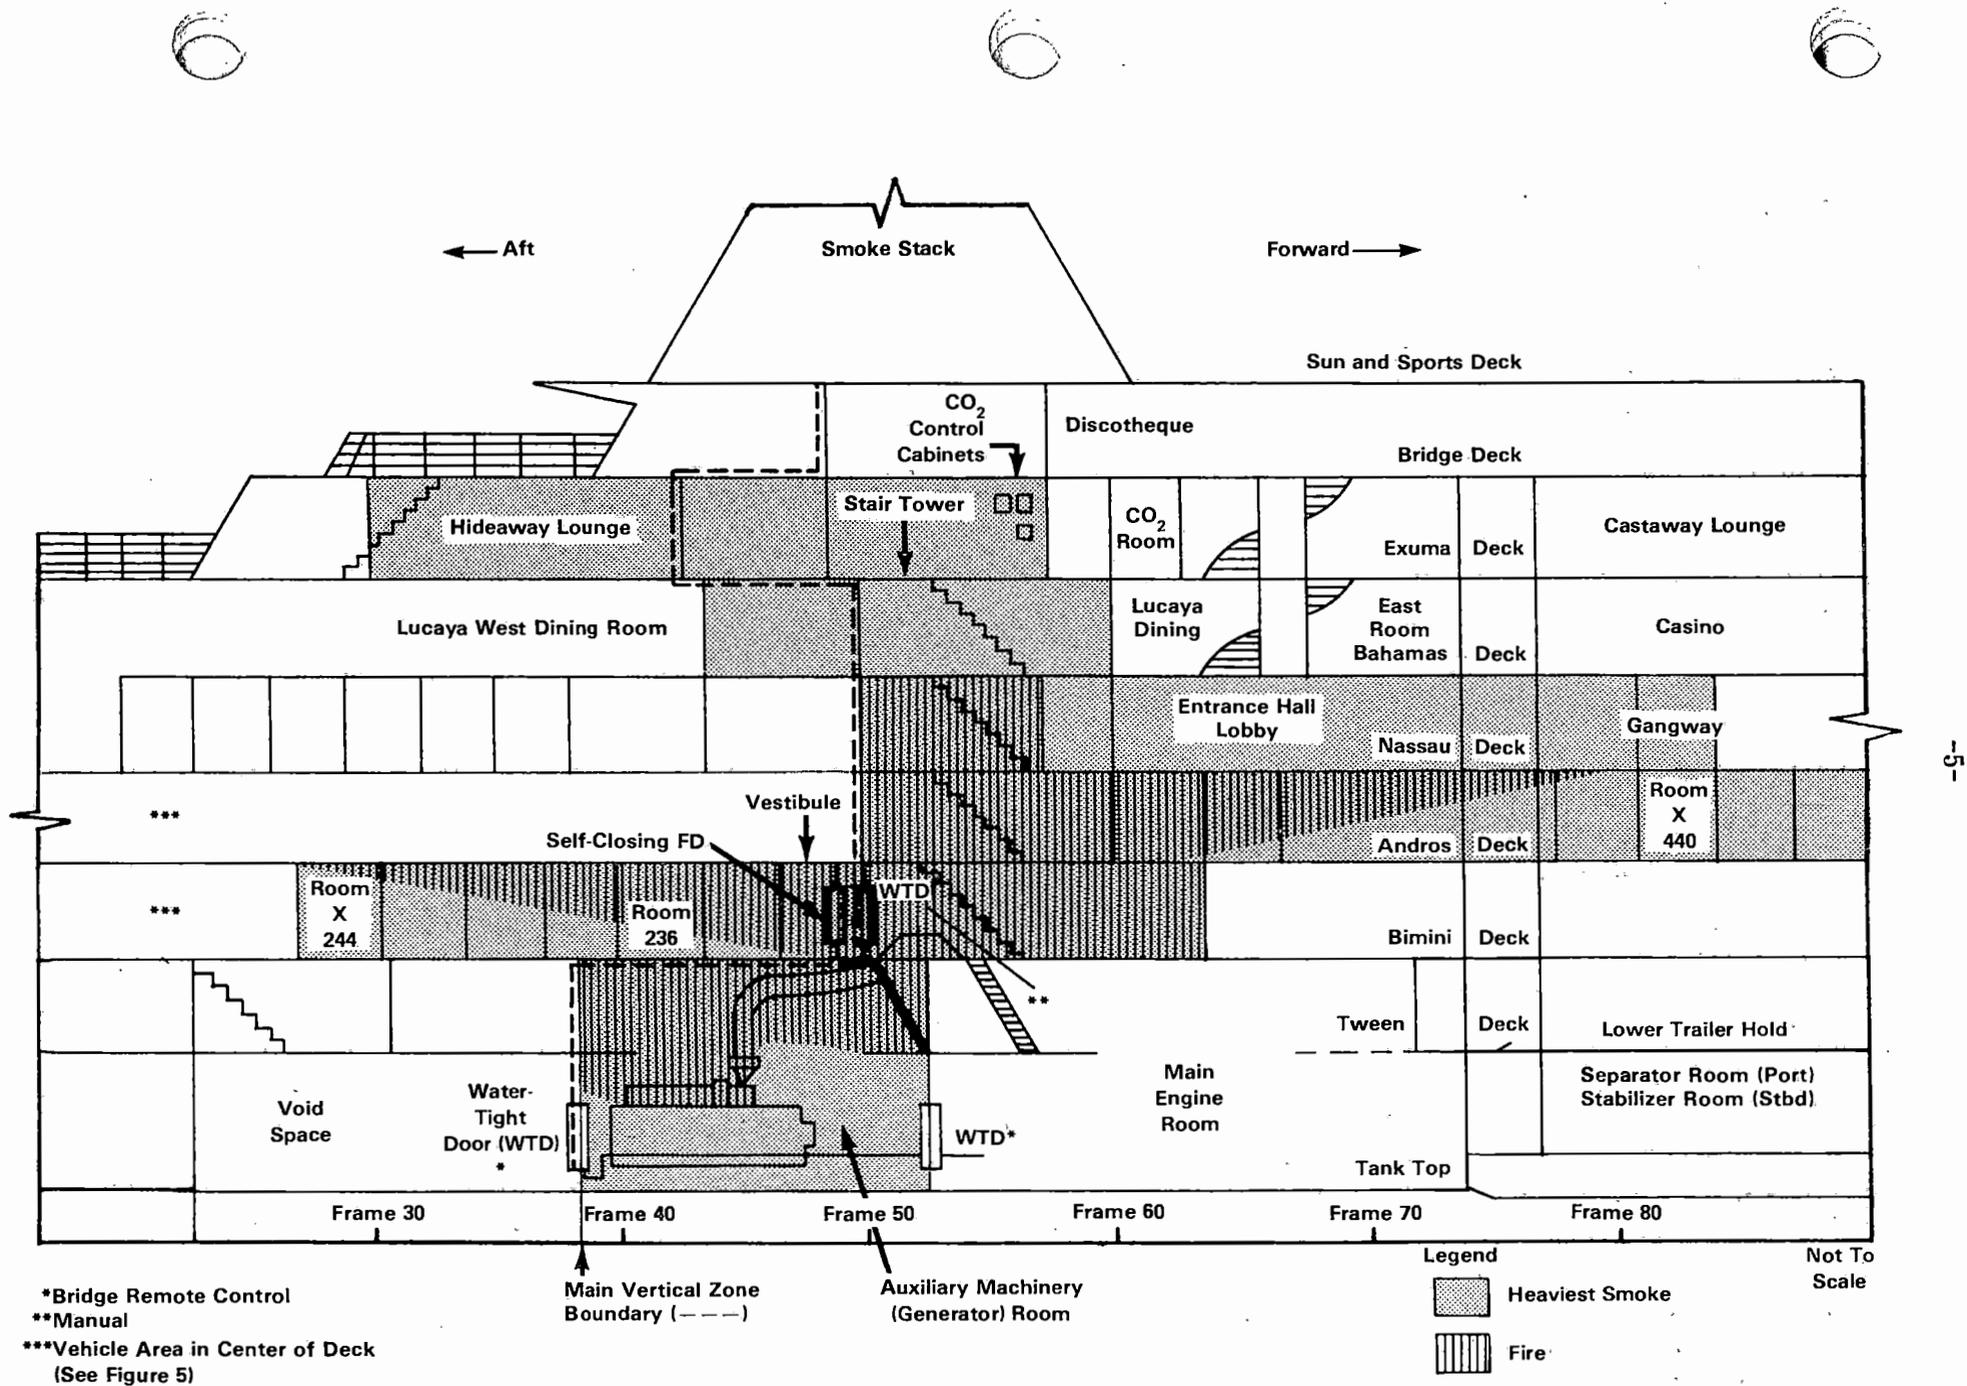
Figure 3.--Inboard profile, portside.

The master was in his room which is below the pilothouse and on the Exuma Deck when he heard the engineer's alarm. He immediately proceeded to the pilothouse where he saw that the fire detection panel indicator lights were flashing for the generator room; Bimini Deck-port side aft and vehicle area; Andros Deck-port side aft and amidships; Nassau Deck-aft, port and starboard and lobby; Bahamas Deck-Lucaya West dining room and casino; Exuma Deck-Hideaway Lounge, Castaway Lounge, smokestack, and starboard circular stairway; and Bridge Deck-circular stairway and Discotheque. (See figure 3.) The lights indicated that at least one fire detector in each zone had been activated.
