PB92-916406  
NTSB/MAR-92/01/SUM

## **MARINE ACCIDENT/INCIDENT REPORT SUMMARY REPORT**

**COLLISION OF THE U.S. SAILING VESSEL  
AMERICAN PROMISE AND THE U.S. FREIGHT  
BARGE E-2, BEING PUSHED AHEAD OF THE  
U.S. TUG M/V SUN COAST, OFF COVE POINT,  
CHESAPEAKE BAY, APRIL 21, 1991**

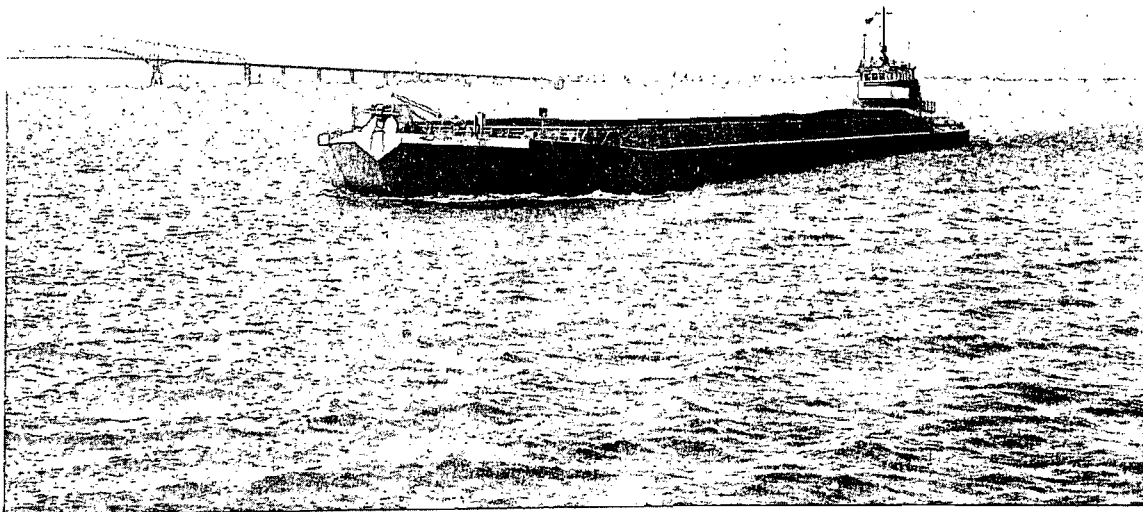
The SUN COAST, an 85-foot-long, 1,800-HP, twin-screw diesel engine tug was bound from Newport News, Virginia, to Baltimore harbor, pushing the 350-foot-long Barge E-2, which was carrying about 7,000 tons of coal. The tug's bow was secured in the notched stern of the barge. (See figures 3 and 4.) The barge's drafts were 14' 4" forward and 15' 2" aft. The tug's 5-man crew comprised a master, relief master, two deckhands, and an engineer; the barge was unmanned.

Figure 3.--Photograph of Barge E-2 being pushed by the tug GULF COAST.

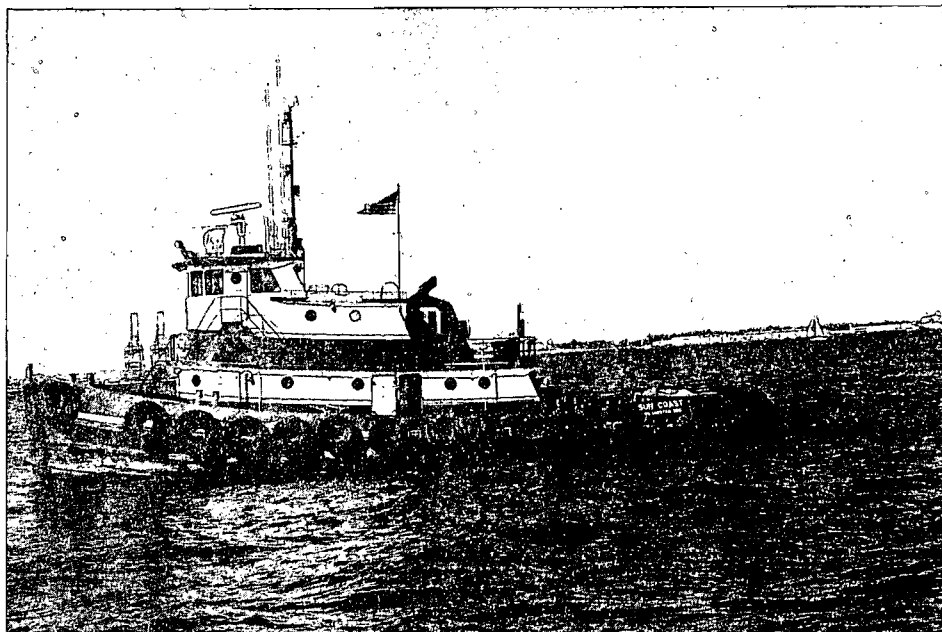
Figure 4.--Photograph of the SUN COAST.
