MIR-24-17

Engine Room Fire on board Passenger Ferry *Sandy Ground*

Anchorage Channel, New York Harbor
Staten Island, New York
December 22, 2022

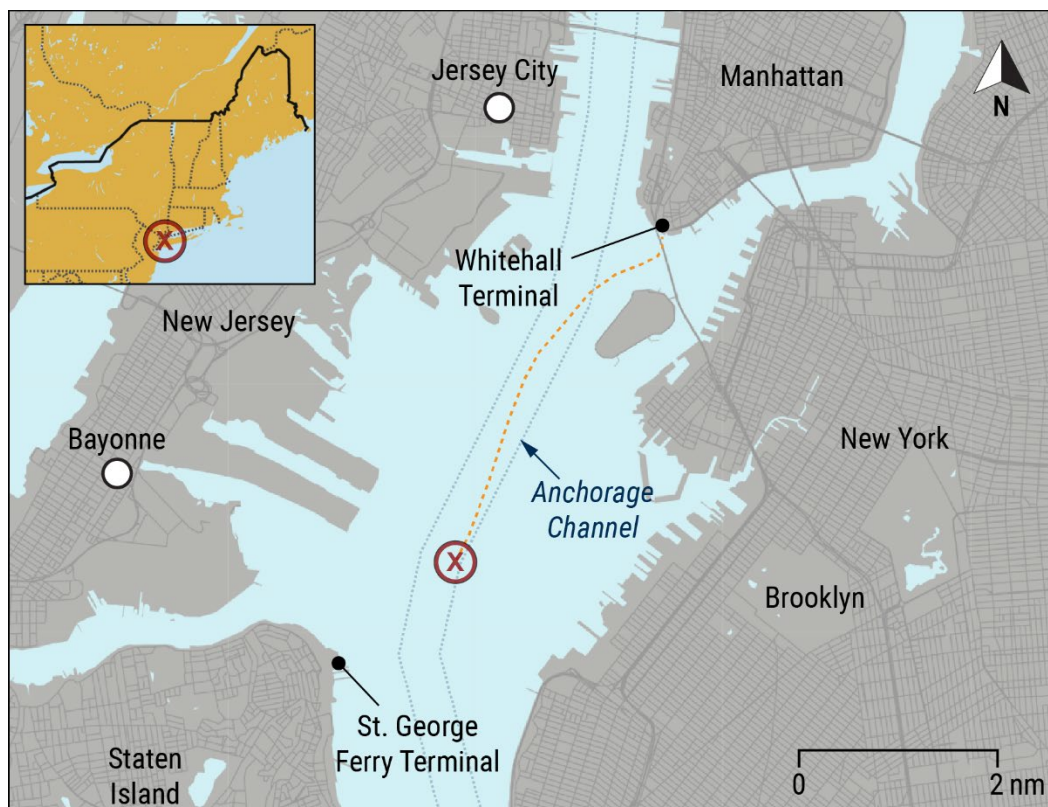
At 1654, when the *Sandy Ground* was near buoy 30 in Anchorage Channel, about 12 minutes after departing Manhattan, CCTV footage showed a fire breaking out on the exhaust manifold of the no. 2 main engine (see figure 8 and figure 9). Oiler 1, in the engine room by the no. 1 main engine, smelled smoke and saw fire. The fire spread onto the upper covers of the engine, and embers began falling from the overhead.

Figure 9. Approximate track of *Sandy Ground* through New York Harbor. The area where the engine room fire broke out on board the vessel is indicated by a circled X (Background source: Google Maps)

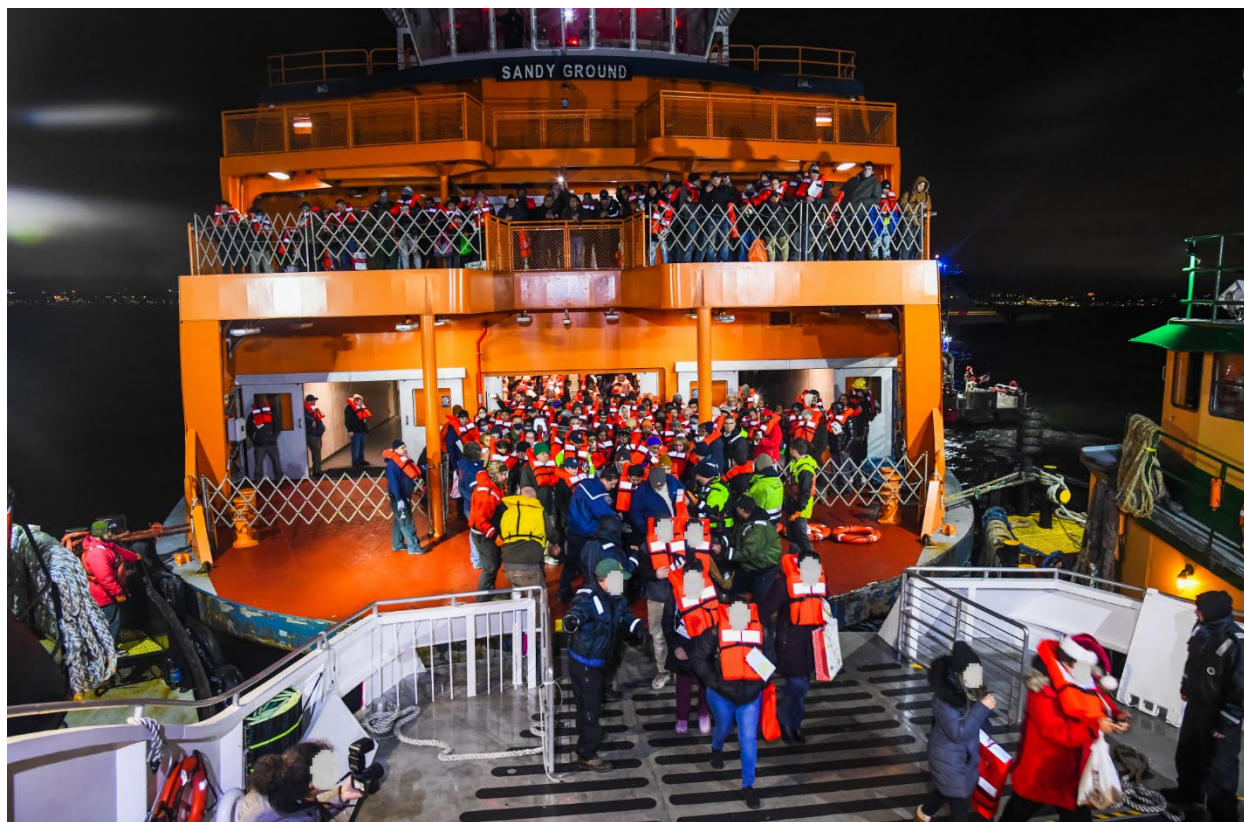
The *River Sprinter* was the first vessel to position its bow against the *Sandy Ground*'s bow. About 1725, *Sandy Ground* passengers began transferring to the *River Sprinter*; the *River Sprinter* took 138 passengers. Next, the *Franklin Delano Roosevelt* took 558 passengers (see figure 10), and the *Great Eagle* took 120 passengers (accounting for 816 of the 884 persons on board the *Sandy Ground*). The decks of the *Sandy Ground* and the *Franklin Delano Roosevelt* were about the same height, so passengers could walk from one vessel to the other. The other two ferries were smaller and had a lower freeboard, so passengers had to step down as they were disembarking the *Sandy Ground*.¹²

Figure 10. Evacuation of passengers from the *Sandy Ground* to the *Franklin Delano Roosevelt*. (Source: NYCDOT Ferry Division)

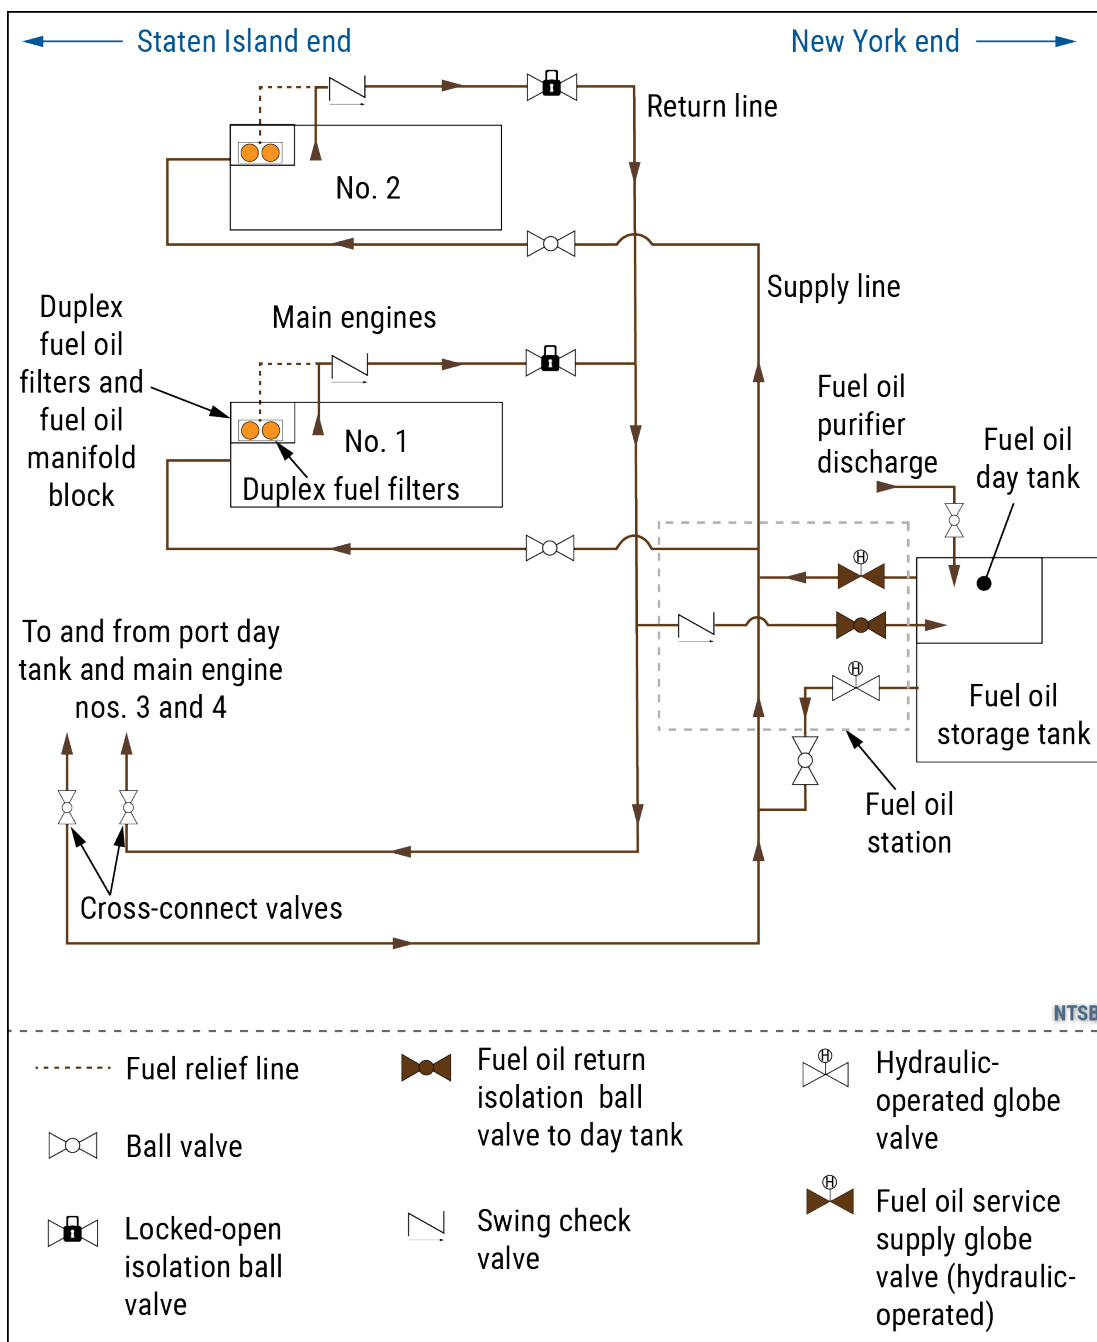
The fuel oil system consisted primarily of a fuel transfer pump, supply and return piping, and a purifier. The port and starboard fuel oil day tanks supplied fuel oil to the main diesel engines, diesel engine-driven electrical generators, and heating boilers, also referred to as “consumers” (see figure 13). The fuel oil supply system was equipped with a cross-connect valve, which could be used to separate equipment between day tanks. When the supply cross-connect valve was closed, the port day tank supplied the nos. 3 and 4 main engines and nos. 2 and 3 generators, while the starboard day tank supplied the nos. 1 and 2 main engines, no. 1 generator, and both boilers.

Figure 13. Simplified fuel oil piping drawing showing only engine nos. 1 and 2 for clarity. (The boilers and generators are not shown; see [Appendix D](#) for a more detailed drawing showing the fuel oil piping system.)

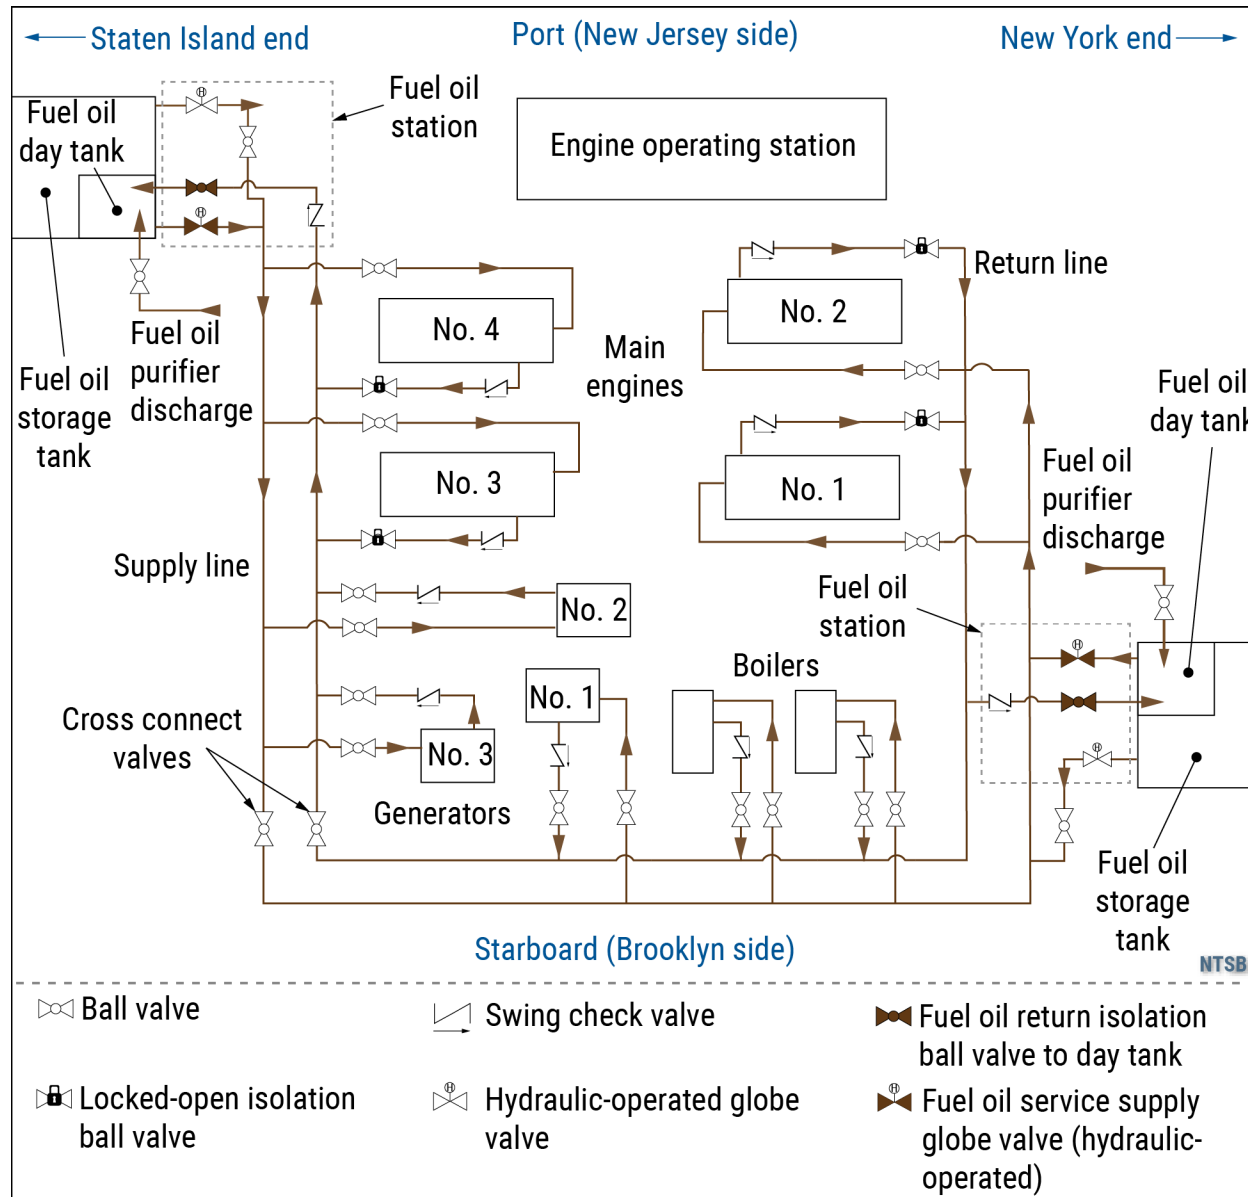
Figure D-1. Fuel oil piping drawing for the *Sandy Ground* at the time of the casualty, showing the fuel oil supply and return arrangement for the four main engines, three generators, and two boilers to and from the day tanks located on the outboard sides of the engine room.
