July 25, 2024

MIR-24-20

Flooding and Sinking of Towing Vessel *Jacqueline A*

On August 8, 2023, about 1859 eastern daylight time, the towing vessel *Jacqueline A* sank about 3 miles east of North Myrtle Beach, South Carolina, after taking on water while transiting in the Atlantic Ocean (see figure 1 and figure 2).¹ The three crewmembers abandoned the vessel and were recovered by local emergency responders. There were no injuries. Most of the estimated 5,000 gallons of diesel fuel on board the vessel leaked into the sea. Following salvage, the vessel was determined to be a constructive total loss valued at \$660,000.

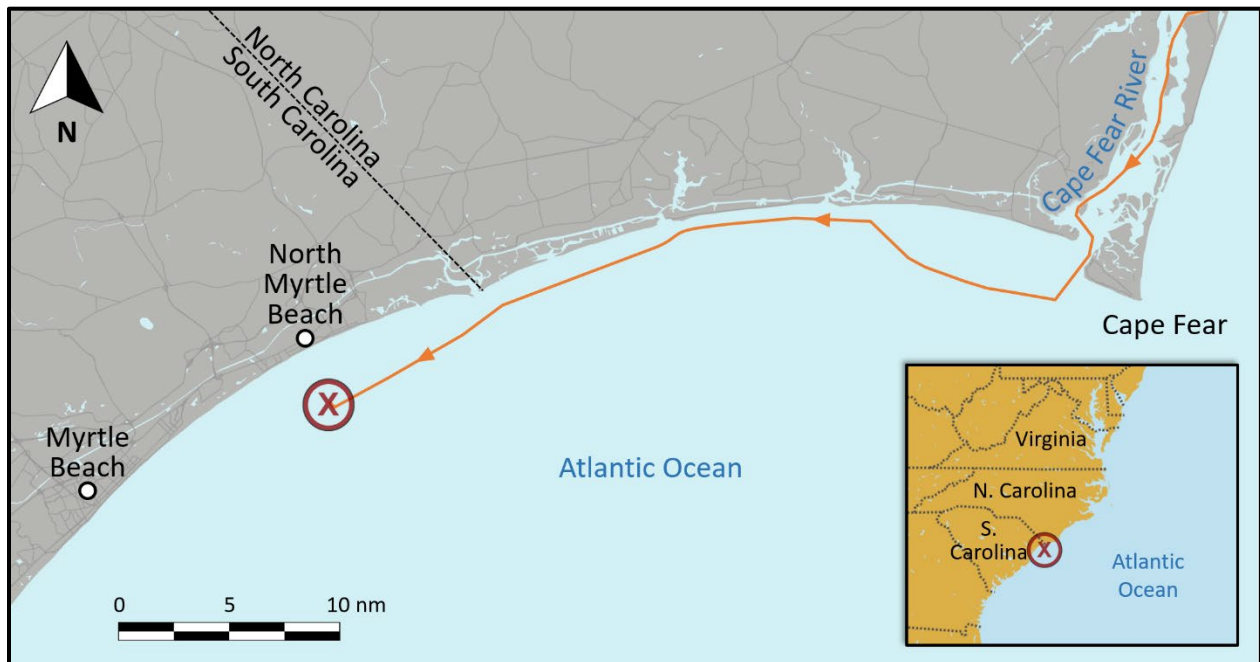
Figure 2. Trackline of the *Jacqueline A* with the location where the vessel sank, as indicated by a circled X. (Background source: Google Maps)

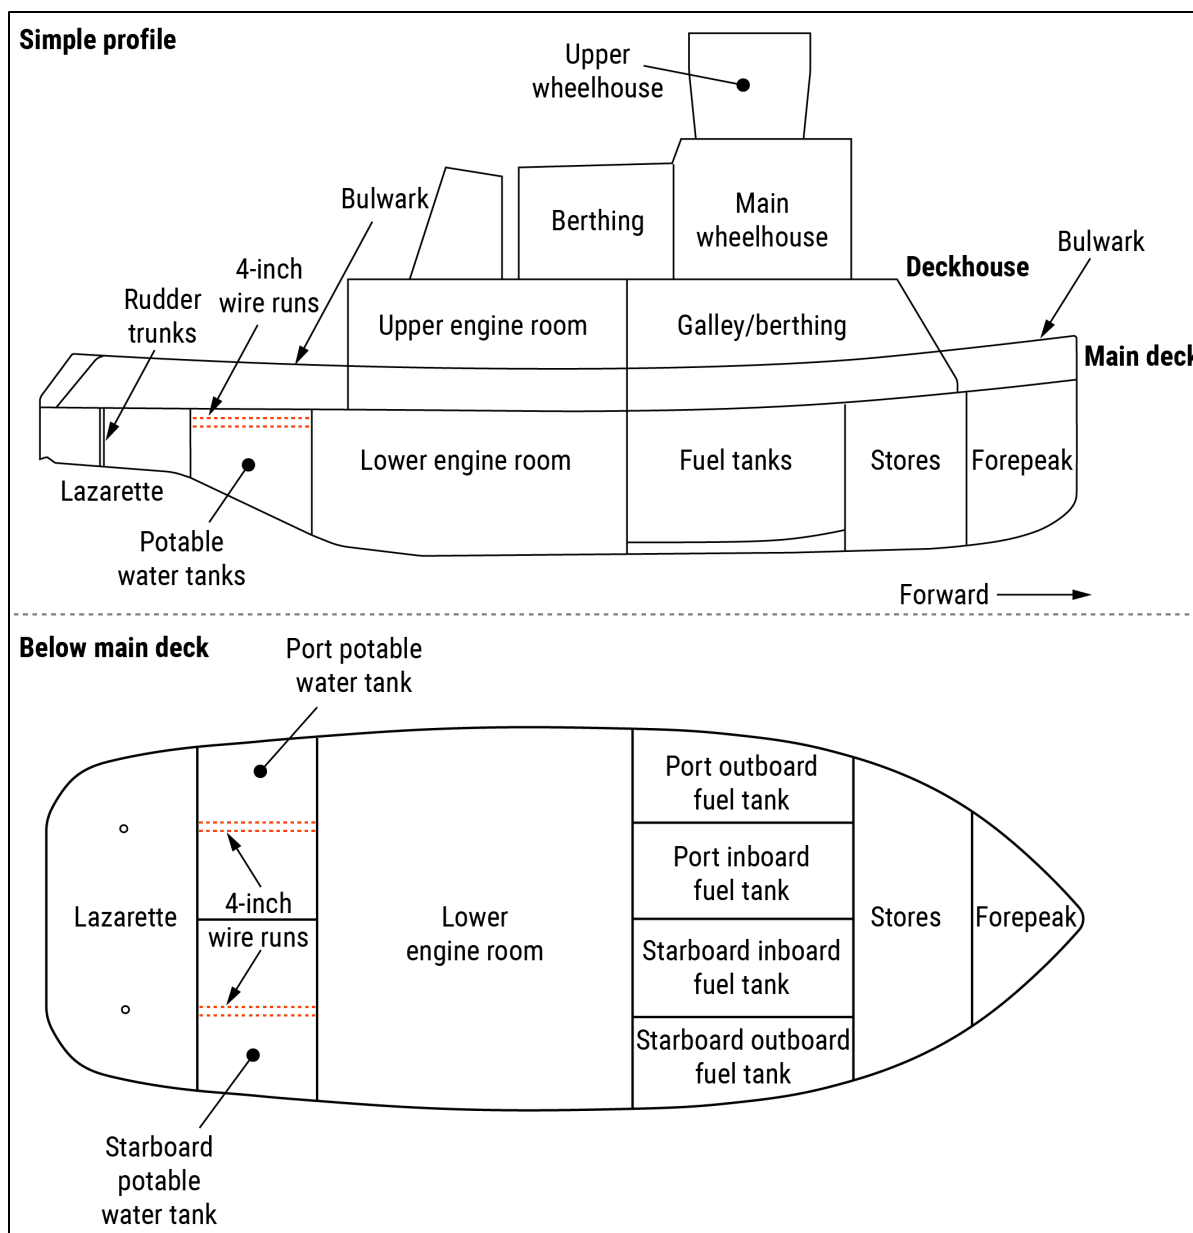
The *Jacqueline A* was configured with a deckhouse above the main deck that included a main wheelhouse, an upper wheelhouse, the upper level of the engine room, a galley, and crew berthing areas (see figure 3). During the casualty voyage, the crew conned the vessel from the main wheelhouse. Below the main deck, the vessel was arranged (forward to aft) with a forepeak tank, a stowage space, fuel tanks, the lower engine room, potable water tanks, and the lazarette. The lazarette was accessible via two hand-operated hatches on the aft main deck.

Two 4-inch-diameter steel pipes ran between the aft engine room bulkhead and the forward lazarette bulkhead, through the port and starboard potable water tanks. The open-ended pipes were designed as wire, or cable, runs to connect the engine room and lazarette. The wire runs were located about 5 feet 9 inches from centerline on the port and starboard sides of the vessel and were about 6.5 inches beneath the main deck. Neither of the wire runs were sealed to prevent water or air from moving between the spaces.

Figure 3. General arrangements of the *Jacqueline A*.

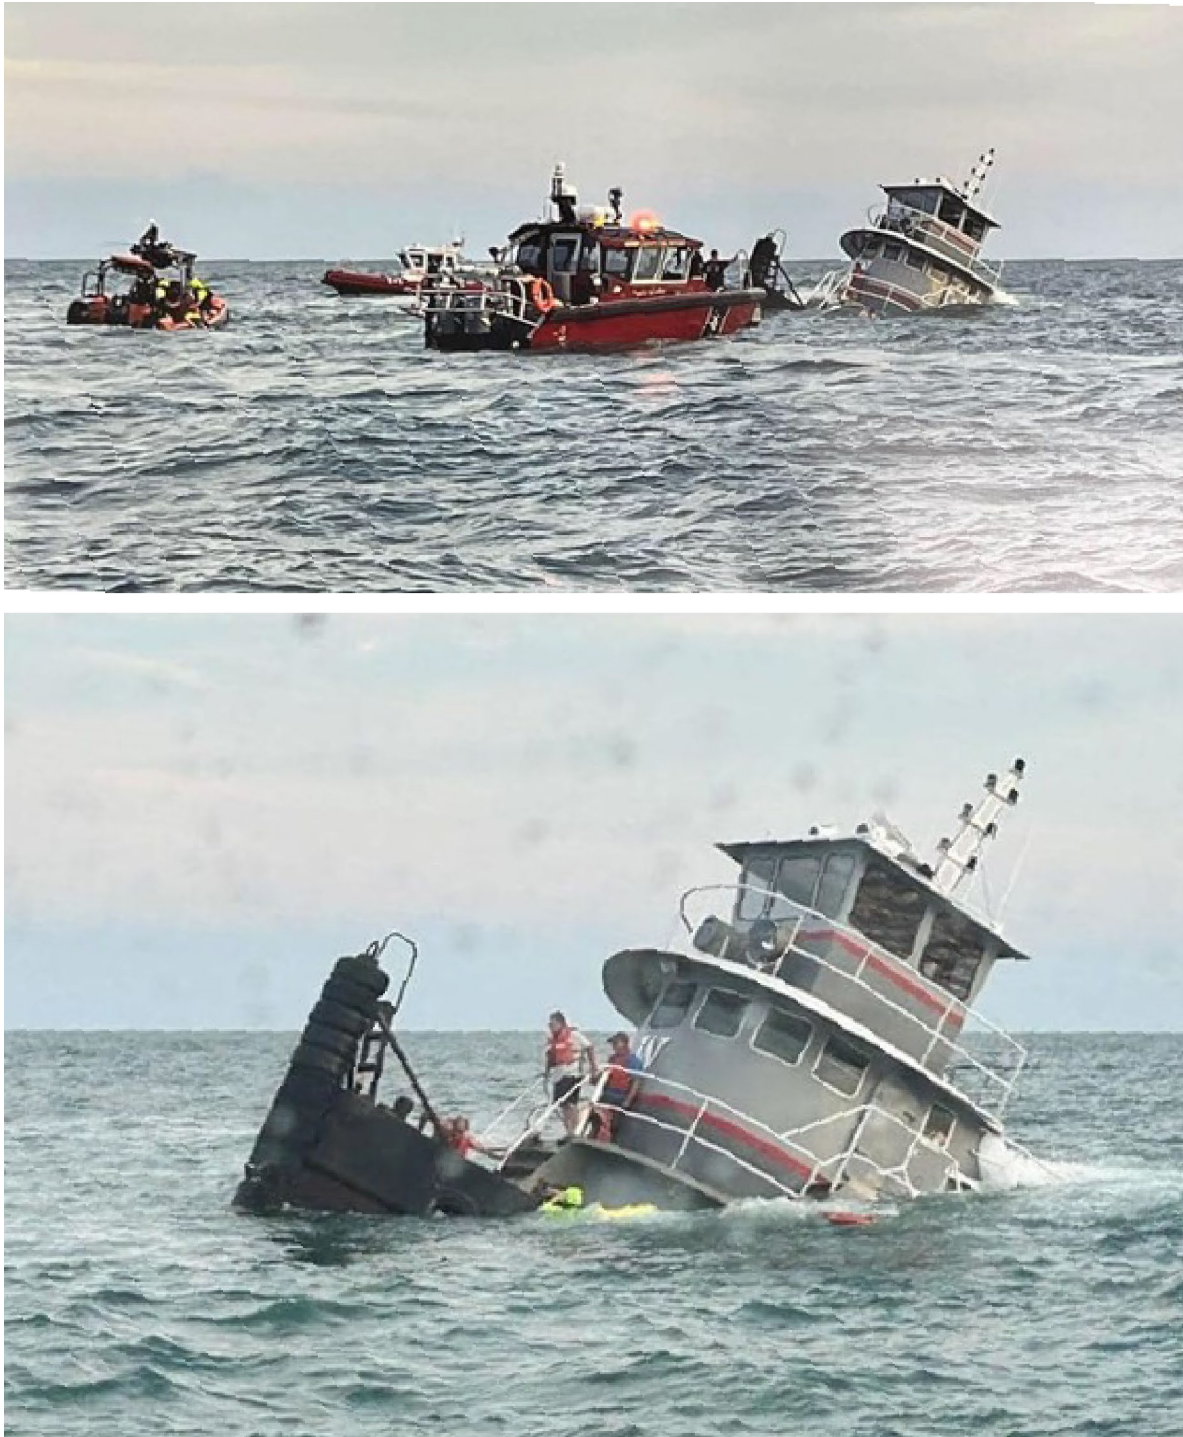
Figure 4. *Jacqueline A* rescue operations. From top: response vessels on scene and rescue swimmer (fluorescent yellow) assisting crewmember into the water. (Source: North Myrtle Beach Rescue Squad)
