August 29, 2024

MIR-24-25

Breakaway of Bulk Carrier *Sirocco* and Subsequent Collision with Moored Barge

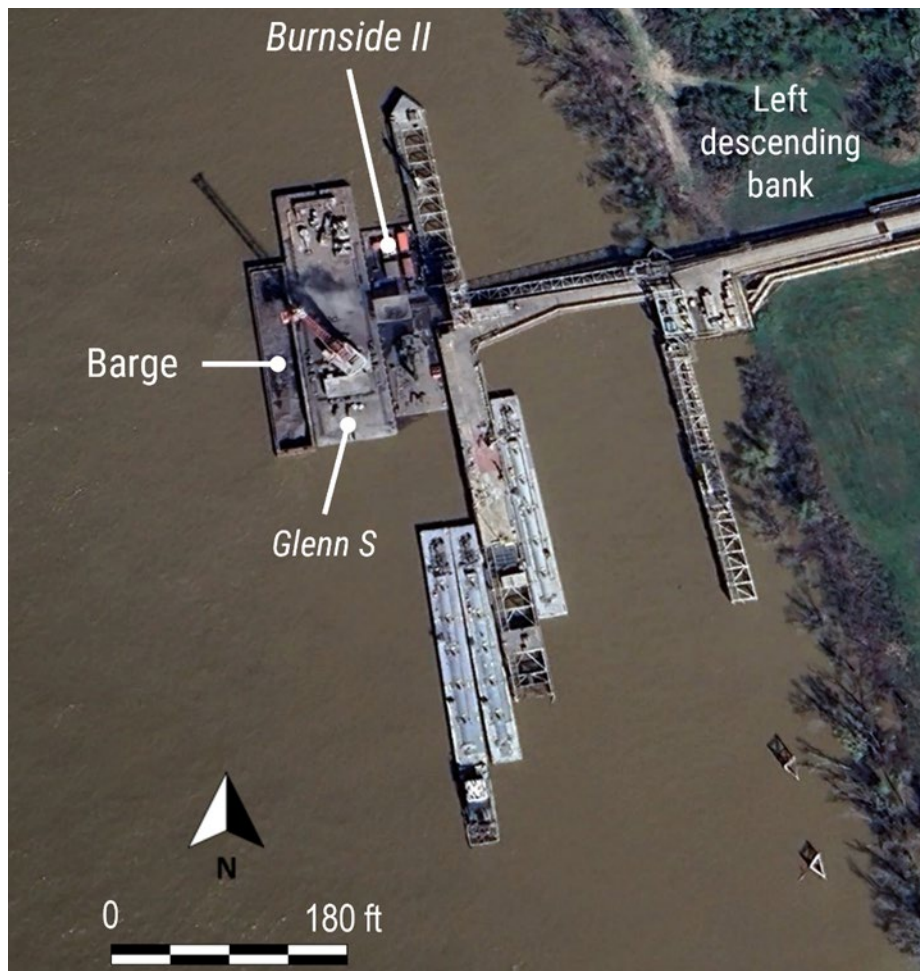
At the Mosaic Uncle Sam dock, three barges were moored alongside each other. The hopper barge *MEM 5087* was outboard of the crane barge *Glenn S* and

the deck barge *Burnside II*, which was moored to the dock (see figure 6). The barge *MEM 5087* was being loaded with phosphoric rock from the crane on the *Glenn S*.

Figure 6. The Mosaic Uncle Sam dock with a barge similar in size to the *MEM 5087*, *Glen S*, and *Burnside II* alongside the dock on March 4, 2023. (Background source: Google Earth)
