## Contact of *Kitty* Tow with Algiers Lock Gate

On July 4, 2023, about 1808 local time, the towing vessel *Kitty* was pushing two loaded tank barges through the Algiers Lock near mile 88.4 on the Lower Mississippi River in New Orleans, Louisiana, when the lead barge, *EMS 317*, struck one of the lock gates (see figure 1 and figure 2).<sup>1</sup> There were no injuries, and no pollution was reported. Damage to the barge was negligible, while damage to the lock gate was about \$2 million.

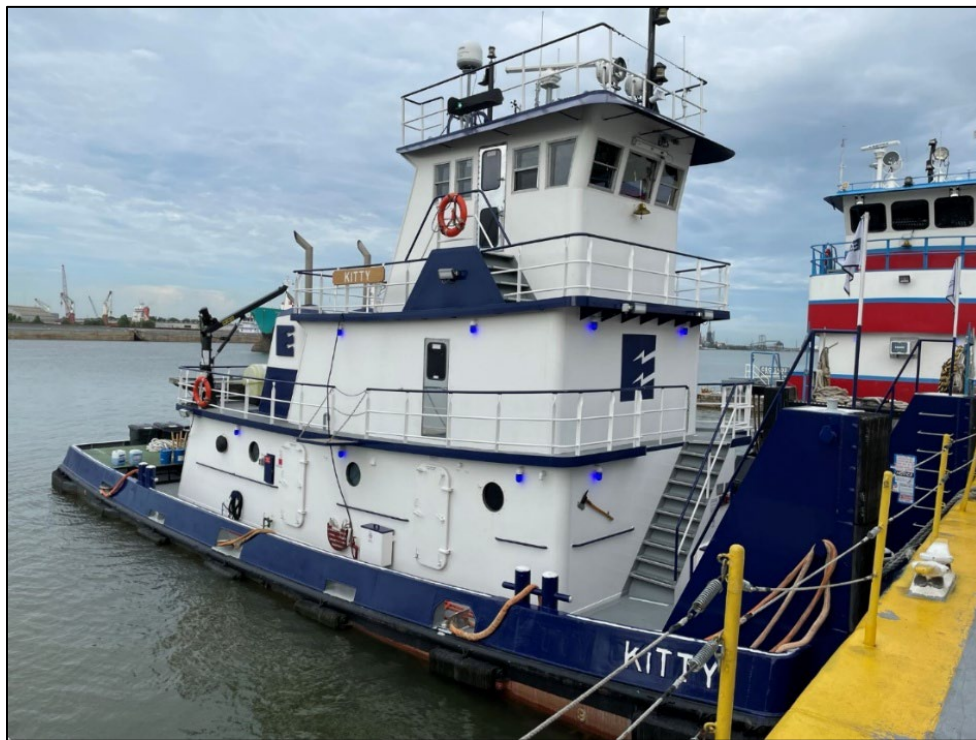
**Figure 1.** The *Kitty* after the casualty.

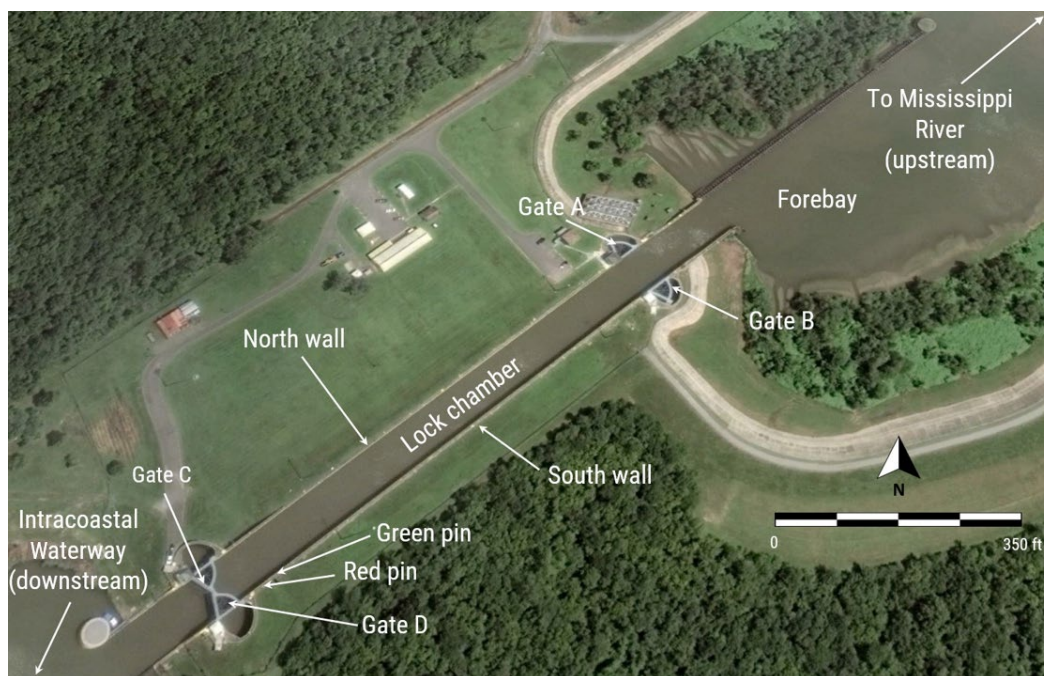
**Figure 3.** Algiers Lock with the lock gates in the position they were in at the time of the casualty. (Background source: Google Earth)

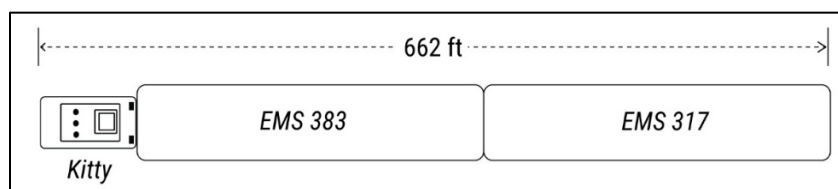
The two tank barges, owned and operated by Enterprise Marine Services, LLC, were strung out with the *EMS 317* (built 2004) at the head of the tow and the *Kitty* faced up to the *EMS 383* (built 2013) at the rear of the tow (see figure 4). Each barge was 297 feet long by 54 feet wide and loaded with about 24,000 barrels of light cycle oil. The deepest draft of the tow was the loaded barges (10 feet). The overall length of the tow was 662 feet, and the width was 54 feet.

**Figure 4.** *Kitty* tow configuration.

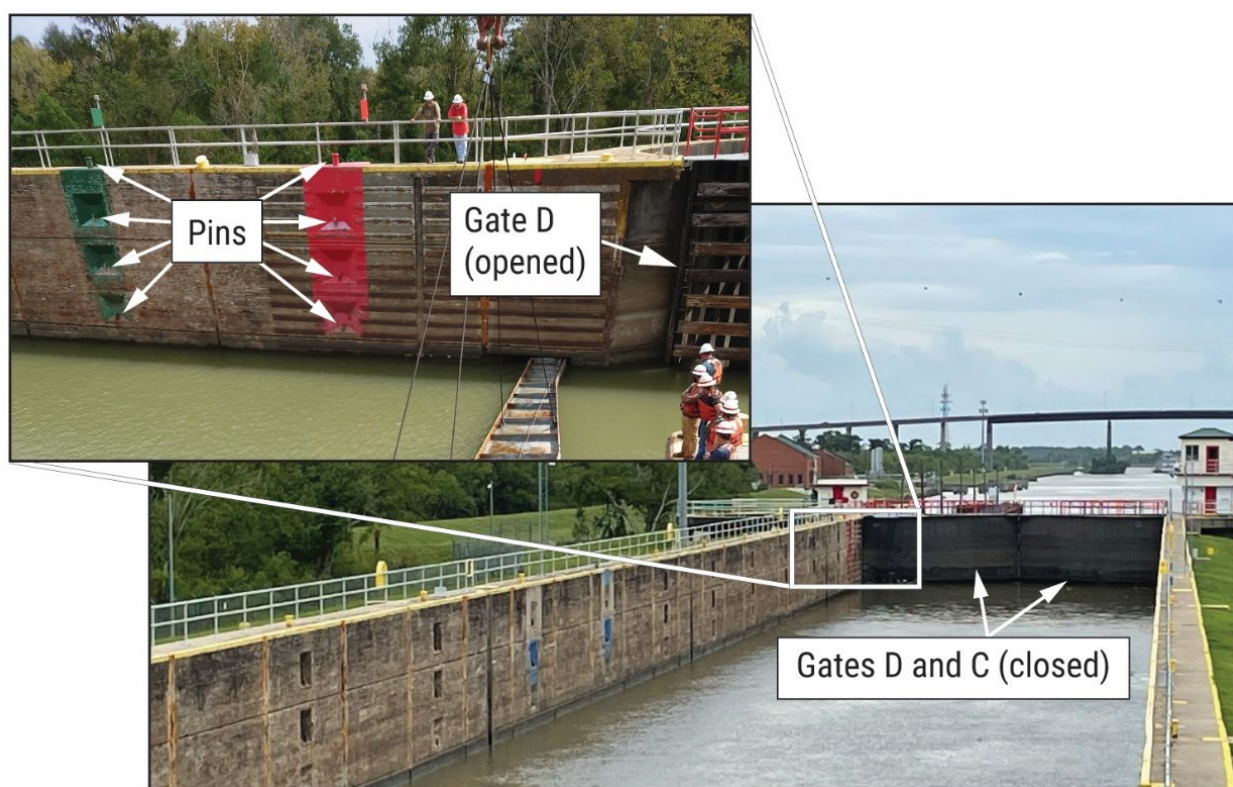
The lock operator requested the *Kitty* have two crewmembers at the head of the tow and its bumpers (fenders) ready as the tow entered the lock. The lock operator also instructed the captain to proceed down and tie up the head of the tow at one of the green pins (about 66 feet from the closed lock gates) on whichever side of the lock he preferred (see figure 5).<sup>6</sup>

**Figure 5.** View downstream (looking southwest from chamber) of the Algiers Lock, showing the area where the red and green pins are located and closed Gates C and D. Inset shows the red and green pins' proximity to Gate D.
