PIPELINE ACCIDENT SUMMARY REPORT

PIPELINE RUPTURE, LIQUID BUTANE RELEASE,
AND FIRE
LIVELY, TEXAS
AUGUST 24, 1996

**NTSB/PAR-98/02/SUM
PB98-916503
Notation 7081
Adopted: November 6, 1998**

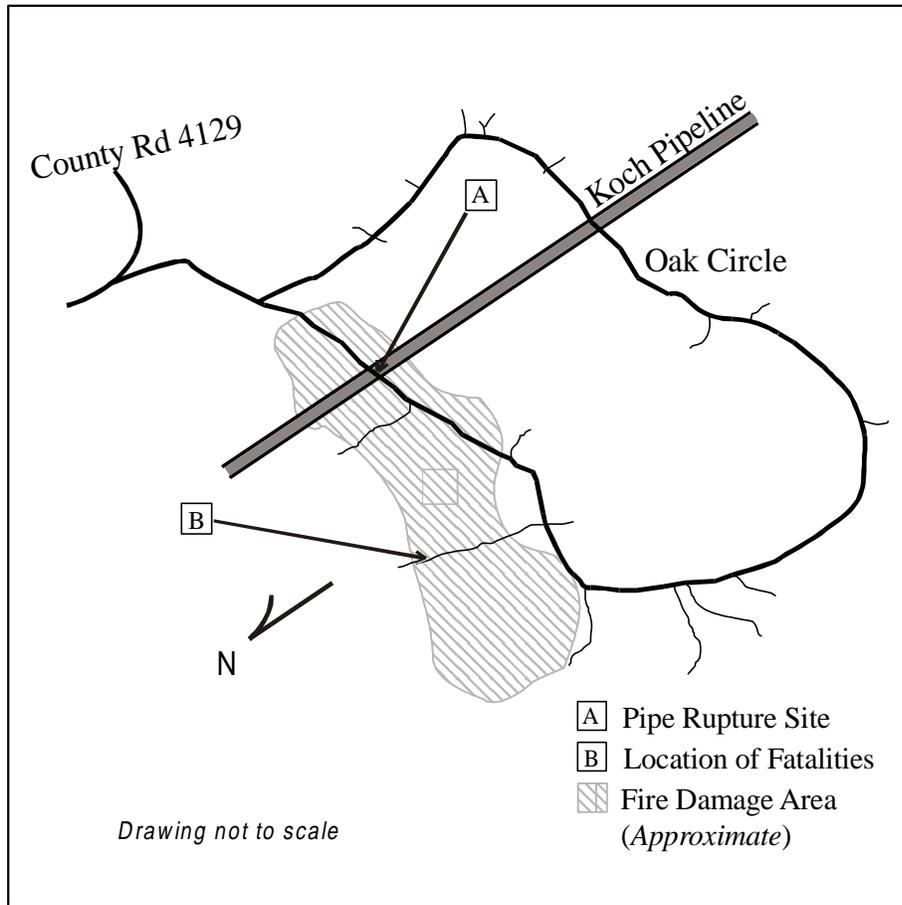
Figure 1. Sketch showing area of butane vapor dispersement and corresponding fire

On Saturday, August 24, 1996, about 3:26 p.m.,¹ an 8-inch-diameter steel LPG (liquefied petroleum gas) pipeline transporting liquid butane,² operated by Koch Pipeline Company, LP (Koch),³ ruptured near Lively, Texas, sending a butane vapor cloud into a surrounding residential area. The rupture occurred under a roadway in the Oak Circle Estates subdivision (figure 1).

In 1996, about 45 families lived on two roads in the area of the accident, Oak Park Circle and County Road 4129 (figure 1). Of the 45 residences listed on the two roads, only 5 addresses appeared on Koch’s 1996 preaccident mailing list. The two families that suffered fatalities were not on the mailing list. The person who called Koch to report the release was on the mailing list.

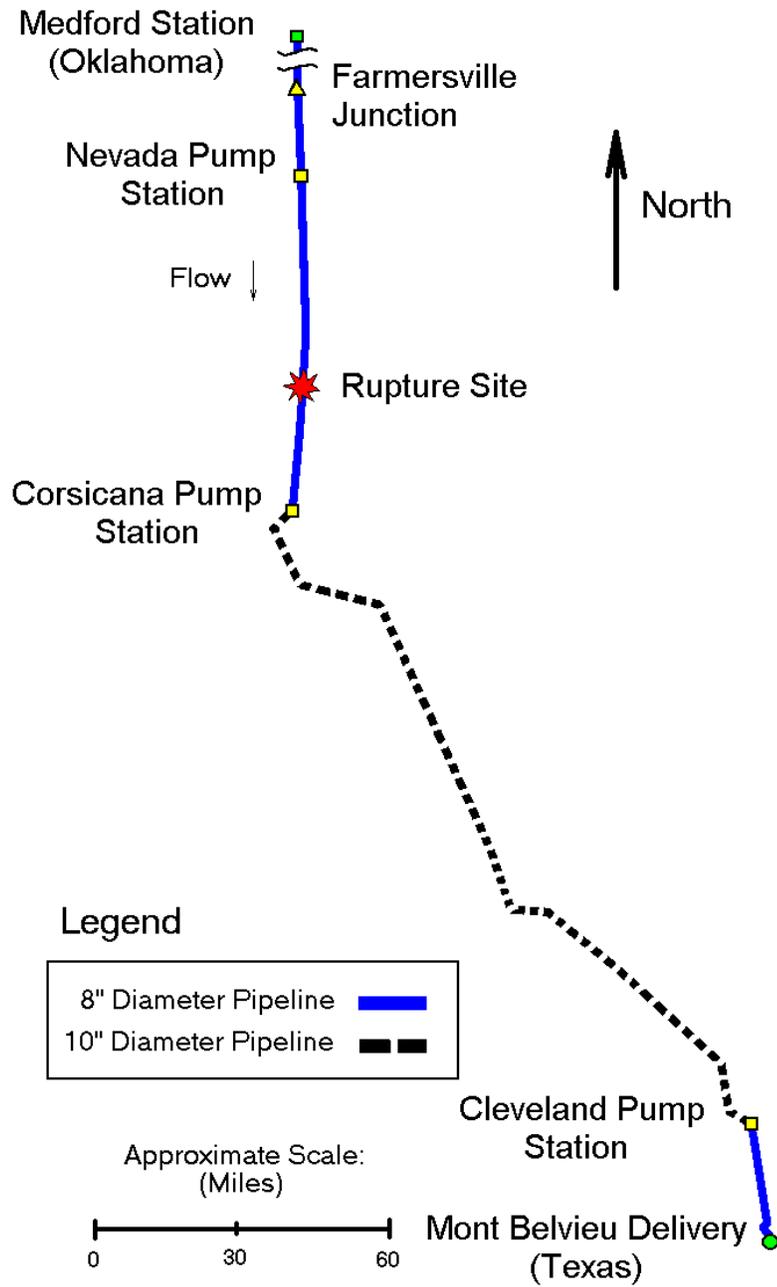
Figure 3. Koch Pipeline Company—
Medford, Oklahoma, to Mont Belvieu, Texas

At 2:05 p.m. on the day of the accident, Koch's Cleveland pump station (see figure 3 for station locations) experienced an automated shutdown due to the activation of a hydrocarbon vapor detection alarm in the station. A technician who was called out to check the station found no vapor or evidence of a leak at the station. Cleveland pump station is about 200 pipeline miles downstream of the accident site, and this shutdown reduced flow through the pipeline. Corsicana station, the first pump station upstream of Cleveland station, automatically shut down at 3:05 p.m. because the rising pipeline pressure activated a high-discharge pressure alarm.⁴ The Corsicana pump shutdown created a

pressure surge⁵ in the pipeline that traveled upstream to the previous station, Nevada pump station. The rupture occurred between Nevada and Corsicana pump stations.

At 2:05 p.m. on the day of the accident, the pump at Cleveland pump station (see figure 3) experienced an automated shutdown due to a hydrocarbon vapor detection alarm in the station. As a result of the shutdown, pressure increased on the pipeline upstream of Cleveland pump station. At 3:05 p.m., Corsicana pump station automatically shut down due to a high-discharge pressure alarm being activated. When the Corsicana pumps shut down, a pressure surge traveled from Corsicana upstream toward Nevada pump station. Based on an analysis of SCADA data, the pipeline ruptured between the two stations about 3:26 p.m.
