National Transportation Safety Board

Railroad Accident Brief

Accident No.: DCA-12-FR-004
Location: Madison, Illinois
Date: February 28, 2012
Time: 11:57 a.m. central standard time¹
Railroad: Amtrak (National Railroad Passenger Corporation)
Vehicle: 2007 Pontiac Grand Prix four-door sedan
Property Damage: \$3,794
Fatalities: 1
Injuries: None
Type of Accident: Highway-rail grade crossing collision

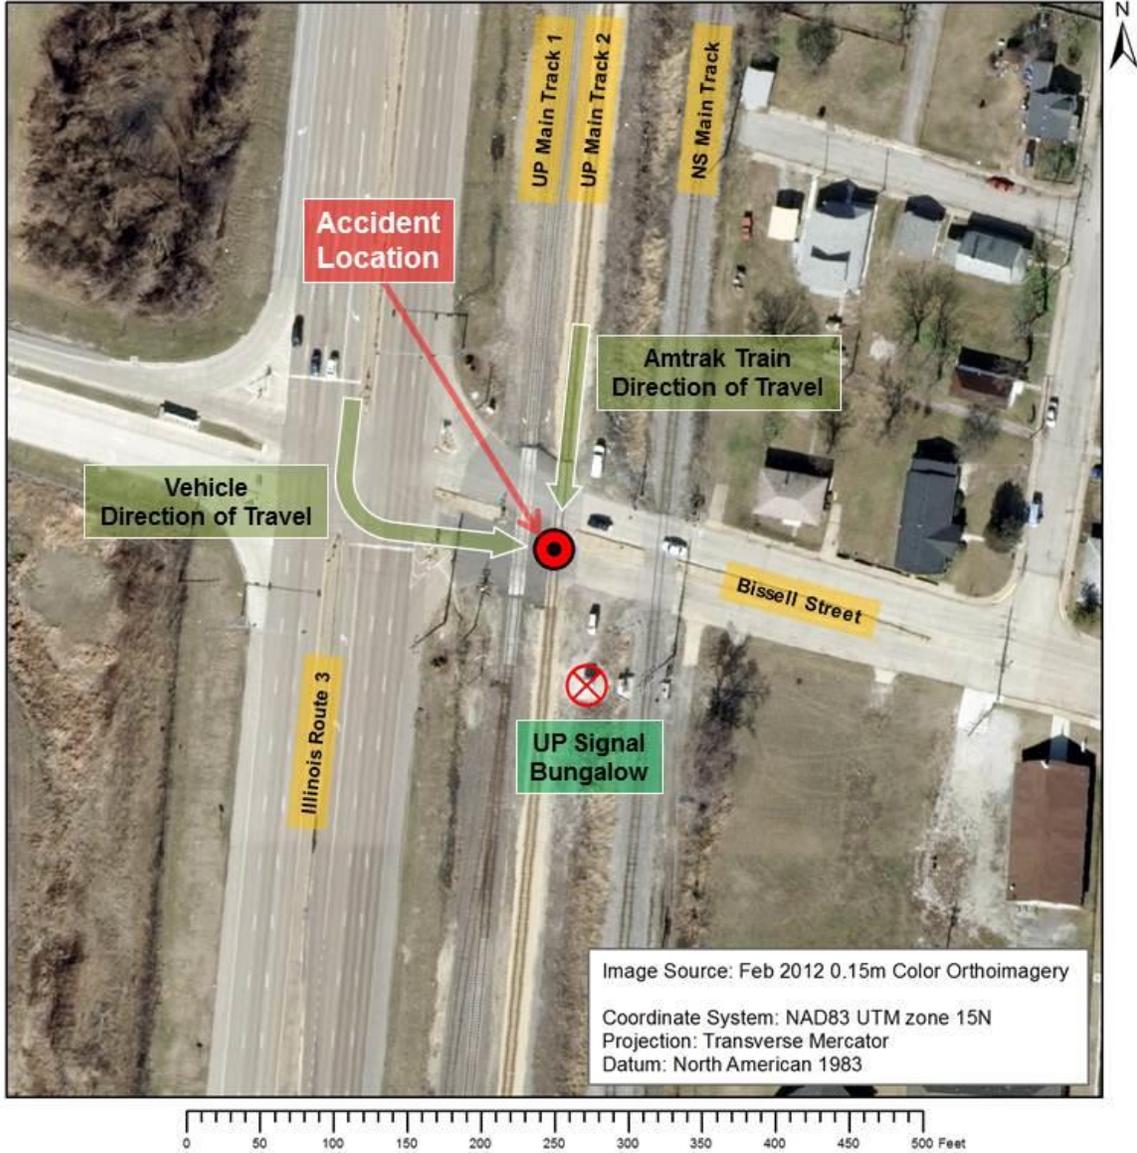
Figure 1. Accident location

Bissell Street intersects Illinois Route 3 in a geographic east-west direction in the city of Madison, Illinois, which is a suburb of St. Louis, Missouri. Bissell Street, a two-lane asphalt road, extends about 50 feet from Illinois Route 3 and intersects the UP and NS main tracks. (See figure 1.) The crossing traffic lanes are separated by a center median across the three main tracks. The posted speed limit on Bissell Street is 30 mph. The US Department of Transportation crossing inventory information indicates an annual average daily traffic count of 1,450 vehicles for the Bissell Street crossing.
