# National Transportation Safety Board

## Railroad Accident Brief

### Metro-North Railroad Derailment

| <b>Accident No.:</b> | DCA13FR009 |

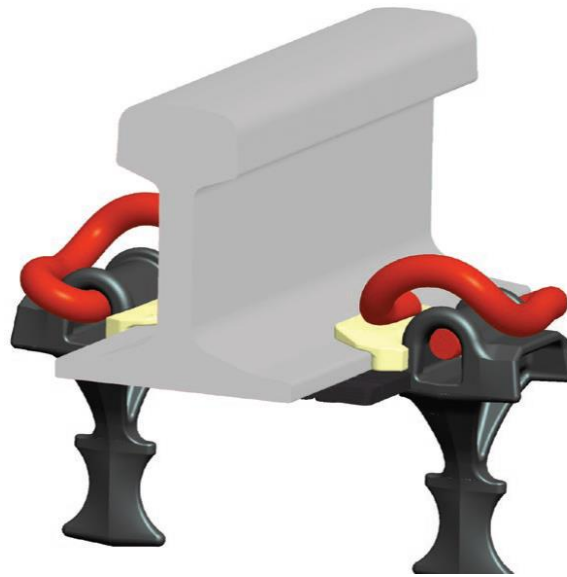
Figure 4. Diagram showing proper installation of Pandrol insulators (shown in yellow) and clips (shown in red). The rail is shown in grey. (Source: Pandrol brochure)

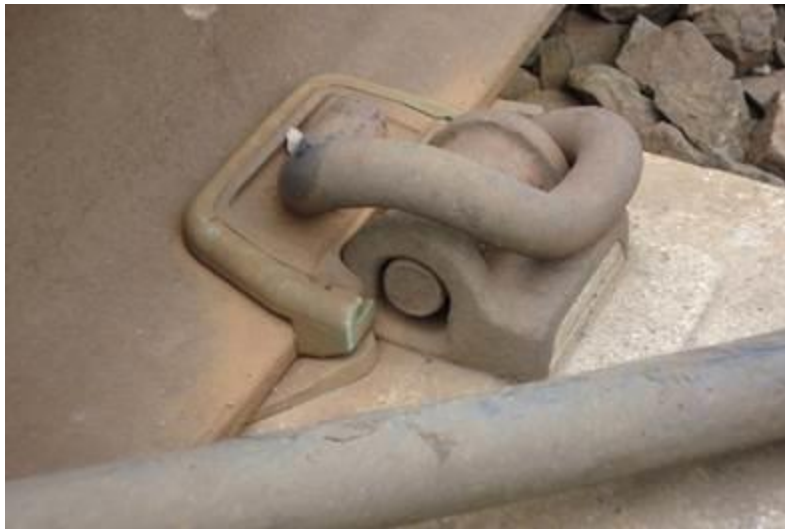
In the vicinity of the POD, investigators noted that the clip insulators on the field side of the rail had slipped out of place, so they were incorrectly positioned above the base of the rail on a number of ties. With the bottom of the insulator above the rail base, a gap is created allowing the rail to move further outward and thereby widening the gage by approximately 5/16 inch.

Figure 5. Proper installation of a Pandrol clip and insulator.
