National Transportation Safety Board

Railroad Accident Brief

South Florida Regional Transportation Authority Highway-Rail Grade Crossing Collision

West Palm Beach, Florida

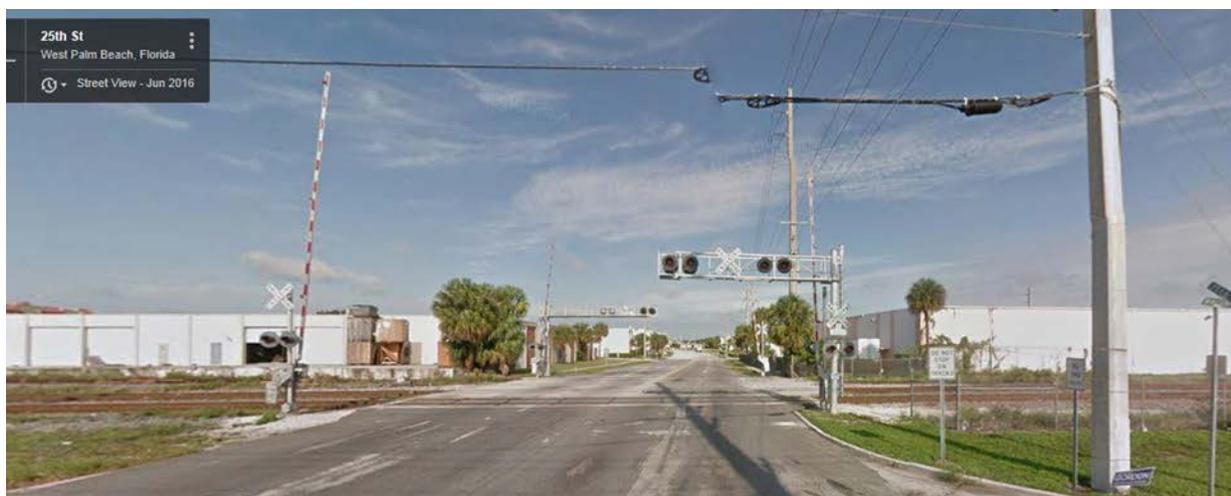
The 25th Street crossing in West Palm Beach, Florida is on the northern end of the 72-mile SFRTA rail corridor. (See figure 3.) Three tracks (two main and one industry) traverse the grade crossing in a north-south direction.

Figure 3. 25th Street crossing. (Photo courtesy of Google Maps.)

At the accident crossing, 25th Street is a four-lane undivided highway oriented in an east-west direction with a speed limit of 30 mph. The crossing is marked with stop lines (on the pavement) and warning signs. The crossing warning system is equipped with four quadrant gates, lights, bells and two cantilever structures for over-lane lighting. There are
