Collision of Amtrak Passenger Train 371 and Norfolk
Southern Railway Company Freight Train 23M
Chicago, Illinois
November 30, 2007

NTSB/RAR-09/01
PB2009-916301

Railroad Accident Report

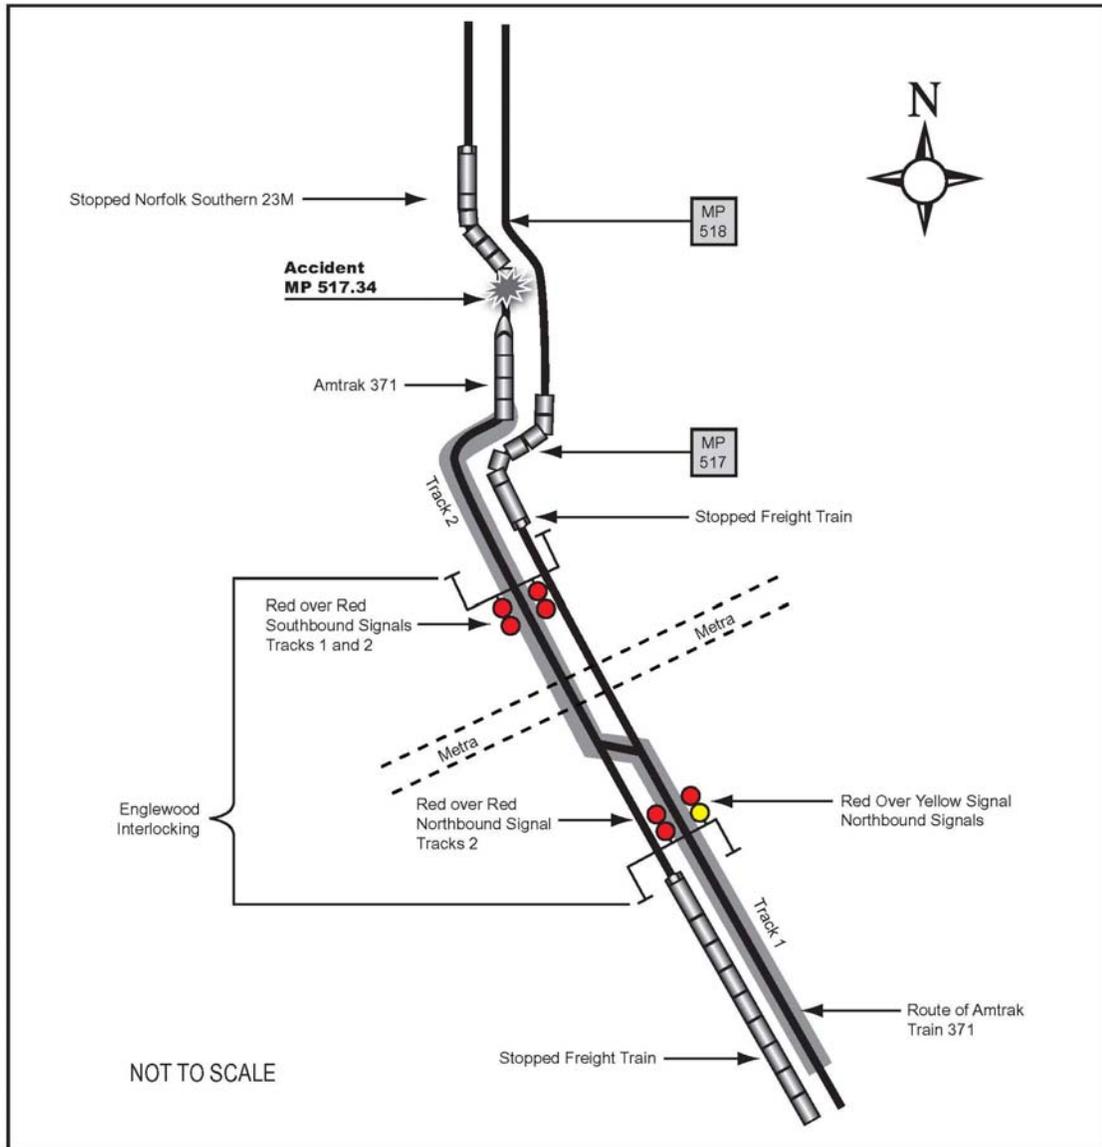
Figure 2. Path of accident train.

In the postaccident interview, the Amtrak relief engineer also said, "... [the] speed was still low while I was going through signals in my head." The locomotive's event recorder indicated that the engineer had slowed the train to 10 mph while traveling through the crossover switches from track 1 to track 2. When the train cleared on track 2, it accelerated to 25 mph until it cleared a permanent speed restriction (due to curved track) at MP 516.3. (See figure 2.)

Based on the event recorder data and the postaccident crew interviews, the rear of the standing Norfolk Southern freight train on track 2 came into view about a minute after the train was accelerated to 40 mph and while the crew was debating the last signal indication. The engineer reacted and started applying the brakes 8 seconds before the collision. The event

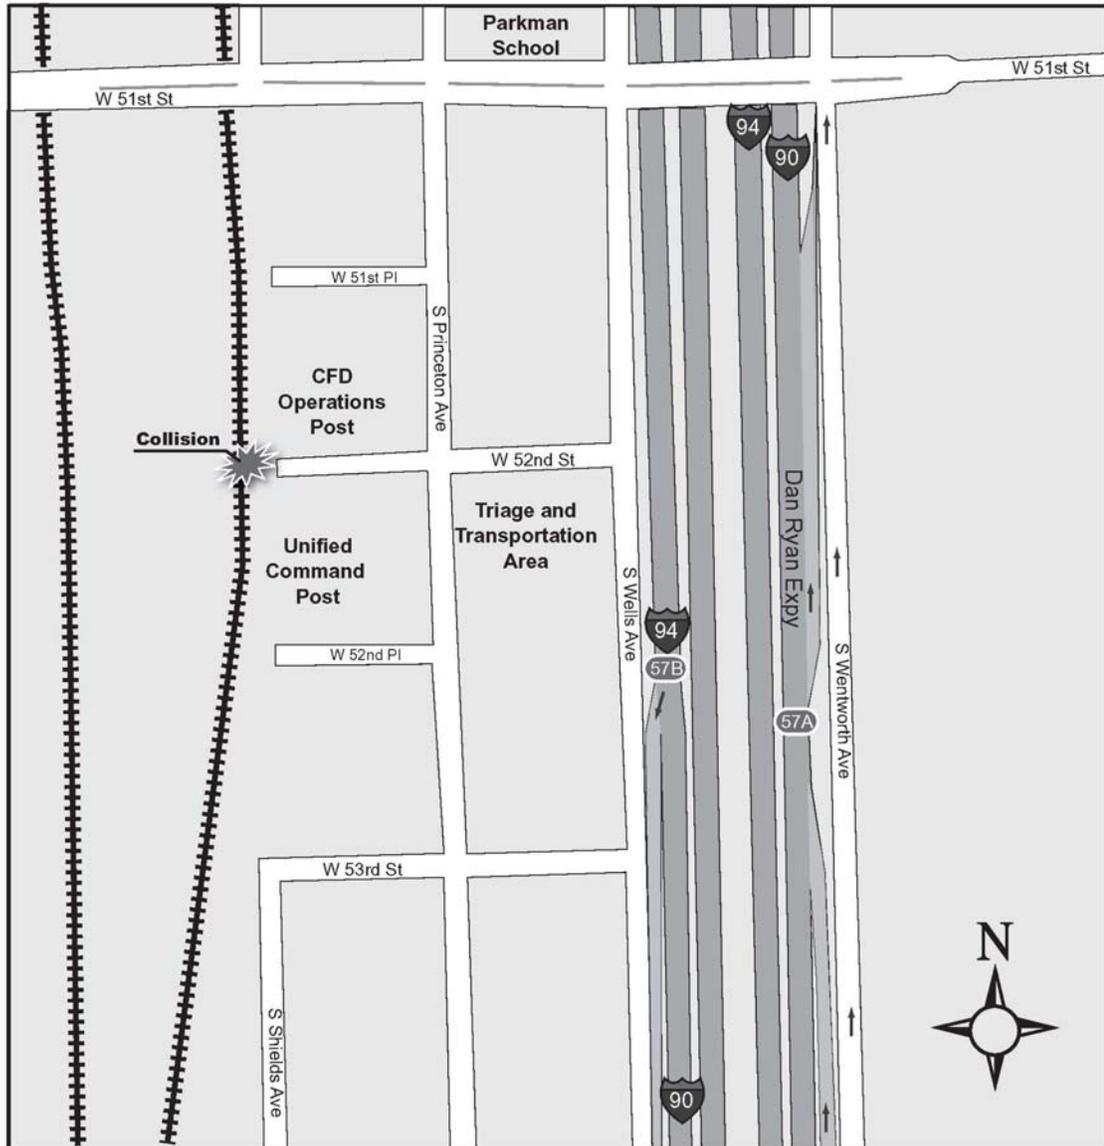
Figure 5. Emergency response locations.

A unified command post was established at 5220 South Shields Avenue. Representatives of the Chicago Fire Department, the Office of Emergency Management and Communications, Amtrak, the Red Cross, and the Chicago Police Department were at this location. The Chicago Police Department assisted with the evacuation of the passengers and provided security at the accident site and school. Norfolk Southern police and personnel also responded. (See figure 5.)
