Washington Metropolitan Area Transit Authority L'Enfant
Plaza Station Electrical Arcing and Smoke Accident
Washington, D.C.
January 12, 2015

Accident Report

NTSB/RAR-16/01
PB2016-103217

National
Transportation
Safety Board

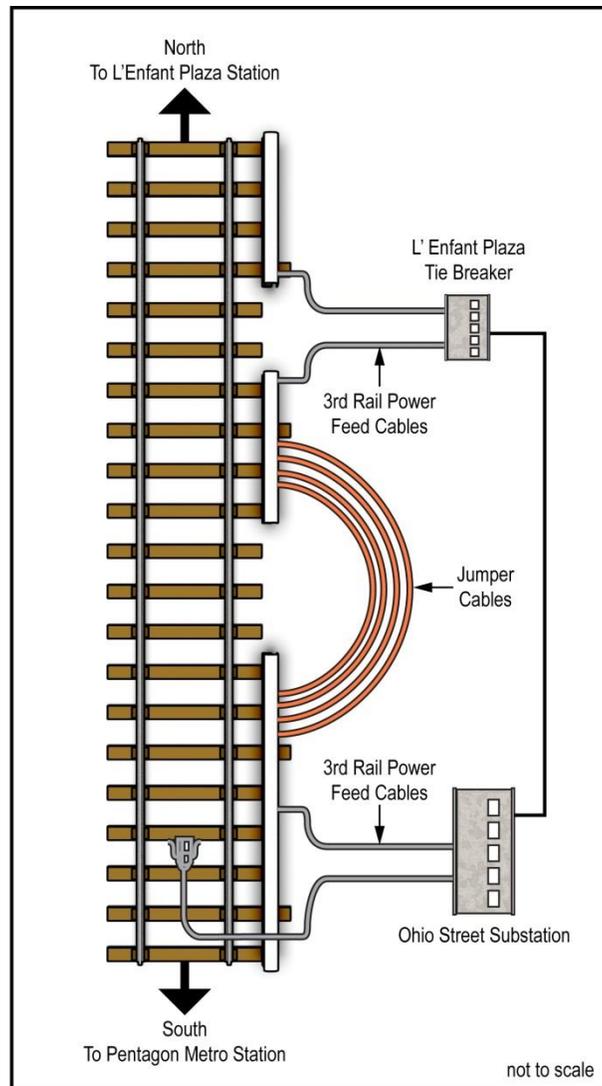
Figure 2. Power supply to third rail in tunnel south of L'Enfant Plaza.

At 3:06:40 p.m. an electrical circuit breaker on a circuit feeding power from L'Enfant Plaza to the third rail of the southbound Yellow Line tripped and remained open, degrading power to this section of the third rail.¹⁹ However, the third rail continued to receive power from an electrical feed south of the accident site. (See figure 2.)

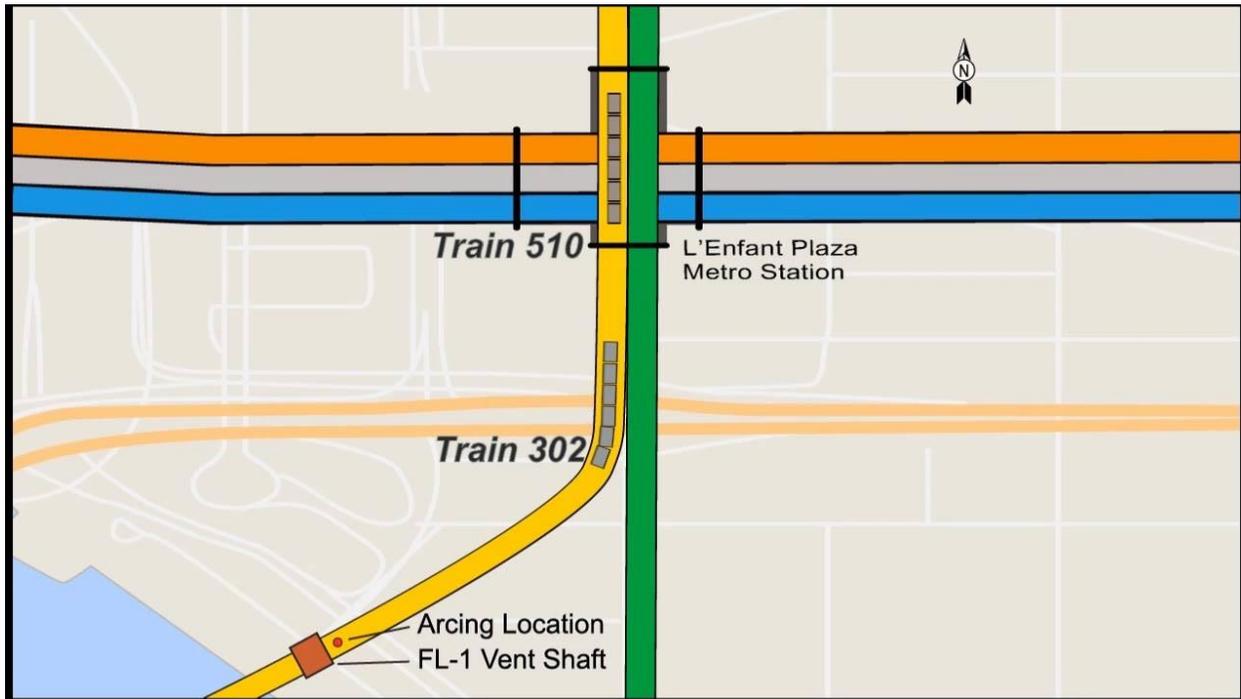
Figure 3. Accident site.

At 3:17:38 p.m. the ROCC instructed train 510 to stop, on track 2, between Archives and L'Enfant Plaza. The assistant superintendent on duty in the ROCC then instructed a senior rail control operator to take over as radio control operator, which he did, about 5 minutes later, at 3:22:10 p.m. The senior rail control operator then instructed train 510 to proceed to and service L'Enfant Plaza, and about 3:23 p.m. the train stopped at the L'Enfant Plaza platform. Heavy smoke in the station caused the train operator to stop about 100 feet short of the south end of the platform. (See figure 3.)

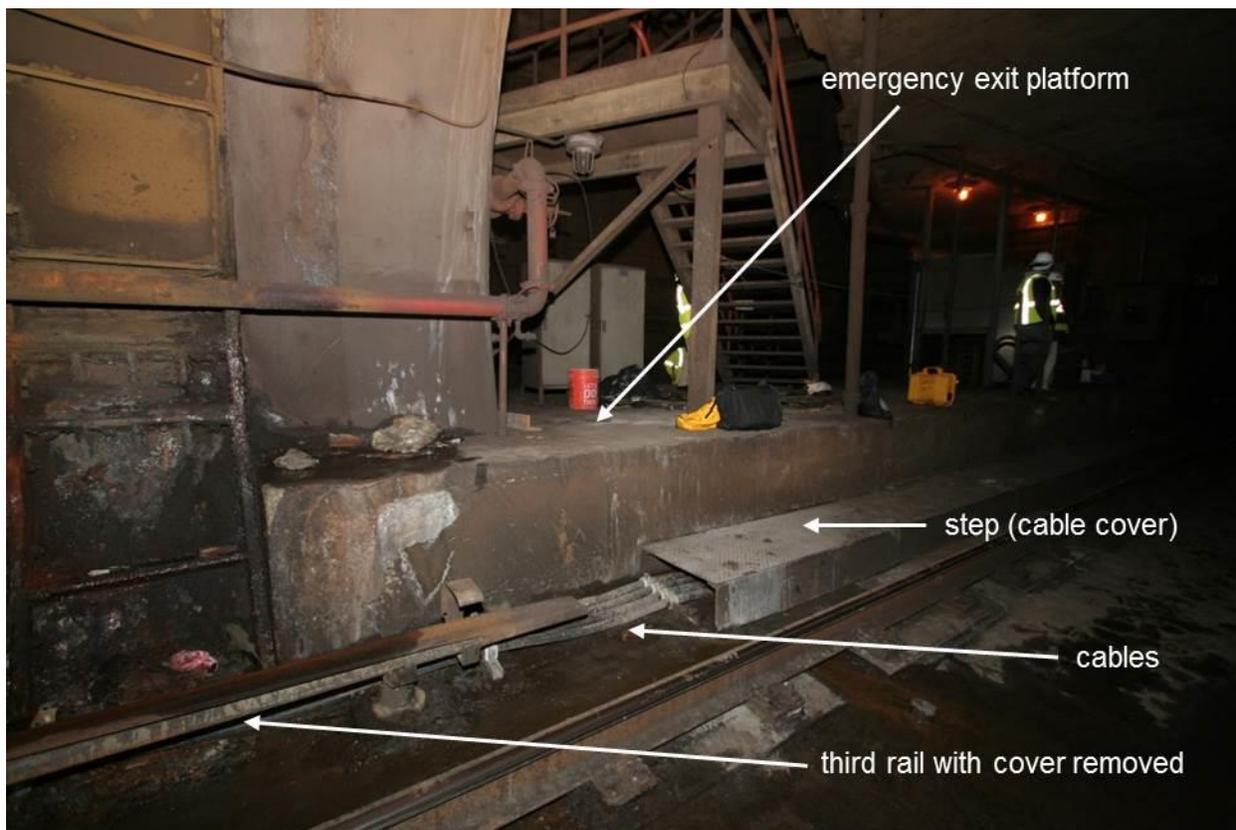
Figure 4. Emergency exit at FL-1 next to track 2 in Yellow Line tunnel south of L'Enfant Plaza.

The origin of the smoke that caused the accident was about 1,910 feet south of the L'Enfant Plaza station, or about 1,100 feet south (in front) of the stopped train. At this location was a ventilation fan shaft, identified as FL-1, that also housed a drainage pump and an emergency exit from the tunnel. If a train had to be evacuated while inside the tunnel, the train could disembark passengers at the emergency exit platform from track 1 and track 2. Passengers evacuating could also step up from the track bed to the emergency exit platform and then use an emergency exit staircase to reach the surface. The tunnel bores for tracks 1 and 2 are connected at the bottom of the FL-1 shaft. Because FL-1 is also an emergency exit, the third rail terminates at each end of the emergency exit platform, and four cables maintain the electrical continuity of the third rail along the length of the platform. (See figure 4.) This arrangement ensures that passengers do not have to step over the third rail when evacuating from a train. This is true for tracks 1 and 2 on either side of the emergency exit platform.

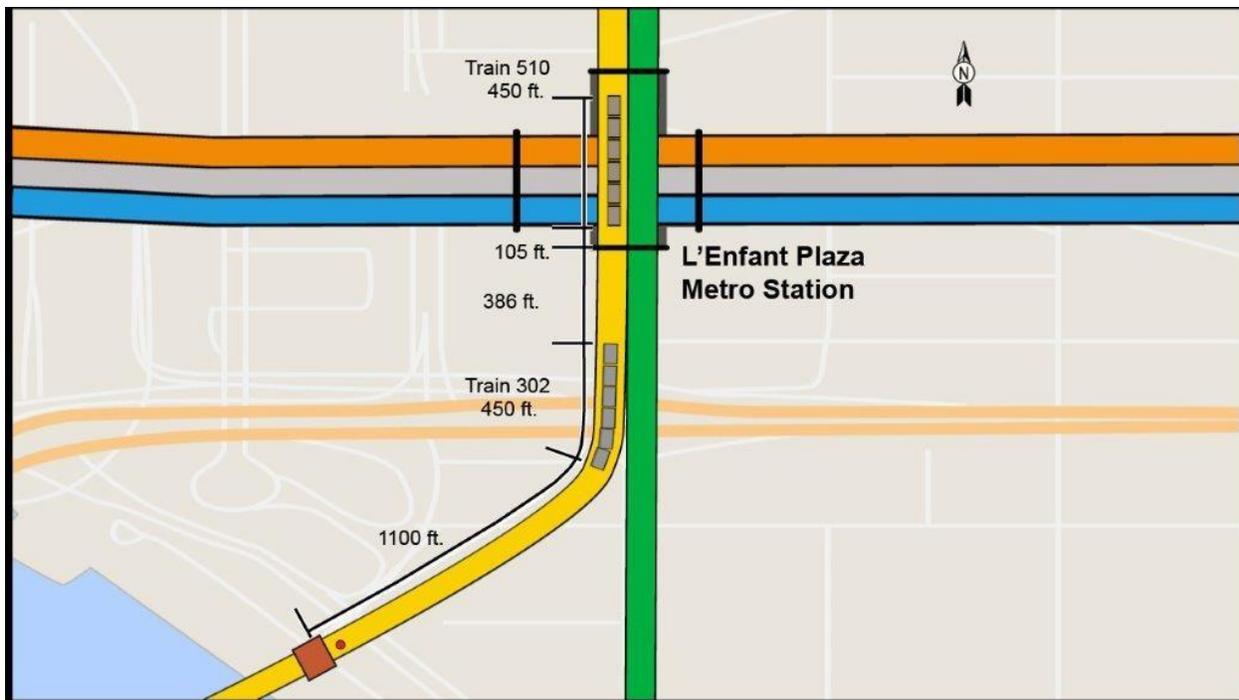
Figure 12. Electrical arcing location.

Smoke was not observed in the station as train 302 departed L'Enfant Plaza at 3:14 p.m., but the train operator stopped the train about 836 feet beyond the south end of the station after encountering heavy smoke. In response to reports of smoke, at 3:16:09 p.m. a ROCC train control operator activated the under-platform fans in exhaust mode in the L'Enfant Plaza station, enveloping train 302 in smoke. It was not until 3:24:28 p.m. that fans in the ventilation shaft near the smoke origin were activated in emergency exhaust mode by the ROCC. At this point, train 302 was already blanketed in smoke. Train 510 also was enveloped in smoke once it arrived at the L'Enfant Plaza platform. (See figure 12.)

A ventilation shaft, FL-1, containing ventilation fans was located about 1,940 feet south of the L'Enfant Plaza station and about 24 feet south of the source of the smoke. (See figure 12.) At 3:24:28 p.m. these ventilation fans were activated in exhaust mode by a ROCC train control operator. At this point train 302 was already blanketed with smoke. Also, the railcar ventilation system, which draws air from the outside into the railcar, was still pulling smoke into the railcar because it had not been shut off by the train operator. Because both the station fans and those in the ventilation fan shaft were activated in exhaust mode there was no supply of fresh air to aid in moving the smoke through the tunnel to the outside and away from the train.

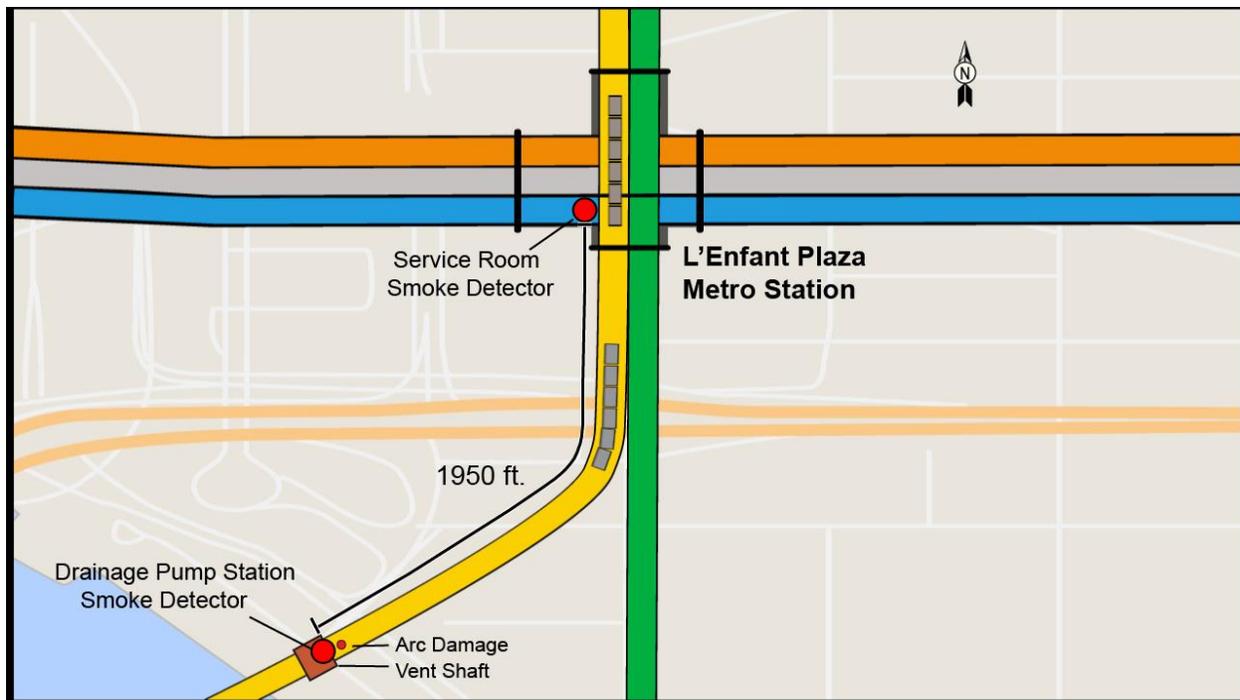
Figure 13. Smoke detector locations.

NTSB investigators reviewed records of smoke detector activations around the time of the accident. The first smoke detector activation was at 3:04:54 p.m. from the smoke detector located above the drainage pump station at the bottom of the FL-1 vent shaft. The second smoke detector activation was at 3:19:19 p.m. from a smoke detector located inside a service room in the L'Enfant Plaza station. The distance between these two smoke detectors was about 1,950 feet, and the time between the two activations was 14 minutes 25 seconds. (See figure 13.) There were no smoke detectors between these locations. After these two smoke detector activations, there were 24 additional smoke detector activations in the L'Enfant Plaza station and on the Yellow Line between the station and the FL-1 vent shaft. The 32nd activation occurred at 7:19:54 p.m.

The first smoke detector activation at 3:04:54 p.m. was not received by the ROCC or at any other location. WMATA told investigators that this alarm was not received because of a loose wire that prevented connection with AIMS.
