# NATIONAL TRANSPORTATION SAFETY BOARD

## RAILROAD ACCIDENT REPORT

COLLISION AND DERAILMENT OF TWO SUBWAY TRAINS  
METROPOLITAN TRANSPORTATION AUTHORITY  
NEW YORK CITY TRANSIT  
IN BROOKLYN, NEW YORK, ON FEBRUARY 9, 1995

**Adopted: March 19, 1996  
Notation 6531A**

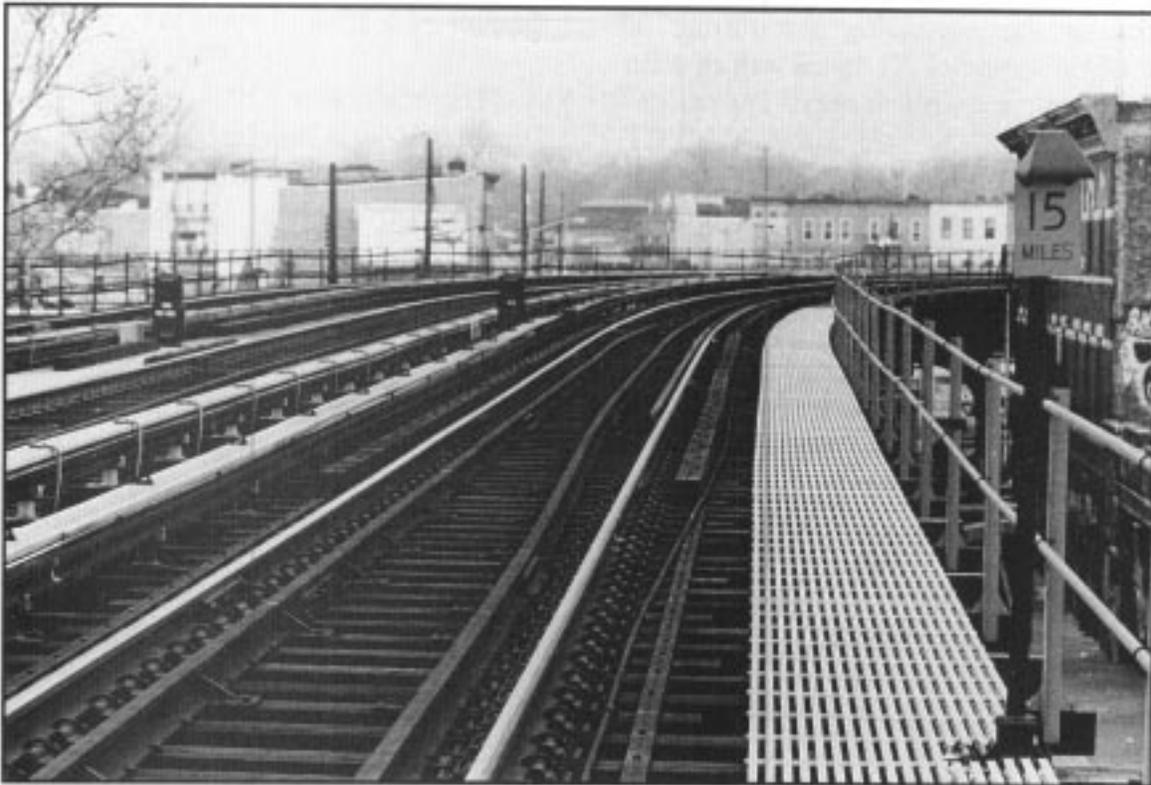
**Figure 6--15-mph speed restriction sign approaching curve.**

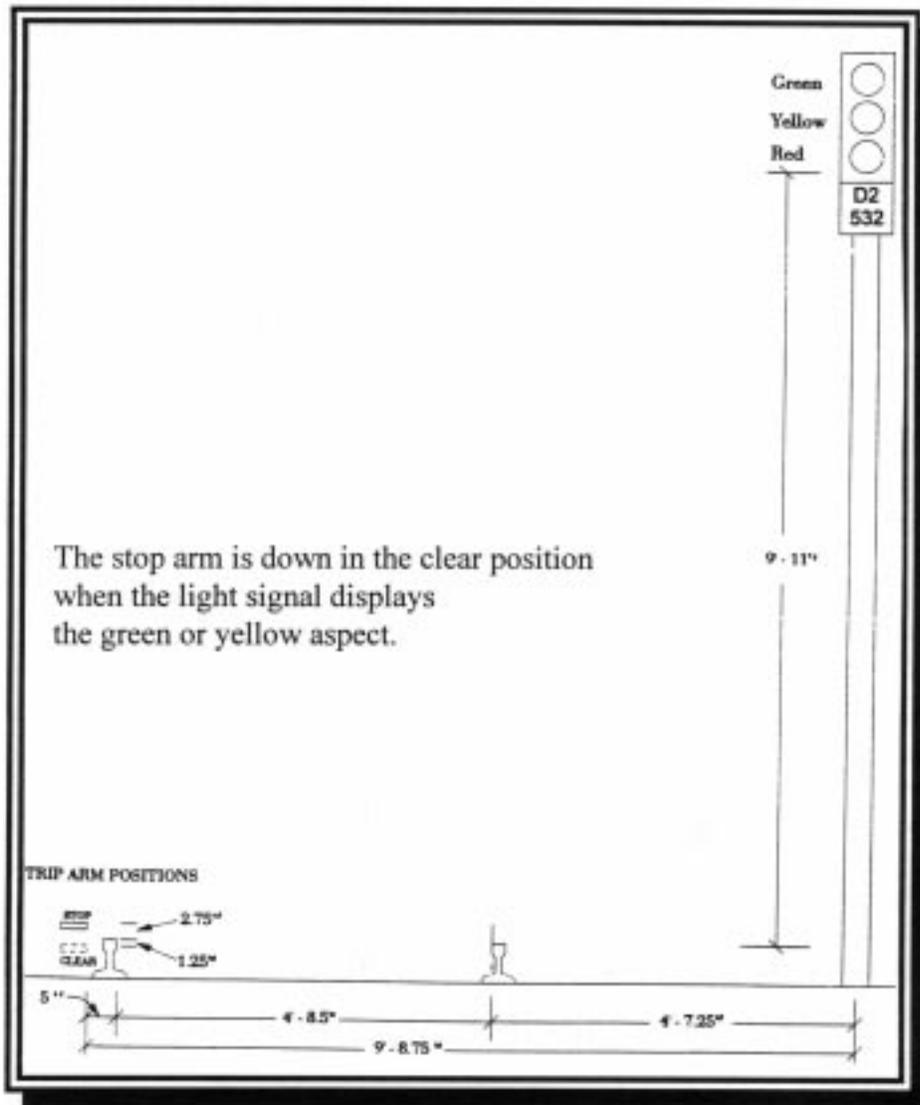
Figure 9—Illustration of stop arm and signal D2-532.

The stop arm is outside of the left rail opposite<sup>9</sup> the D2-532 signal. (See figure 9.) A yellow-painted insulated-joint (IJ) marking acts as stop marker in the approach of the signal. The stop arm is up in the tripping position (see figure 10) when the signal is red, and if a train passes the red signal, the stop arm will strike the trip cock. This action places the train in emergency braking.

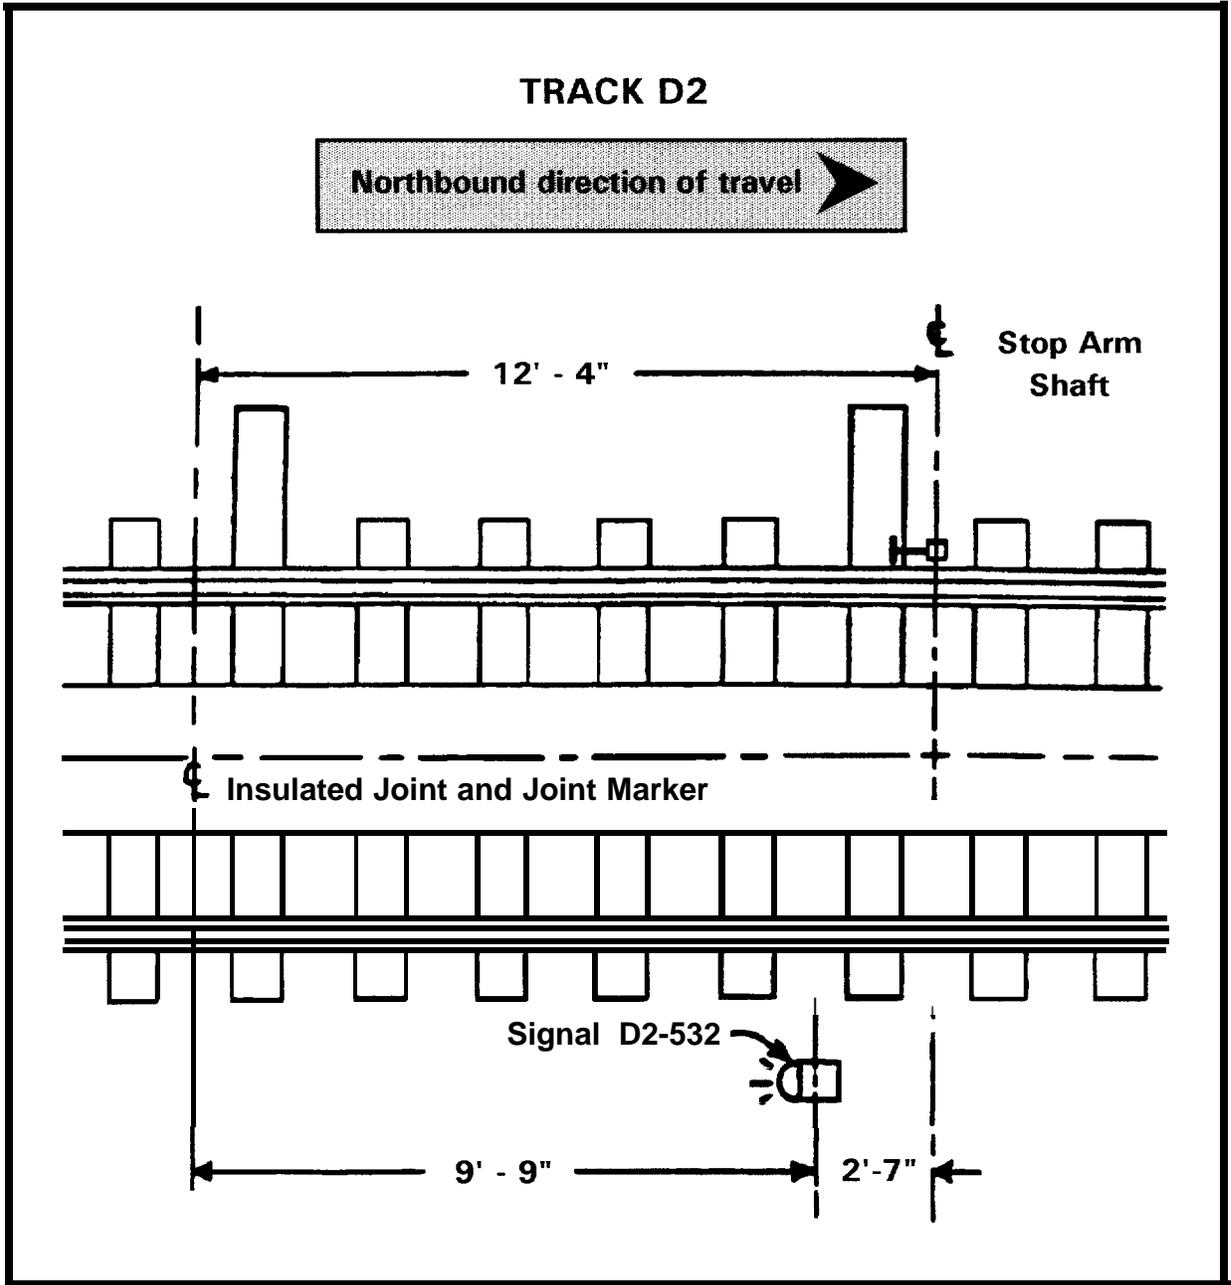
**Figure 1 I--Layout of insulated joint, signal D2-532, and automatic stop arm.**

found during their inspection that signal D2-532 and its corresponding circuits as well as the relays, stop arm, and signals operated as designed. Signal cyclic maintenance records for the 13 months before the collision were

also reviewed and indicated repairs were made within NYCT maintenance requirements. The 12-month incident record disclosed no reportable signal incidents.

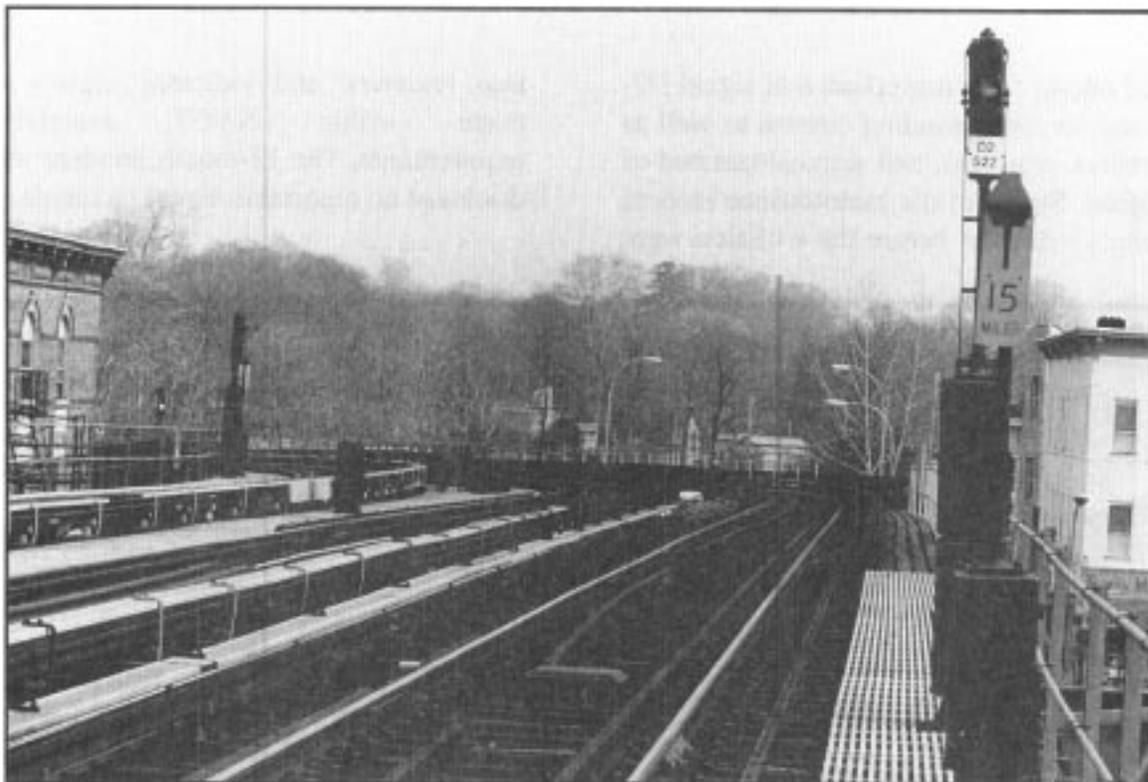
Figure 12--Signal D2-522.

The rear of the stopped B train at the time of the collision was about 220 feet south of the third signal D2-522 (see figure 12), which is about 949 feet north of signal D2-

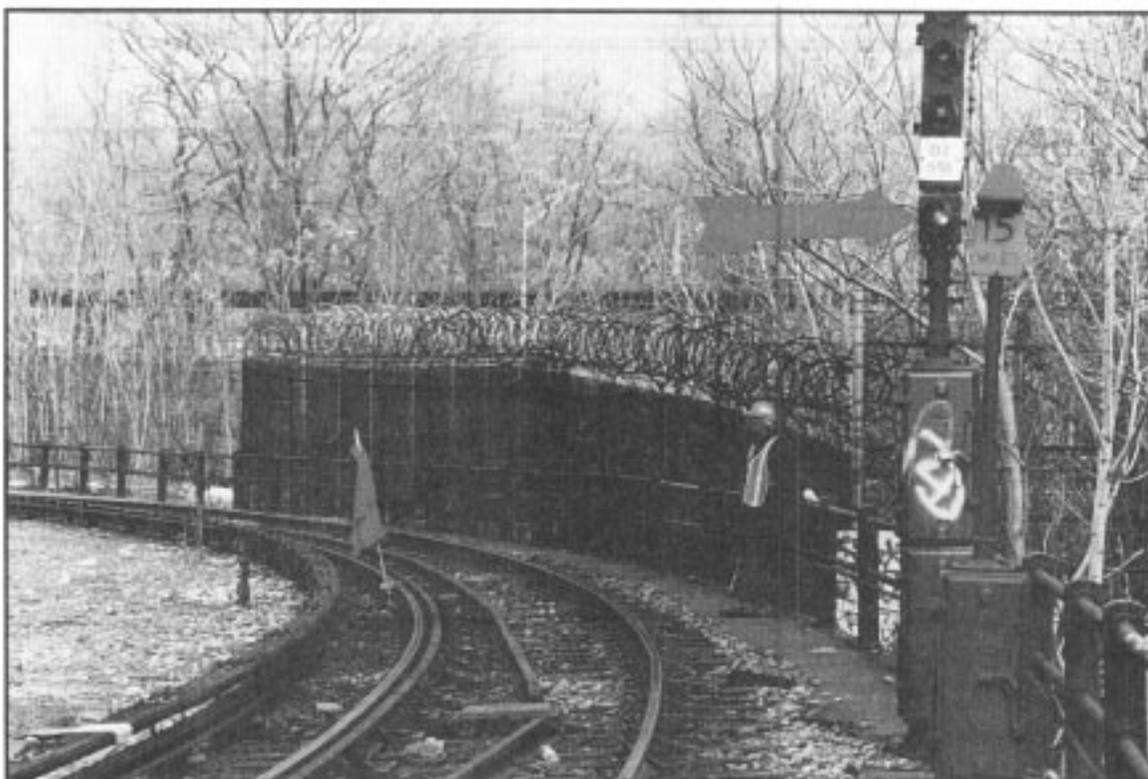
Figure 13--Signal D2-518 (arrow indicates lunar white light).

The fourth signal D2-518, located about 476 feet north of signal D2-522, is a GT signal equipped with a lunar white light. (See figure 13.) The front of the stopped B train was about 75 feet south of this signal at the time of the collision.
