RAILROAD ACCIDENT REPORT

**DERAILMENT OF UNION PACIFIC RAILROAD UNIT
FREIGHT TRAIN 6205 WEST NEAR KELSO, CALIFORNIA
JANUARY 12, 1997**

**Adopted: February 6, 1998
Notation 6921A**

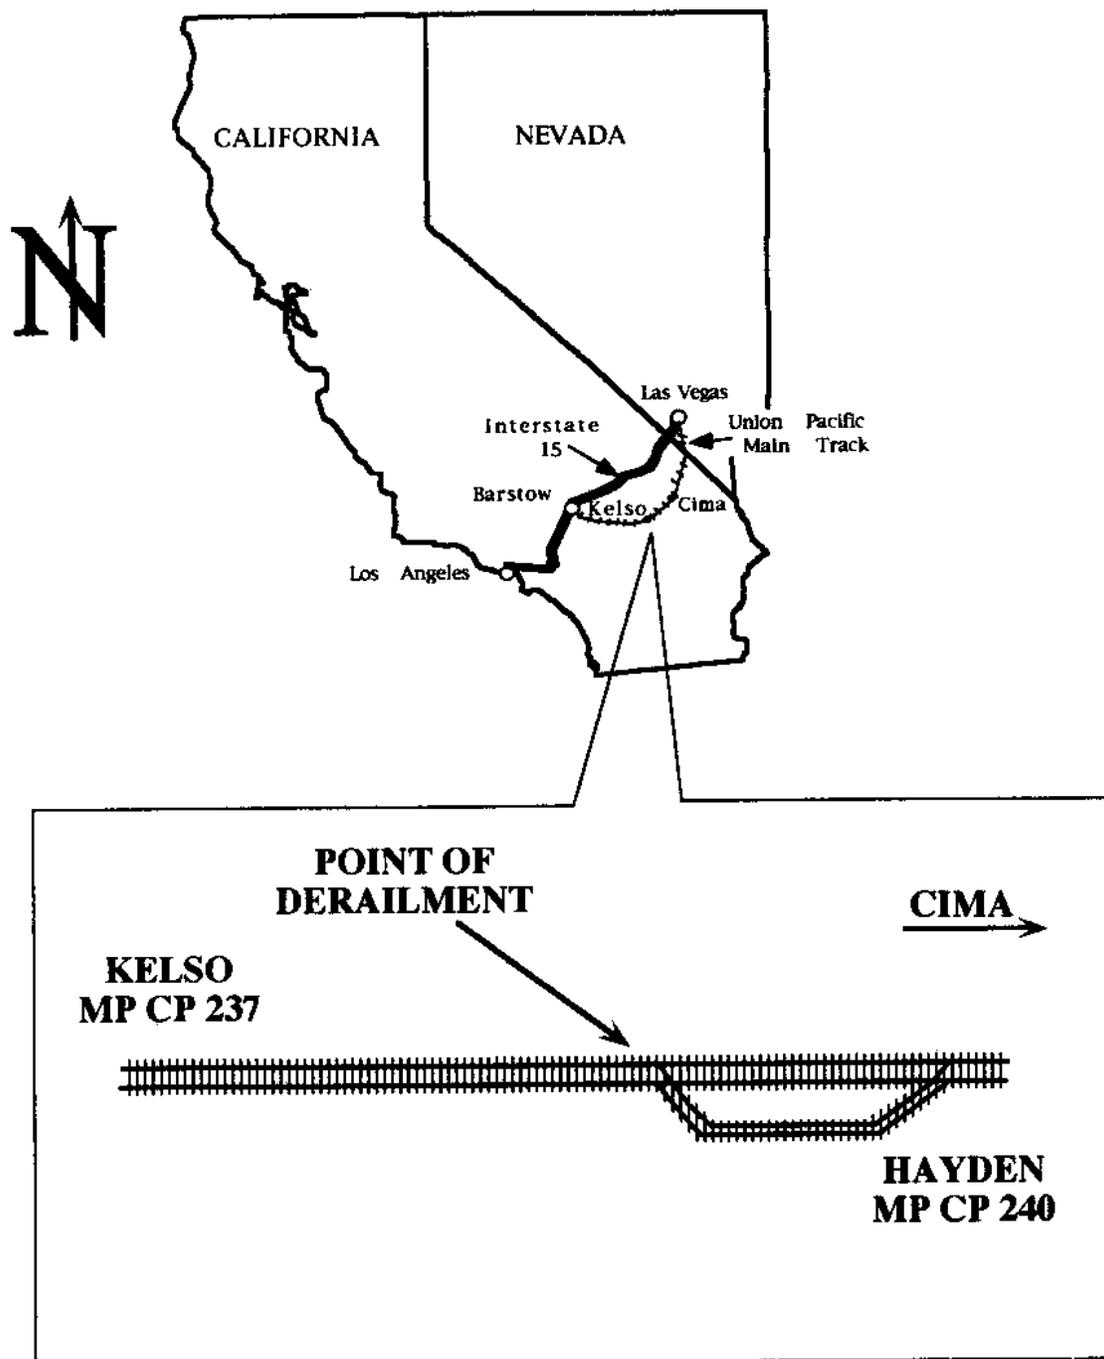
Figure 2 -- Map of the accident site

mainline and came to rest 3 miles away. Sixty-eight of the 75 loaded cars derailed at the west-end turnout at approximately 11:52 a.m. (See figure 2 for a map of the accident site.)
