Railroad Investigation Report RIR-24-05

Norfolk Southern Railway Derailment and Hazardous Materials Release

East Palestine, Ohio
February 3, 2023

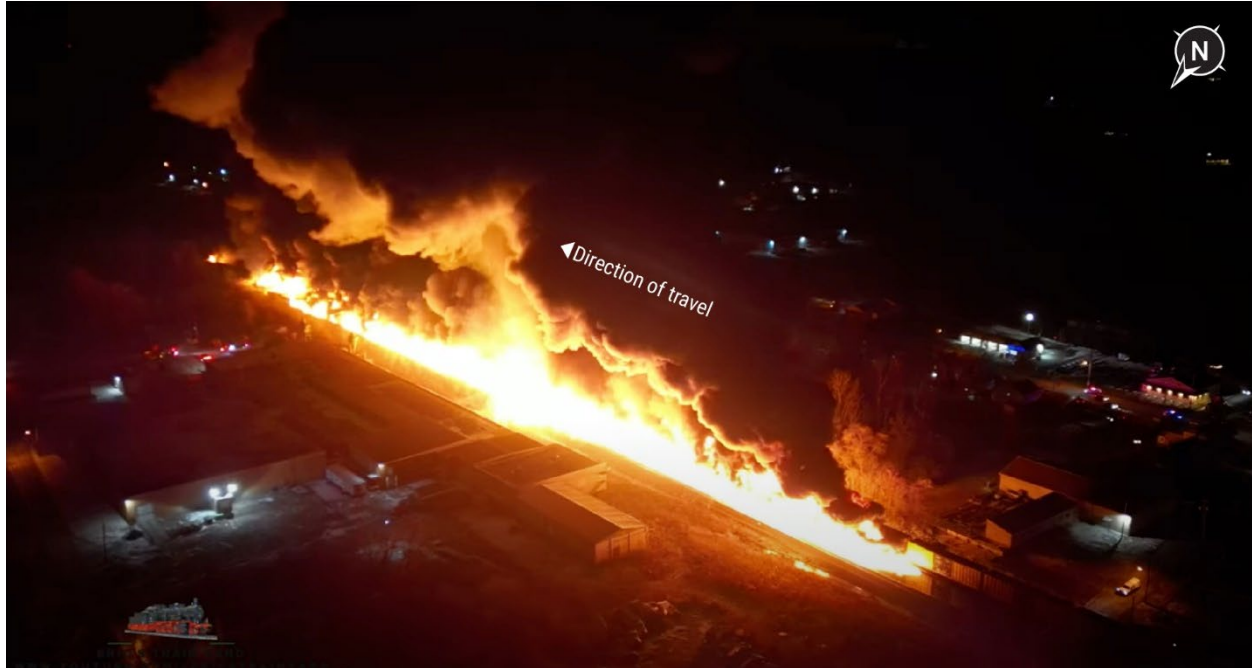
Figure 1. Overhead view of derailment and early fire. (Courtesy of Eric’s Train Yard.)

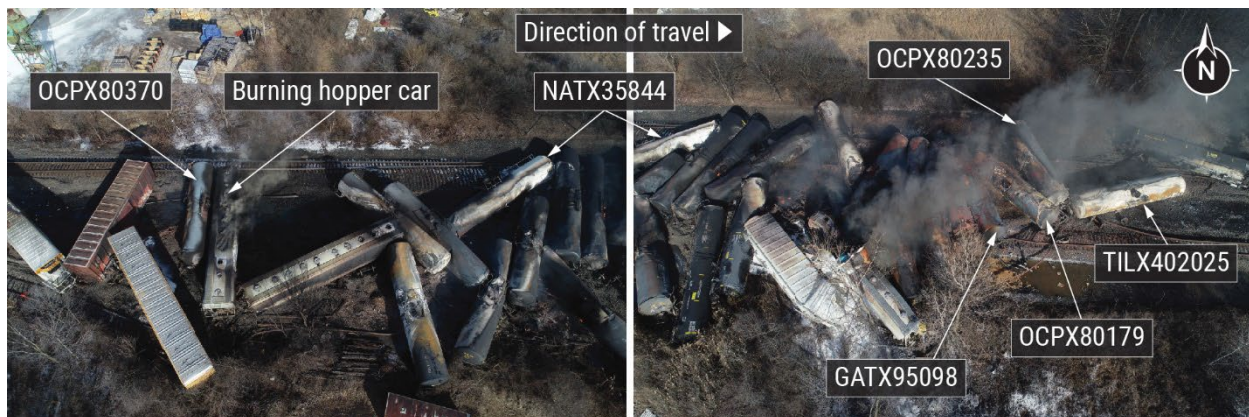
as “UN1055, isobutylene, 2.1.”³⁰ All six were United States Department of Transportation (USDOT) Specification DOT-105J300W tank cars, usually referred to as DOT-105 tank cars. The isobutylene tank car (NATX35844) was positioned near the middle of the derailment pileup. One VCM tank car, OCPX80370 (line 55 in the consist), was positioned near the western end of the derailment pileup, exposed to a pool fire, and resting against a burning hopper car containing plastic pellets. The other four VCM tank cars—TILX402025 (line 28), OCPX80235 (line 29), OCPX80179 (line 30), and GATX95098 (line 31)—were positioned near the eastern edge of the derailment pileup. (See figure 7.) Tank car TILX402025 had come to rest between the two main tracks and was not directly exposed to a pool fire. Aerial images showed that the cover over the protective housing on TILX402025 remained closed during this period.³¹ The other three VCM tank cars at the eastern edge of the pileup were grouped together and exposed to postderailment fires.

Figure 7. Derailment pileup and VCM tank cars.

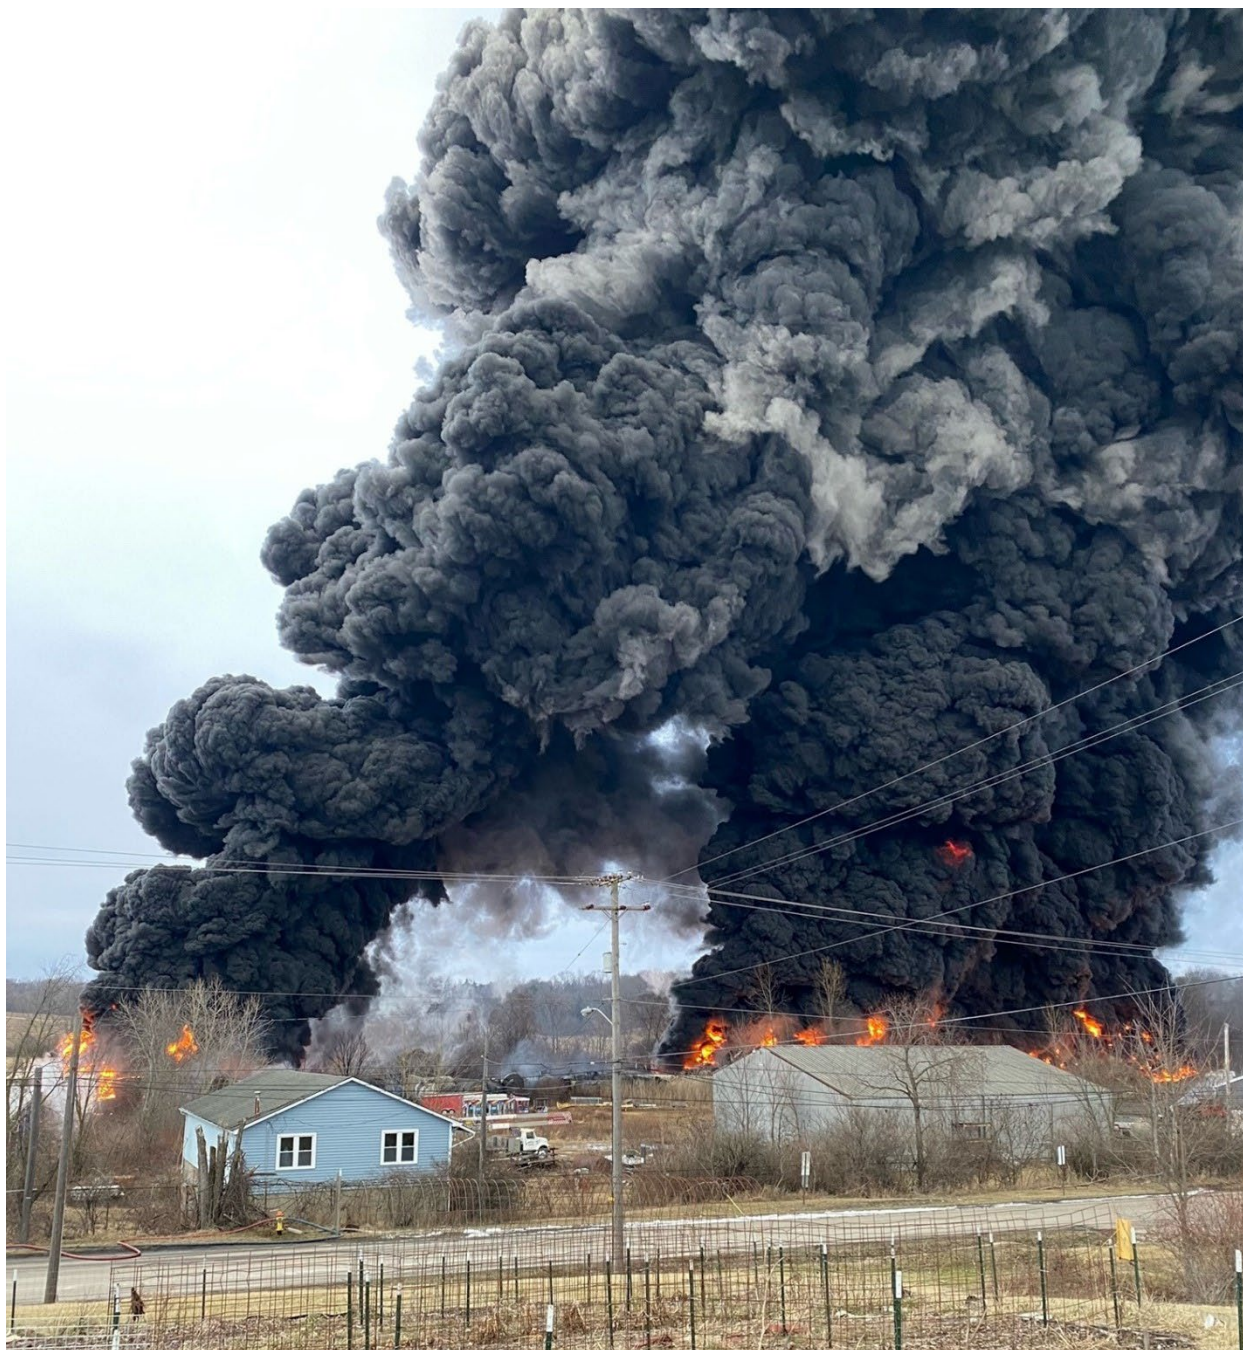
The vent and burn was originally scheduled for 1:00 p.m. on February 6, 2 hours ahead of the 3:00 p.m. deadline described to the incident commander by SPSI and SRS. However, the vent and burn was repeatedly delayed for technical and safety reasons: once to rewire the charges and three times because of unauthorized persons entering the evacuation zone. ESI detonated the vent and burn charges at 4:37 p.m. for all five VCM tank cars, puncturing each tank car at two points: the highest point in the vapor space and the lowest point where the liquid had pooled. The punctured tank cars expelled vapor, which was ignited by flares positioned near each tank car. Burning VCM resulted in a column of black smoke that grew into a persistent cloud. (See figure 10.) According to the NS system manager for hazardous materials, the cloud likely contained soot particles, carbon dioxide, carbon monoxide, hydrogen chloride, and a trace of phosgene (a toxic gas).

Figure 10. The vent and burn 3 minutes after detonation. (Courtesy of NS.)

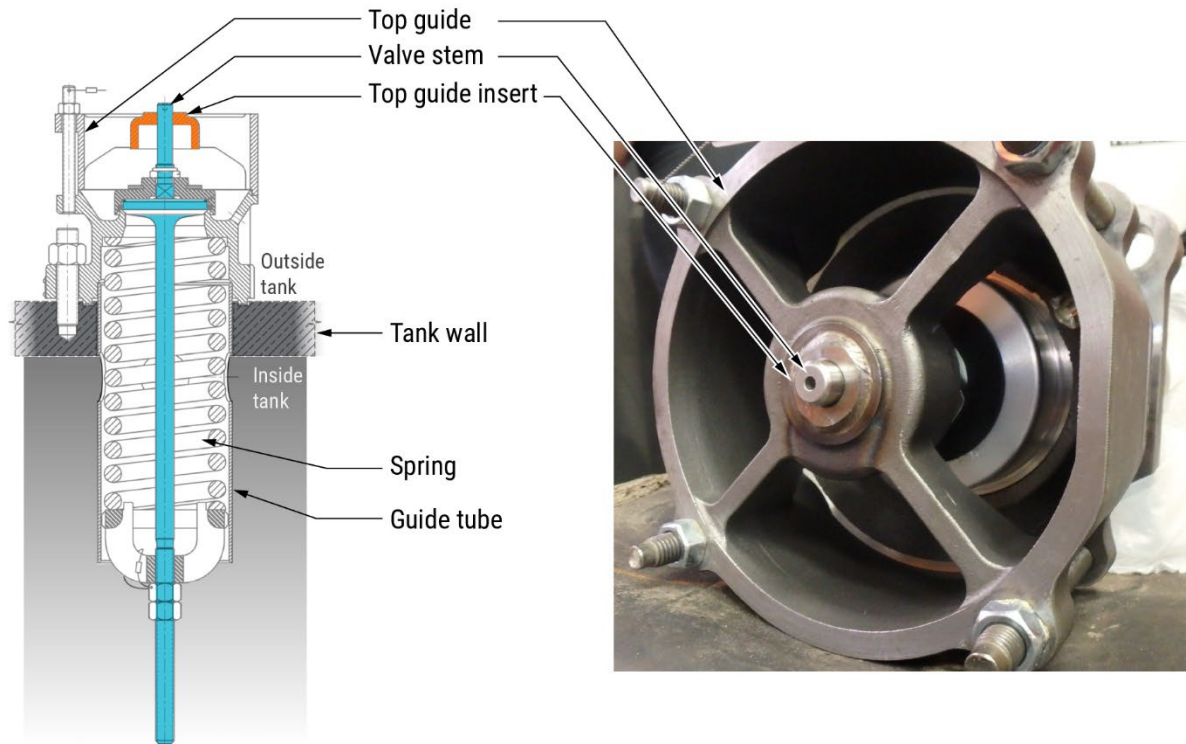
Figure 23. PRD diagram (left) and top-down view of exemplar (right). (Diagram courtesy of Midland Manufacturing with NTSB edits.)

The TILX402025 PRD top guide throat contained loose fragments of metallic debris. During testing, the PRD began to leak (release material without actuating) at 33.4 psig. According to its part specification, the spring was originally coated in aluminum. After bead blasting to remove carbon and soot, visual examination of the spring revealed that most of its aluminum coating was missing. The PRD did not contain any foreign matter obstructing its internal components.

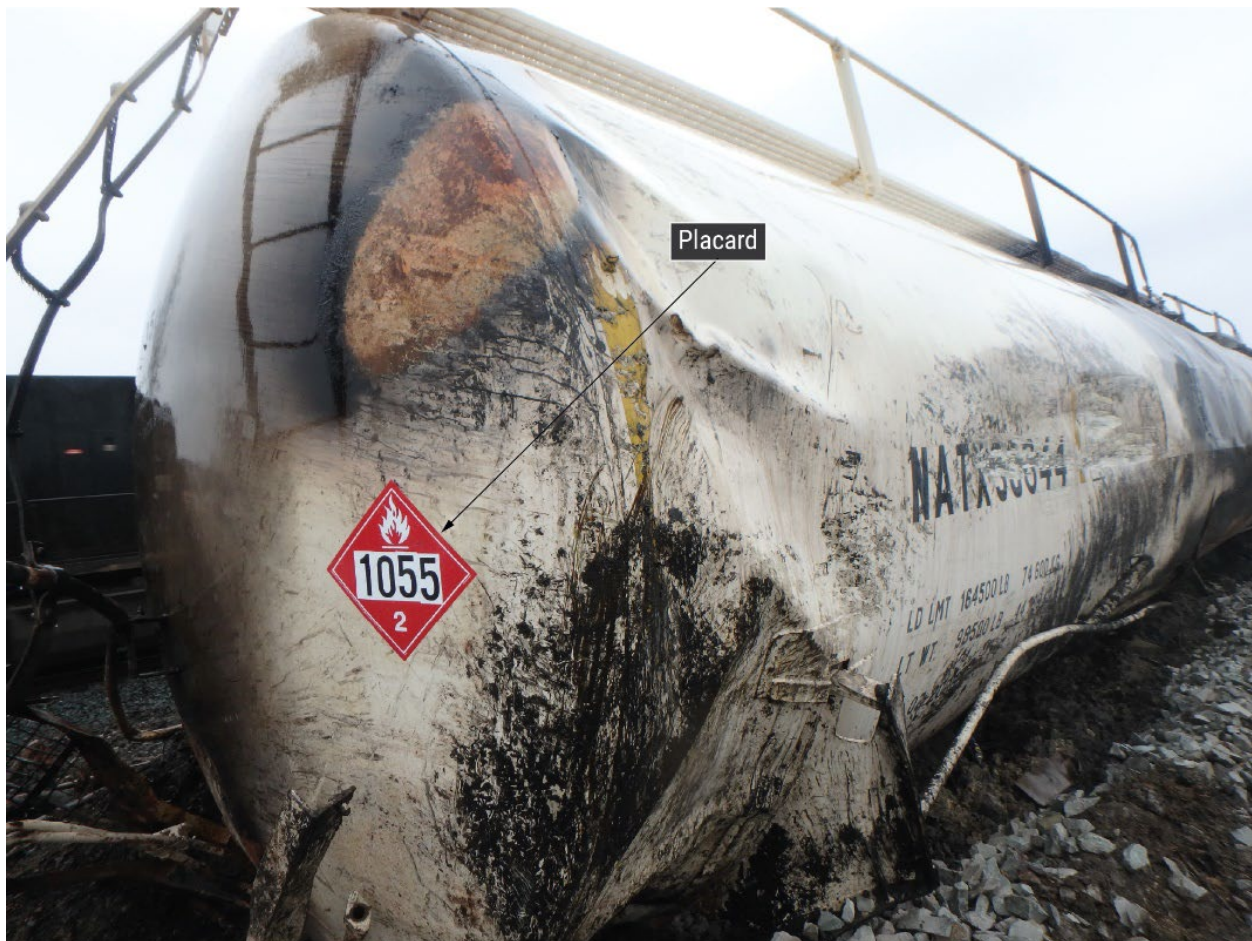
Figure 25. Replacement placard on a derailed DOT-105 tank car containing isobutylene.

Federal placarding requirements include a performance standard for durability; under 49 *CFR* 172.519, placards must be capable of withstanding 30 days of exposure to open weather conditions without deterioration or a substantial reduction in effectiveness. The performance standards do not extend to postaccident survivability in a fire. Federal regulations allow placards to be made of any plastic, metal, or other material that can meet the performance standard, though if the

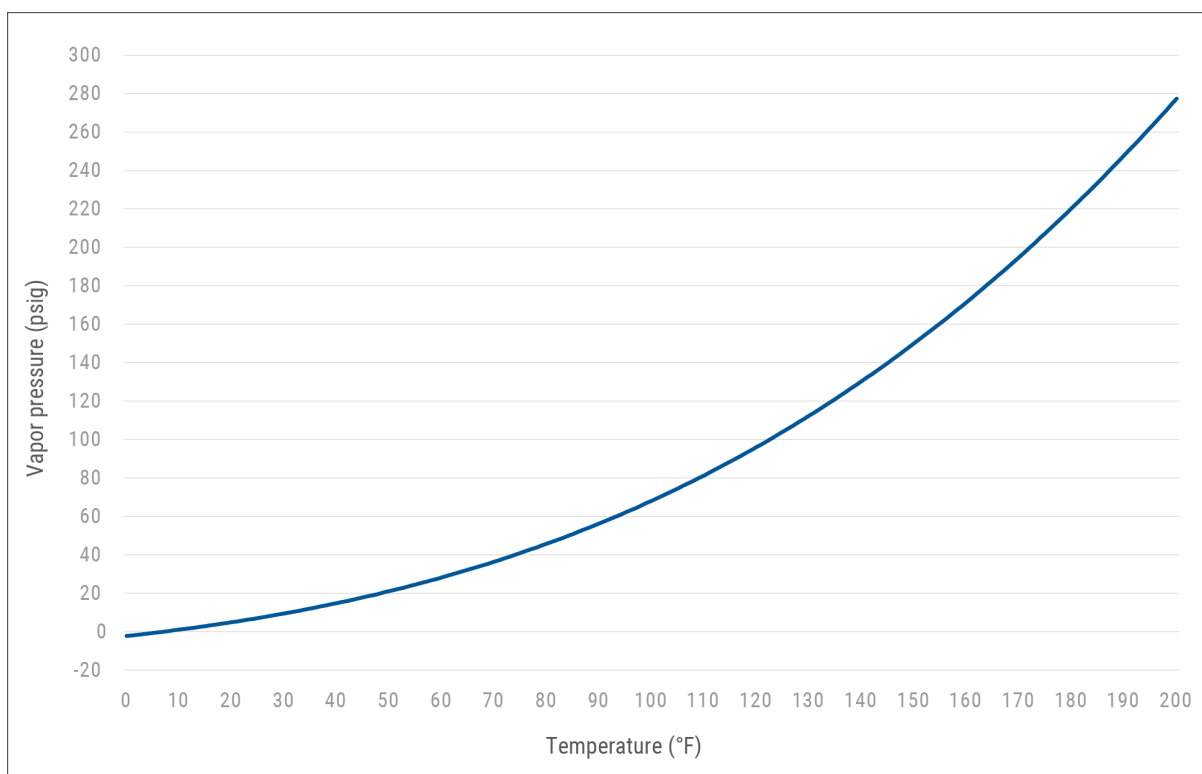
A PRD on a tank car transporting a liquefied compressed gas reaches its start-to-discharge pressure when the temperature of the lading increases, raising the lading's vapor pressure (which normally equals the internal tank pressure).¹⁵² *Yaws' Critical Property Data for Chemical Engineers and Chemists* provides vapor pressure values for VCM at different temperatures (Yaws 2014). Based on those values, VCM vapor pressure rises with temperature along the curve shown in figure 30.¹⁵³

Figure 30. Graph of VCM vapor pressure by temperature.

The lowest start-to-discharge pressure identified during postaccident testing of a PRD known to actuate during fire exposure and then cease was 122 psig (OCPX80235). This pressure corresponds to a lading temperature of about 136°F. For OCPX80179, the start-to-discharge pressure identified during testing was 149.7 psig, which corresponds to a temperature of about 150°F. Typical measured temperatures for tank cars OCPX80235 and OCPX80179 ranged from 62 to 67°F. Similar analysis applies to the PRD with an elevated start-to-discharge pressure (from tank car OCPX80370). Given that this PRD would not start to discharge at 275 psig during testing, the lading temperature would have to exceed 199°F to actuate the PRD. The highest measured temperature for this tank car was 139°F, indicating a pressure of about 128 psig—much too low to overcome the stuck valve stem. Therefore, lading temperatures (and therefore internal tank pressures) are sufficient to explain the cessation of PRD activity even for PRDs with reduced start-to-discharge pressures, and PRD activity is not indicative of polymerization.

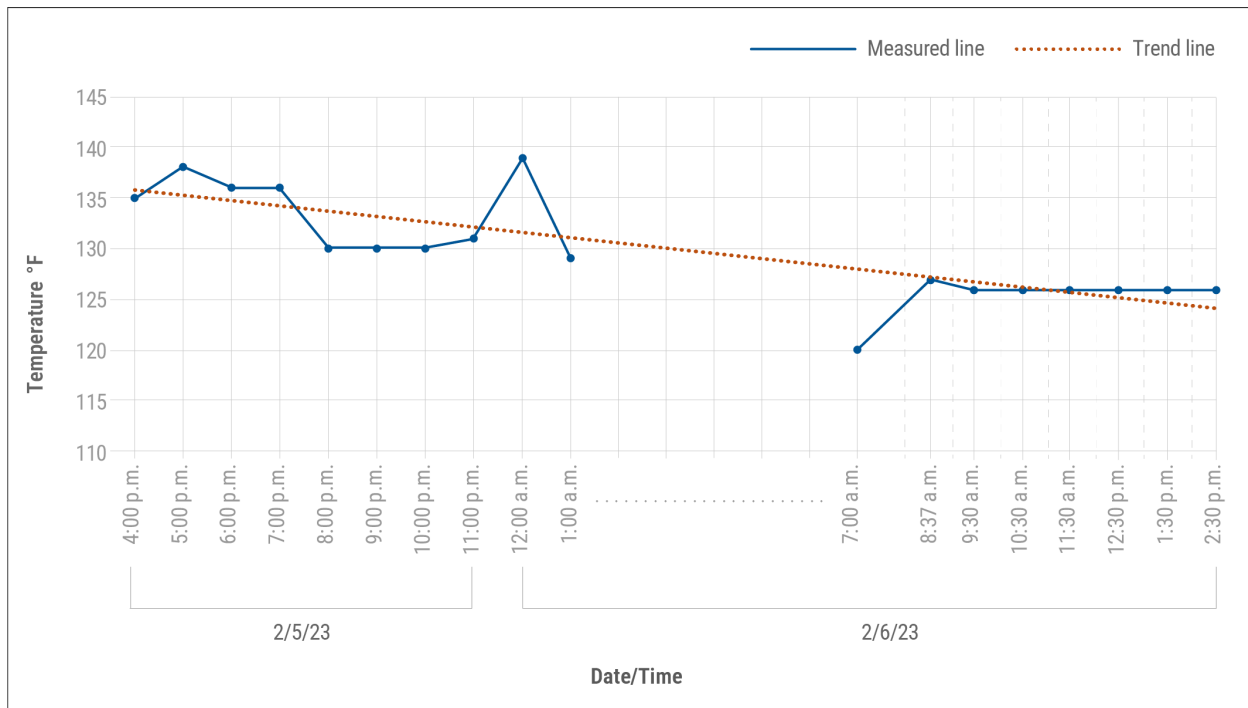
temperatures are listed in table 3. In discussions with the incident commander and the NTSB on scene, NS noted a 3°F increase in temperature for tank car OCPX80370 as an indication that polymerization was occurring. This increase to 138°F on the afternoon of February 5 was close to the highest temperature recorded on a tank car shell (139°F, measured during a brief fire under the tank car about midnight on February 5-6). Tank car OCPX80370 was the only tank car to show significant variations in temperature during monitoring.¹⁵⁴ The temperature for OCPX80370 is plotted in figure 31 (blue), along with a trendline (red).

Figure 31. Measured temperatures and trendline for OCPX80370.

According to information Oxy Vinyls provided the NTSB after the vent and burn, a runaway polymerization reaction would produce “a rapid, significant, and sustained increase in temperature and pressure.” The dashed red trendline in the figure shows a gradual decline instead. The surface temperature measurements therefore do not indicate exothermic polymerization in tank car OCPX80370. Measured variations in temperature were likely the result of environmental conditions and the limitations of the method used. Because of non-uniform heating caused by
