Railroad Investigation Report: RIR-24-07

Union Pacific Railroad Head-On Collision with Stationary Intermodal Railcars

Imperial County, California
September 8, 2022

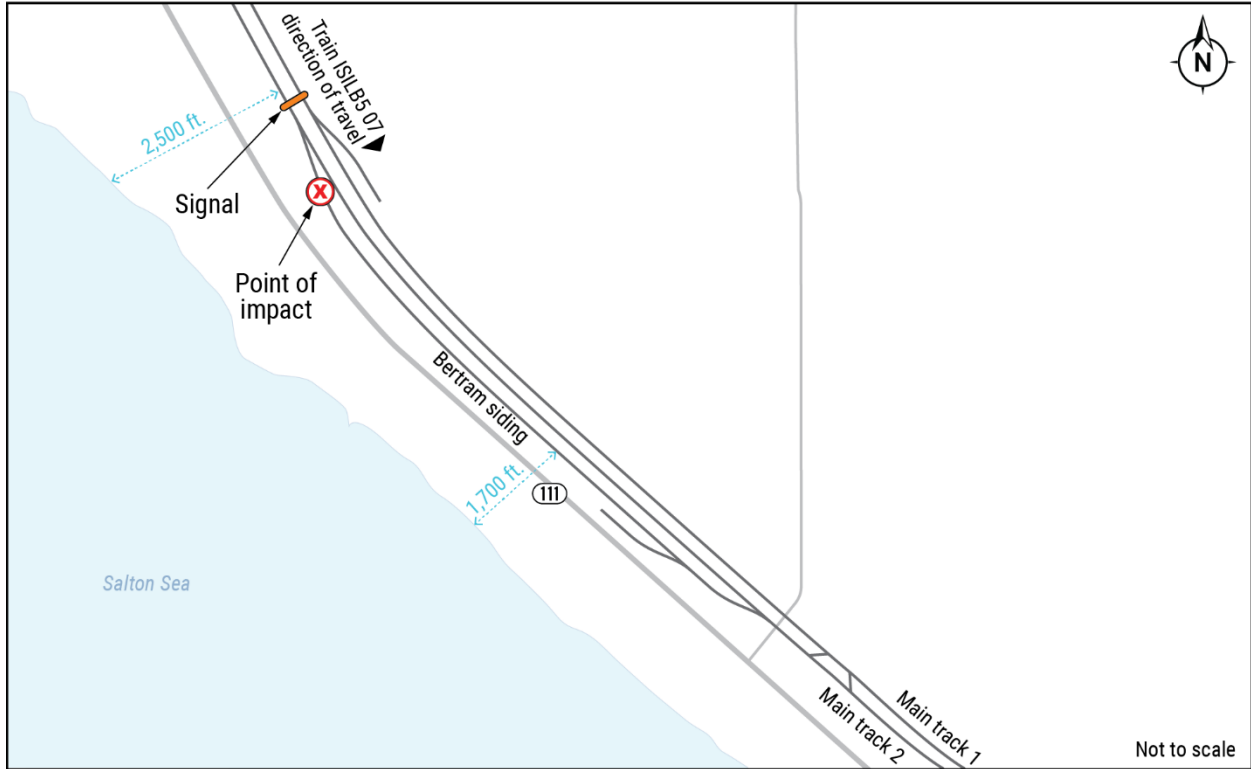
Figure 2. Tracks at the accident location.

Union Pacific Railroad operates primarily in the western and midwestern United States, with 32,534 route miles in 23 states and service at both the northern and southern US borders.⁴ The 194 track miles in UP's Yuma Subdivision extend from milepost 732.4, in Yuma, Arizona, to milepost 538.2 in Colton, California, in a timetable west-east direction. The Yuma Subdivision runs alongside the Salton Sea, a shallow, highly saline body of water in the Imperial Valley of southern California. Bertram siding is about 1,700 feet from the sea. (See figure 2.)
