Illustrated Digest

Norfolk Southern Railway Derailment and Subsequent Hazardous Materials Release

East Palestine, Ohio • February 3, 2023

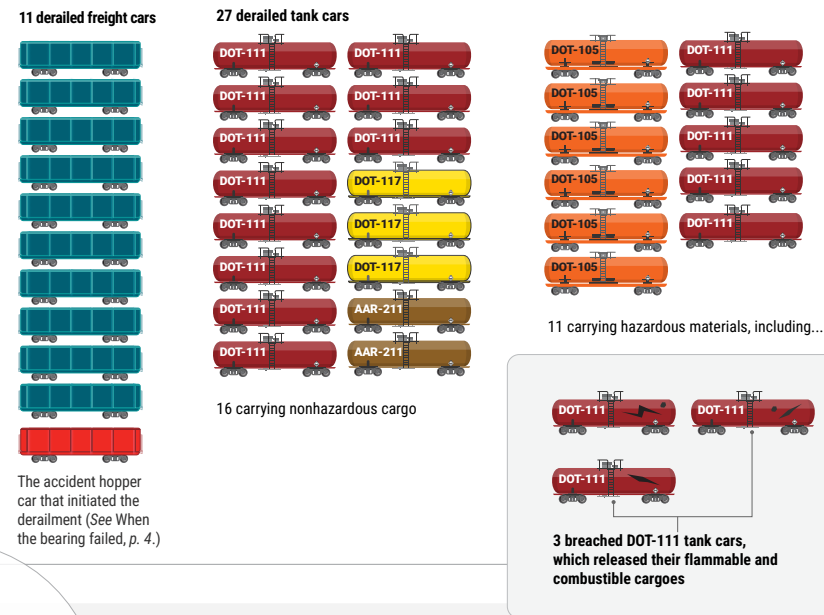
DOT-111 tank cars in a derailment: flip a coin

In a derailment, DOT-111 tank cars fail about as often as a coin comes up heads when you flip it.

More than 30 years later, we saw a similar breach rate at East Palestine: 8 of 16 derailed DOT-111s released at least some of their contents, with a breach rate of 44% from confirmed mechanical damage.

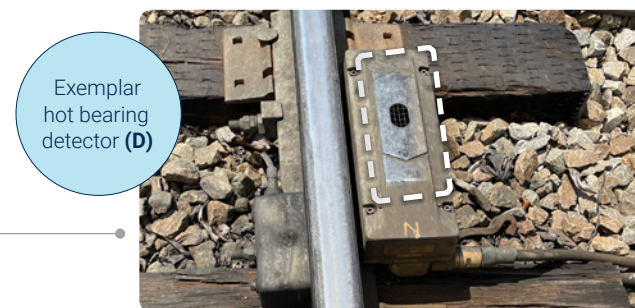
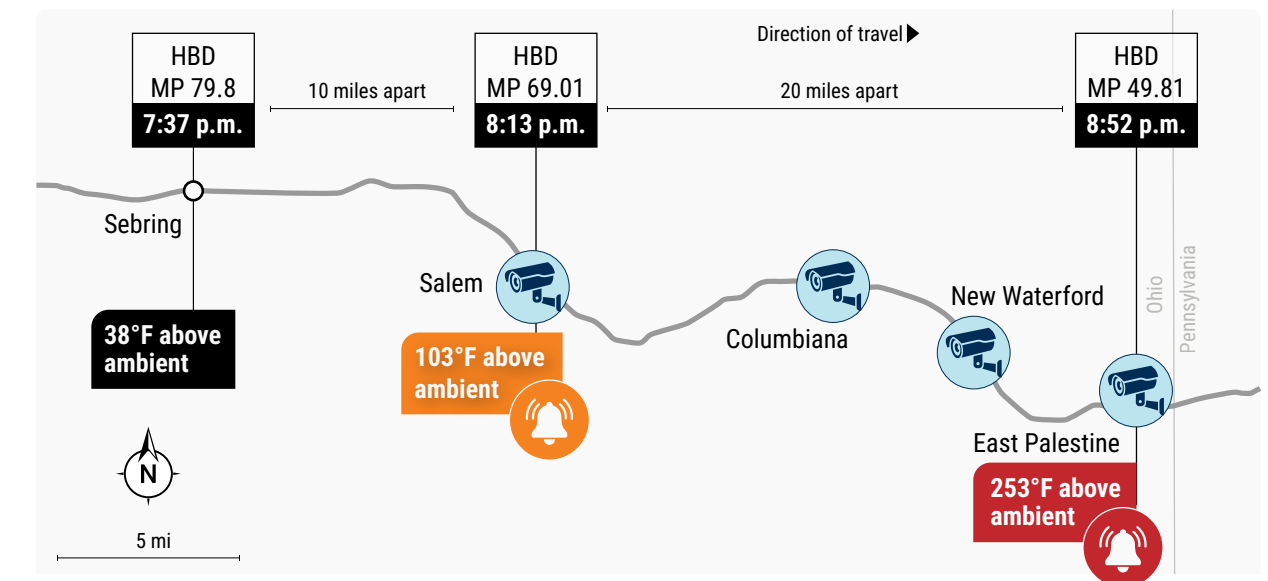
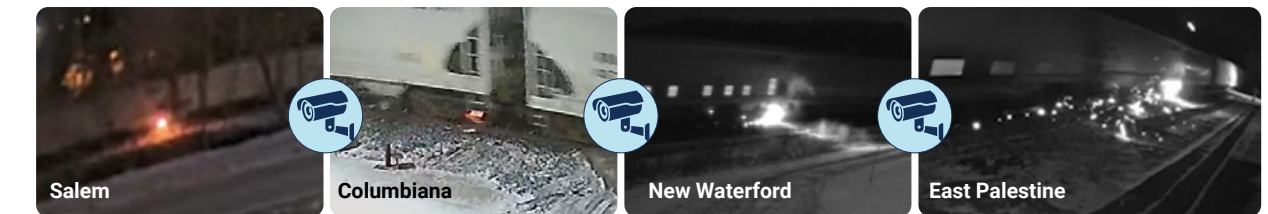
At 8:13 p.m., at the Salem HBD, the reading for the L1 bearing was 103°F above ambient. This reading was high enough to trigger a noncritical alert to the Wayside Help Desk (see box), but not to the crew. A surveillance camera picture from Salem showed fire near the bearing (right). Surveillance cameras in Sebring also captured images of the train, and no anomalies were noted.

Under NS rules, if a train's crew hears a critical alarm, they must stop the train right away and inspect the wheelset that triggered the alarm. The engineer began to slow the train before 8:54 p.m.

But it was too late; the hopper car and 37 others derailed as the train's emergency braking system activated.

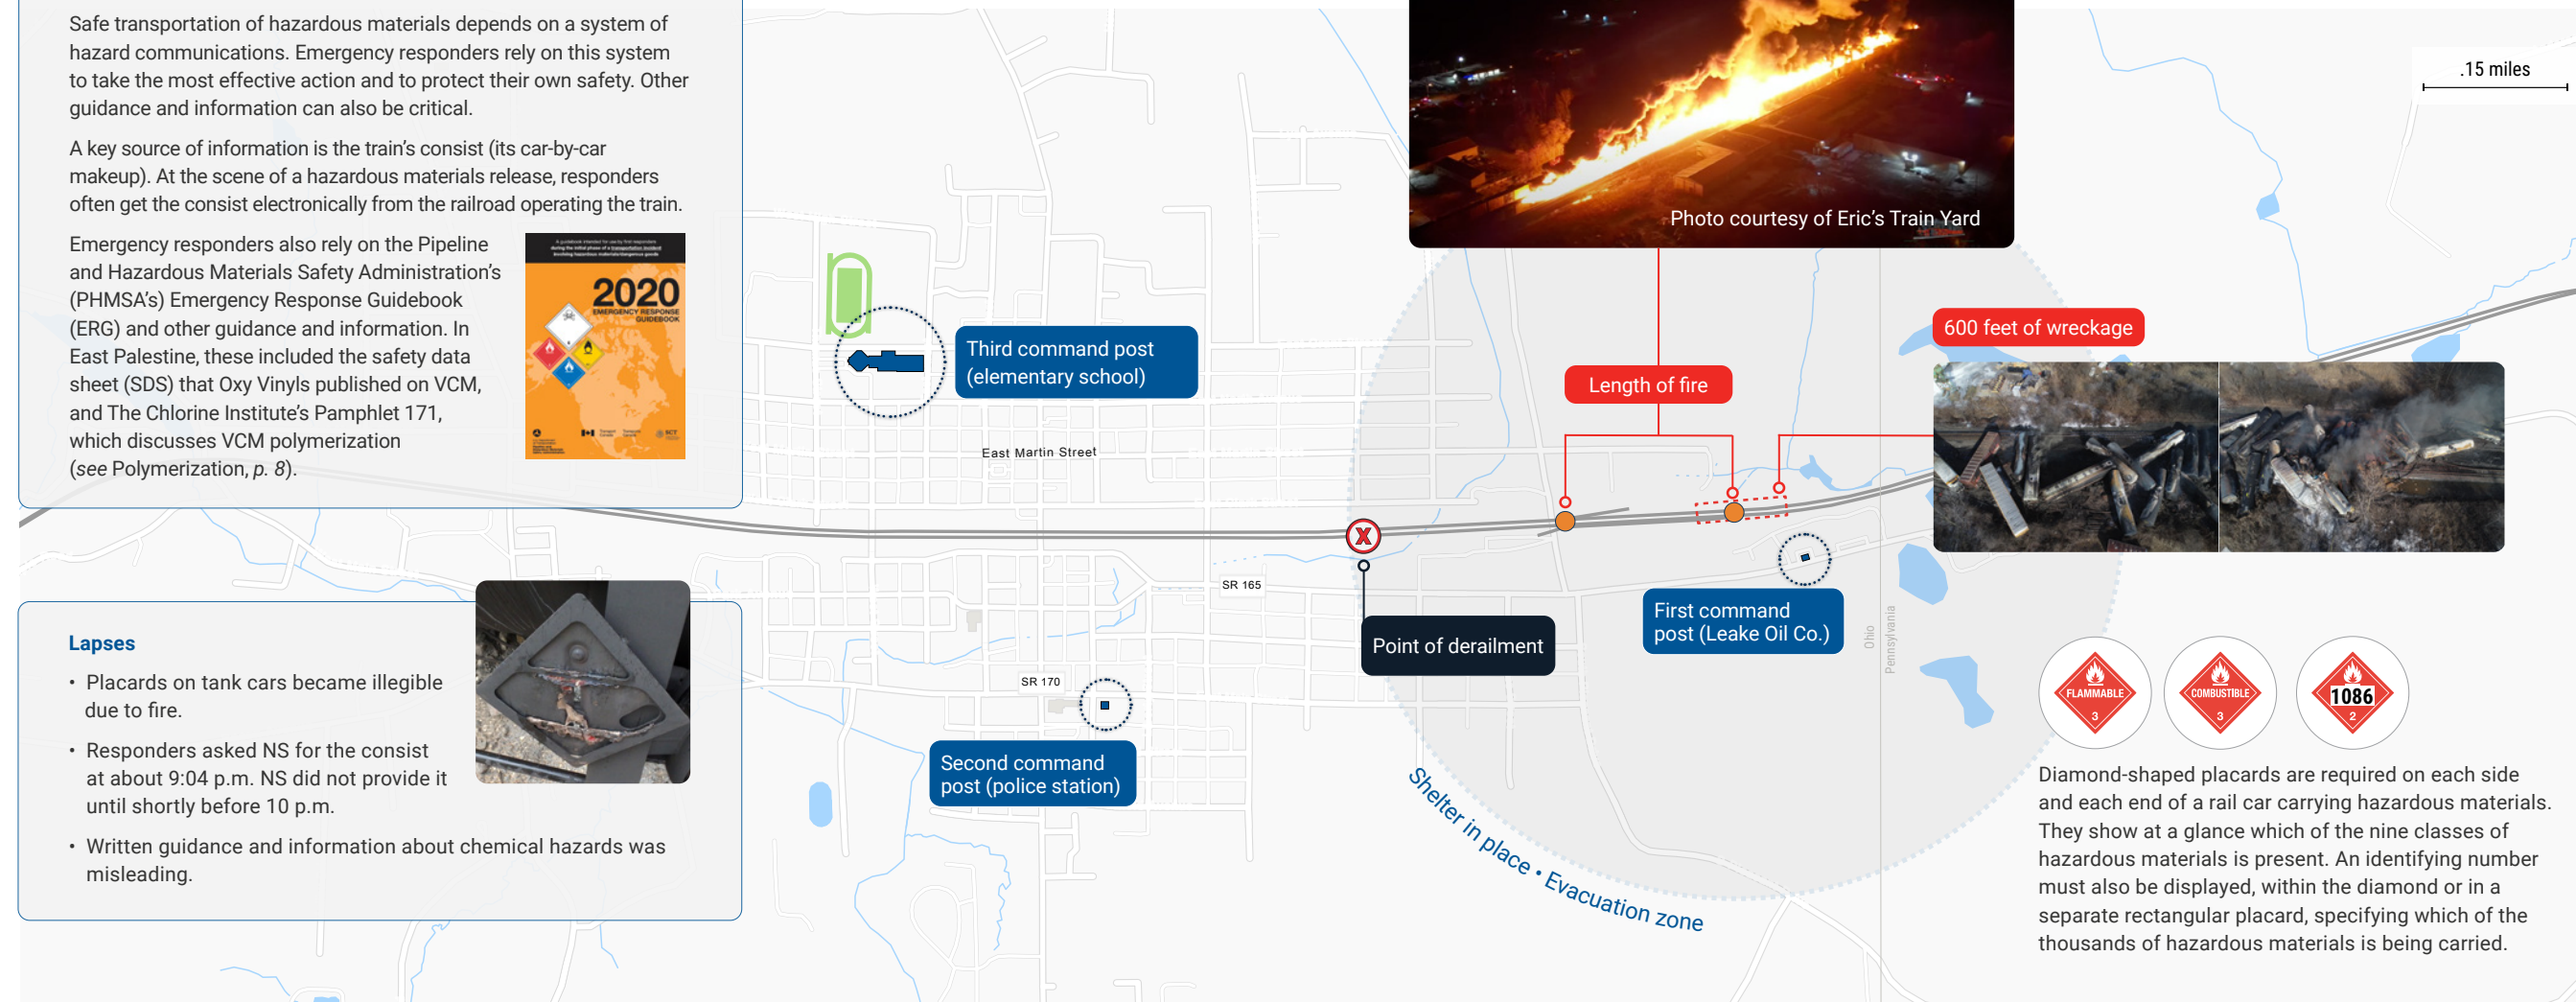
600 feet of wreckage

8:54 p.m. 38 railcars derail, including 27 tank cars, 11 of which are carrying hazardous materials. Three DOT-111 tank cars fail, releasing flammable or combustible material.

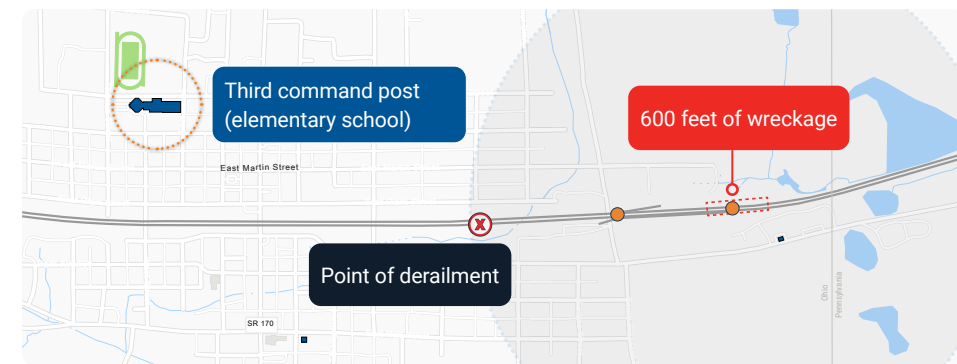
What happened to each derailed car

At right, you can see the fate of the derailed cars. All of the DOT-117 (yellow, black labels) tank cars resisted damage and did not spill their contents. Three DOT-111 tank cars (A-C) did release their flammable and combustible contents through punctures and/or cracks from the derailment, releasing flammable or combustible liquids.

Five DOT-105 cars carrying VCM (D-H) survived the derailment without punctures or tears but contractors vented and burned their contents 3 days later. Four of them had withstood fires without cracks or punctures, even though their PRDs activated and vented some contents.

The initial 2- to 3-hour pool fire that burns in the ditch alongside the derailment is likely fueled by butyl acrylates from tank car (A) in the diagram. Other candidates include the two other red tank cars in the diagram, which carry combustible liquids (B and C).

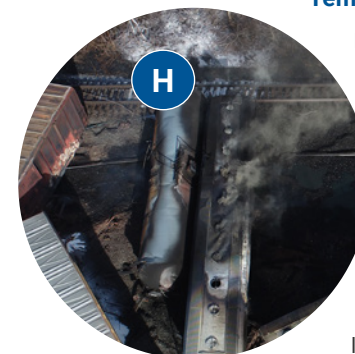
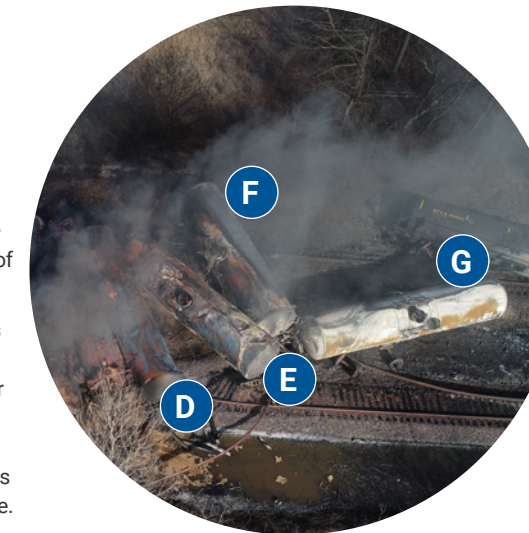
Tank car temperatures, February 5

The temperatures of the five cars, measured on February 5 and 6, do not approach the 185 °F that caused the initial PRD actuations, and temperature trend was even declining (see charts at right).

Most temperatures were in the 60s—room temperature. Other than the VCM tank car at the western edge of the pileup (H), only two readings, both at 7:00 a.m. February 6, were warmer; one was 90° and another was 115°. After that time, only tank car (H) was warmer than room temperature. No car was warmer than 139°.

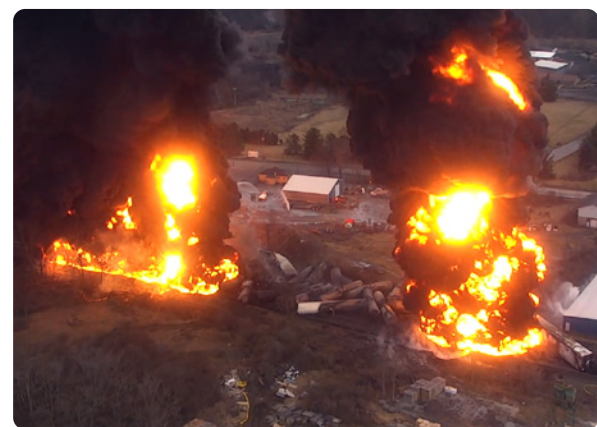
Contractors detonate explosives, releasing and burning VCM

Contractors breached the five tank cars at 4:47 p.m. Contractors positioned flares near each tank car to ignite vapor as it was expelled. Burning VCM resulted in a column of black smoke that grew into a persistent cloud. According to the NS system manager for hazardous materials, the cloud likely contained soot particles, carbon dioxide, carbon monoxide, hydrogen chloride, and a trace of phosgene (a toxic gas).
