Highway–Railroad Grade Crossing Collision  
US Highway 95  
Miriam, Nevada  
June 24, 2011

NTSB/HAR-12/03  
PB2013-103891

# Highway Accident Report

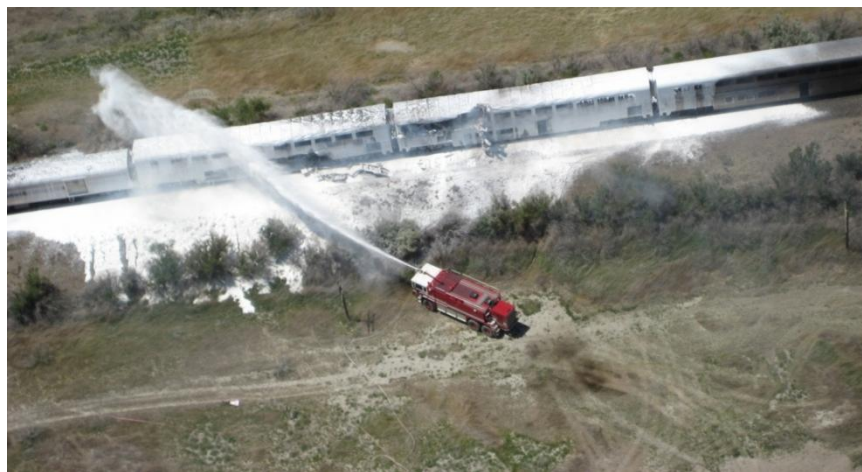
The first fire engine arrived at 11:53 a.m., but efforts to fight the fire were hindered by the off-road location of the engulfed railcars. The need for off-road-capable fire equipment was quickly recognized, and a formal request was made of Naval Air Station Fallon at 11:52 a.m. The all-wheel-drive foam pumper trucks began arriving at 12:46 p.m. to extinguish the railcar fires. (See figure 4.) Photographic evidence from occupants of the train indicated that the fire was substantially suppressed by 1:26 p.m. The fire chief cancelled additional fire equipment at 1:41 p.m. The highway was reopened for traffic at 2:40 p.m.

**Figure 4.** Aerial photograph showing all-wheel-drive foam pumper truck extinguishing fire on Amtrak train. (Courtesy of Nevada Highway Patrol)

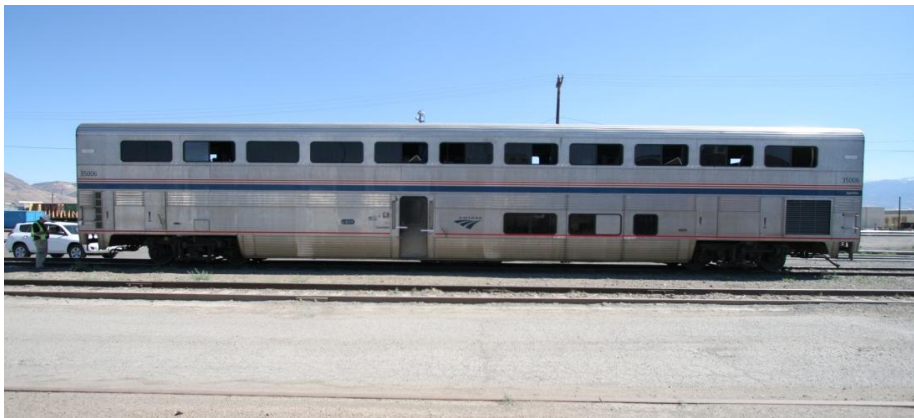
**1.5.1.3 Second Coach Railcar 35006.** The second coach railcar had an upper level passenger compartment, and a lower level consisting of a snack bar and lavatories. This railcar sustained only fire damage. Soot covered the exterior of the railcar. (See figure 8.) The lower level windows on the left-hand side were opaque due to degradation from thermal exposure. On the right-hand side, the lower level windows were covered with soot but had not become opaque. Thermal buckling of the roof structure was observed from the forward portion of the railcar to its middle. The fire consumed the rubber diaphragm of the forward car-to-car door, with more extensive damage on the right side than on the left. The window of the car-to-car door had melted and fallen out of position. Apart from soot, the lower level of the railcar did not sustain fire damage. The passenger compartment on the upper level was coated with soot throughout. (See figure 9.) At the forward end of the passenger compartment, the ceiling and luggage rack materials were charred. This charring extended to approximately the seventh row of seats from the front.

**Figure 8.** Photograph of second coach railcar 35006 at impound lot, with front of railcar at left.

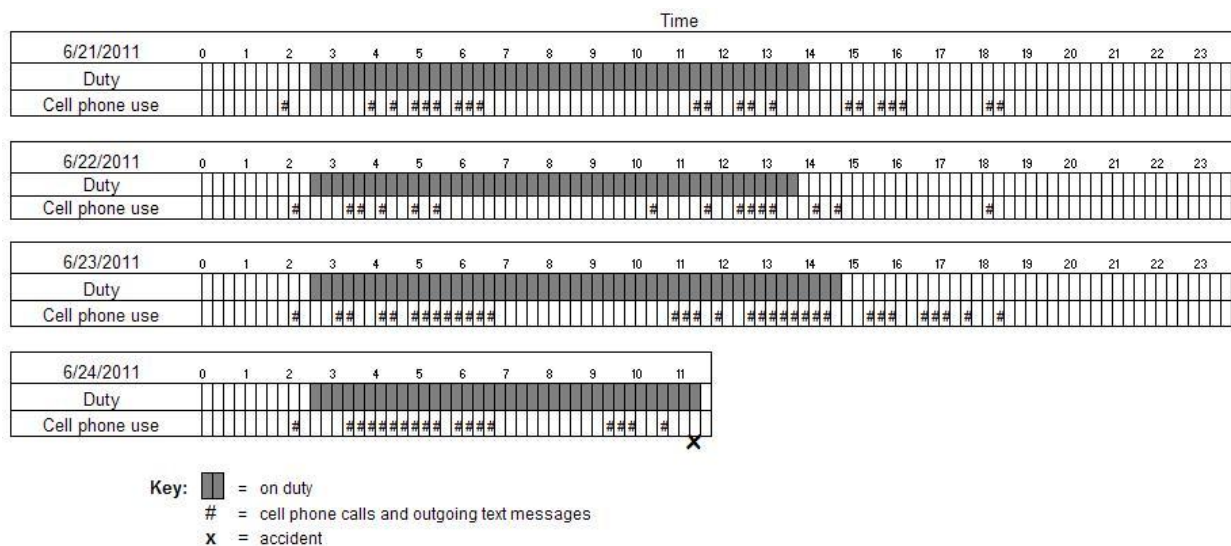
In the 2 weeks preceding the accident, the driver had worked 6 days (June 13–18) followed by 2 days off. The day of the accident—Friday June 24—was his fourth day on duty. On June 21, 22, and 23, the driver had begun his duty day at 2:30 a.m. and ended between 1:45 and 2:45 p.m. On the day of the accident, according to a coworker, the driver arrived at work at 2:30 a.m.

The driver’s recent work/activity history was reconstructed using information from his logbooks for the days preceding the accident, from mine logs, from his cell phone records, and from interviews with his supervisor and his girlfriend. Figure 14 summarizes the driver’s activities on the day of the accident and for the 3 preceding days.

**Figure 14.** Summary of accident driver’s duty schedule leading up to accident.

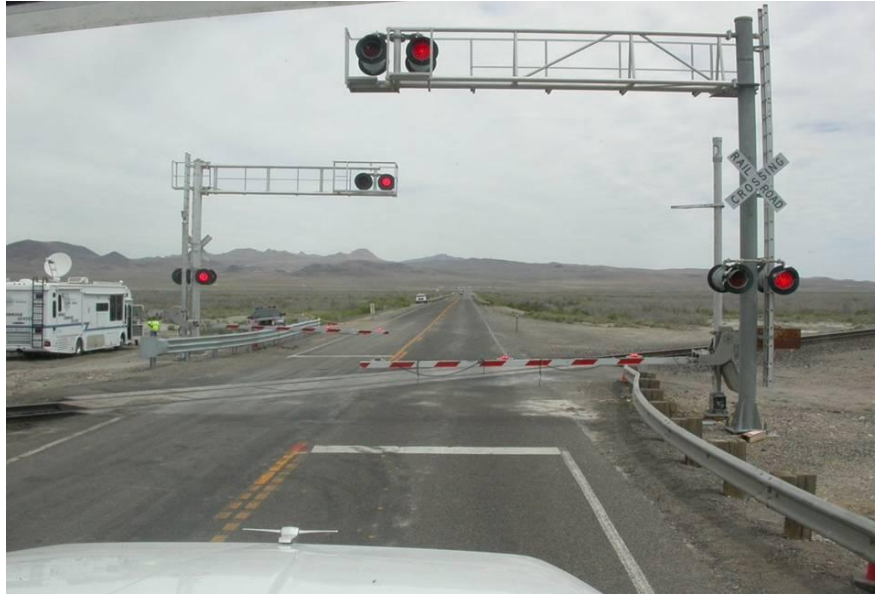
The grade crossing signal system has two gates with aluminum/fiberglass arms, each about 18.5 feet long, as shown in figure 16. Each gate arm has 13 alternating red and white stripes, with each stripe measuring 16 inches wide per the *Manual on Uniform Traffic Control*

**Figure 16.** Photograph of Miriam grade crossing, viewed from northbound side, with crossing gate arms in the descended position.

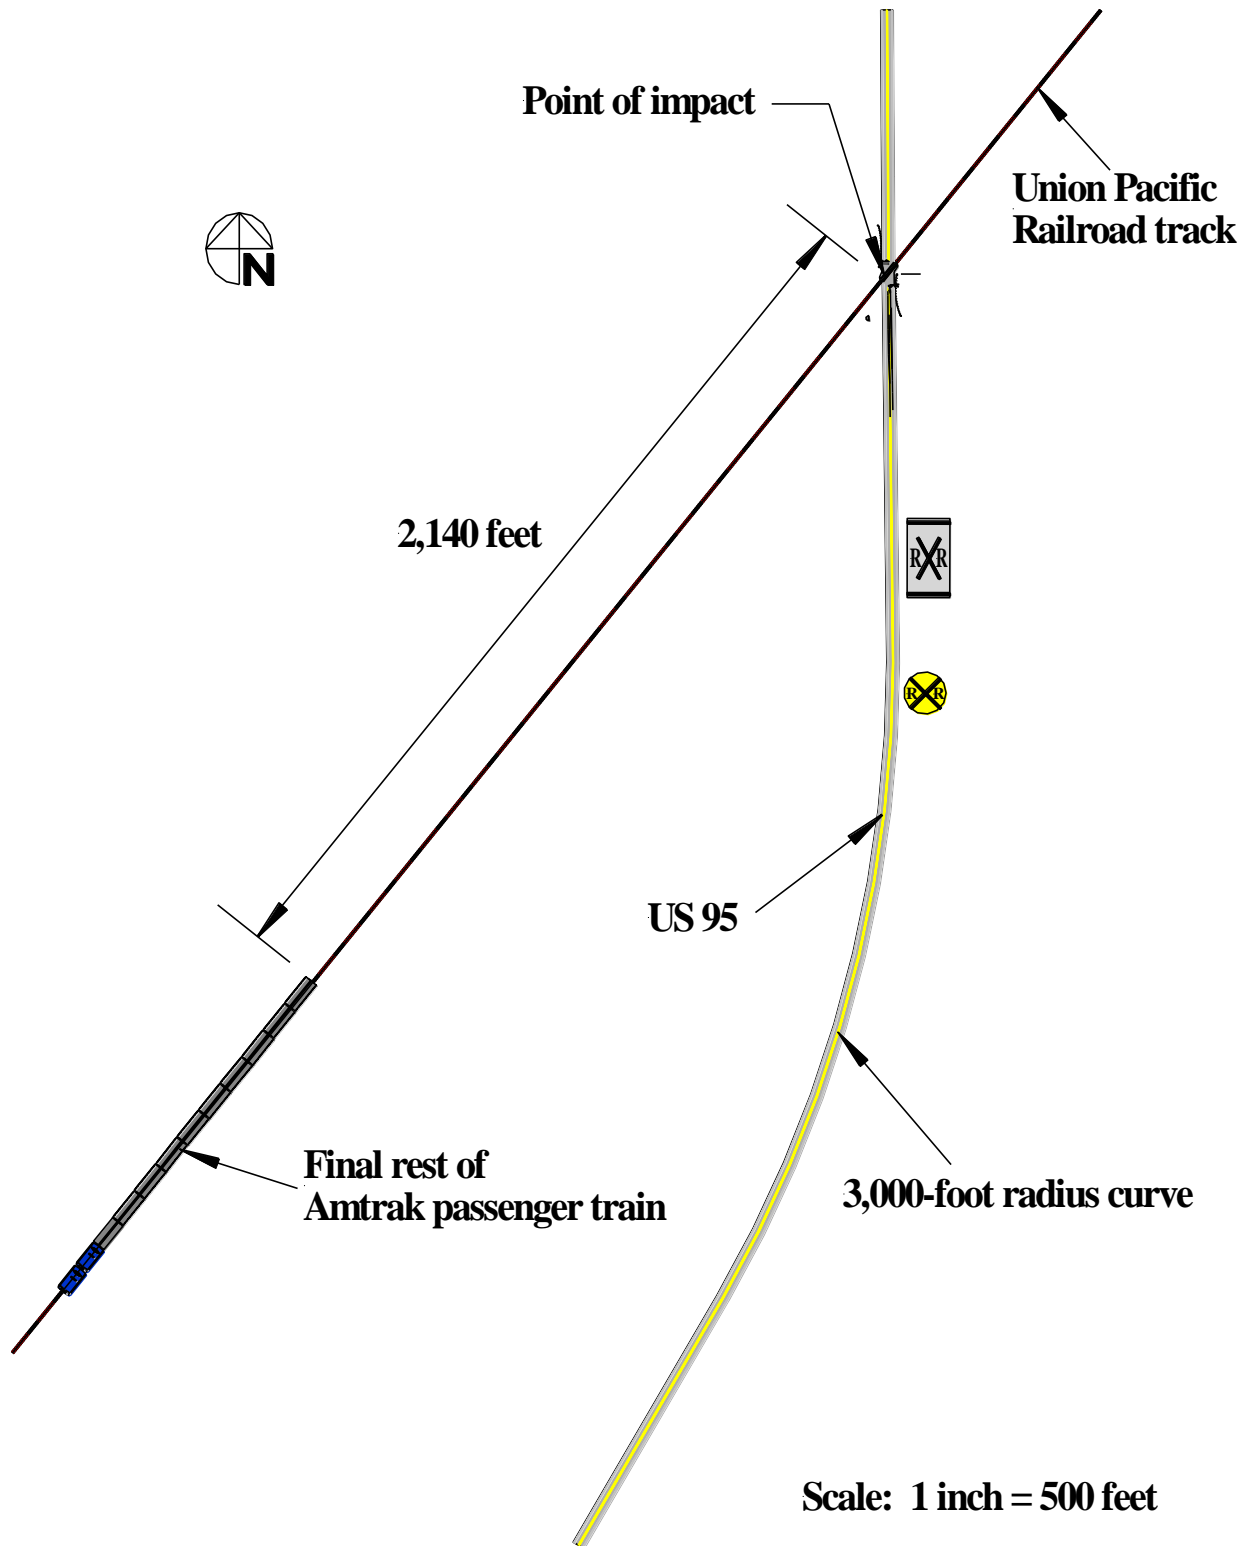
The horizontal curvature on the northbound approach of US 95 prior to the grade crossing advance warning sign has a radius of 3,000 feet and turns to the left in the direction of travel. Figure 20 depicts the horizontal curve and the final rest of the Amtrak passenger train, approximately 2,140 feet west of the impact area. The grade crossing and US 95 form a skew angle of approximately 139 degrees. The vertical grade on the northbound approach of US 95 prior to the grade crossing consists of a +0.35 (percent) slope. The vertical grade on the crossing is level.

**Figure 20.** Diagram showing alignment of US 95 and Union Pacific Railroad track at accident location.

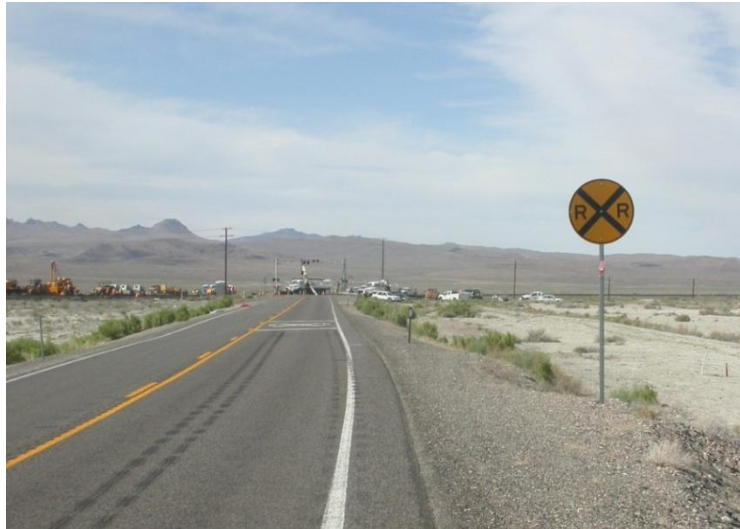
An advance warning sign was located approximately 900 feet from the grade crossing in the northbound lane of US 95.<sup>61</sup> (See figure 21.) A pavement marking was located about 760 feet in advance of the grade crossing in the northbound and southbound lanes. The 140-foot offset between the warning sign and pavement marking deviated from federal guidance for signal and marking placement.<sup>62</sup>

**Figure 21.** Photograph showing advance warning sign on right side of roadway, with pavement marking painted on northbound lane of US 95 about 140 feet beyond sign. (Tire marks in advance of pavement marking were determined not to have originated from accident truck.)

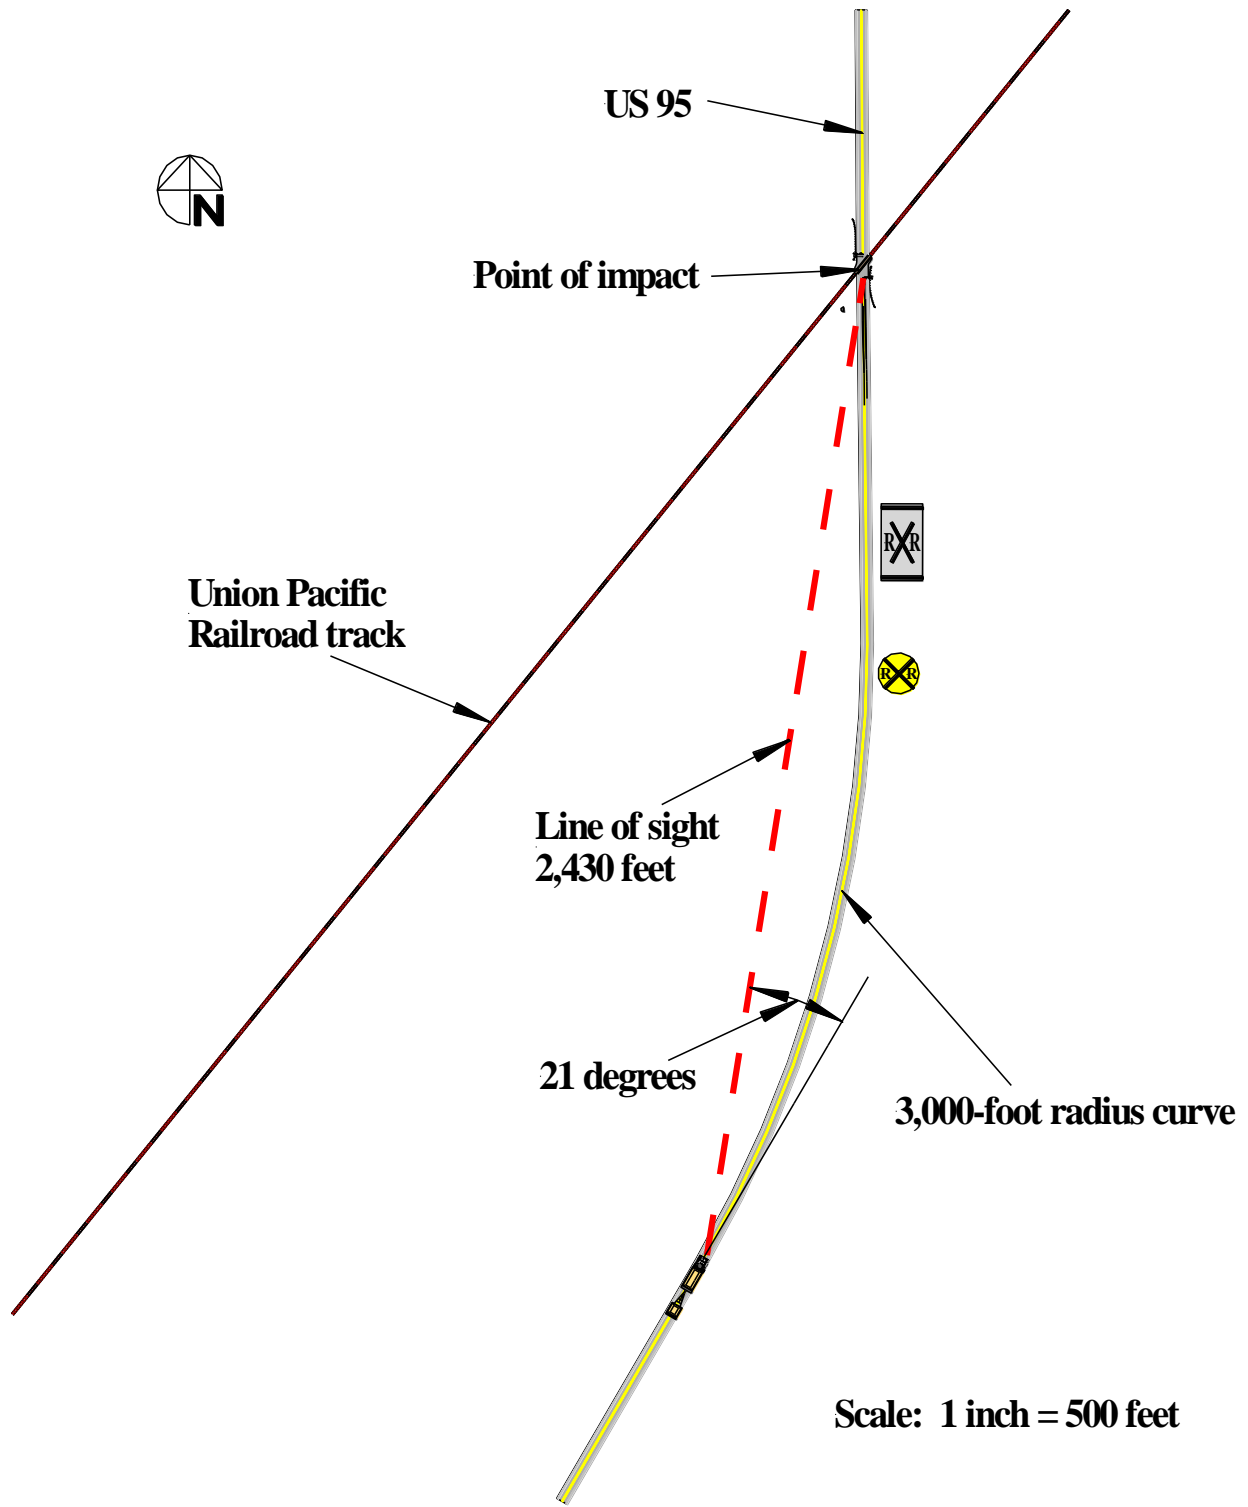
To determine the initial point at which the accident driver would have been able to detect the flashing lights, the exemplar truck was moved approximately 9,000 feet south of the grade crossing and then incrementally forward toward the crossing. At each increment, a determination was made as to whether the flashing lights could be detected, and a photograph was taken in the direction of the flashing lights. Investigators could see the flashing light signals at approximately 2,430 feet from the grade crossing, well in advance of the advance warning sign and pavement markings. At this point, the grade crossing would be 21 degrees left of the driver’s forward view. Figure 23 illustrates the first point at which the flashing lights could have been visible to an approaching driver. As described in the analysis, given the approach speed of the accident truck, it was probably about 2,400 feet from the grade crossing when the flashing lights activated.

**Figure 23.** Diagram depicting initial point at which flashing warning lights located on post-mount and cantilevered overhead structure were visible from exemplar truck.
