# National Transportation Safety Board

## Union Pacific Railroad, Derailment with Hazardous Materials Release March 10, 2017

Michael Hiller, IIC

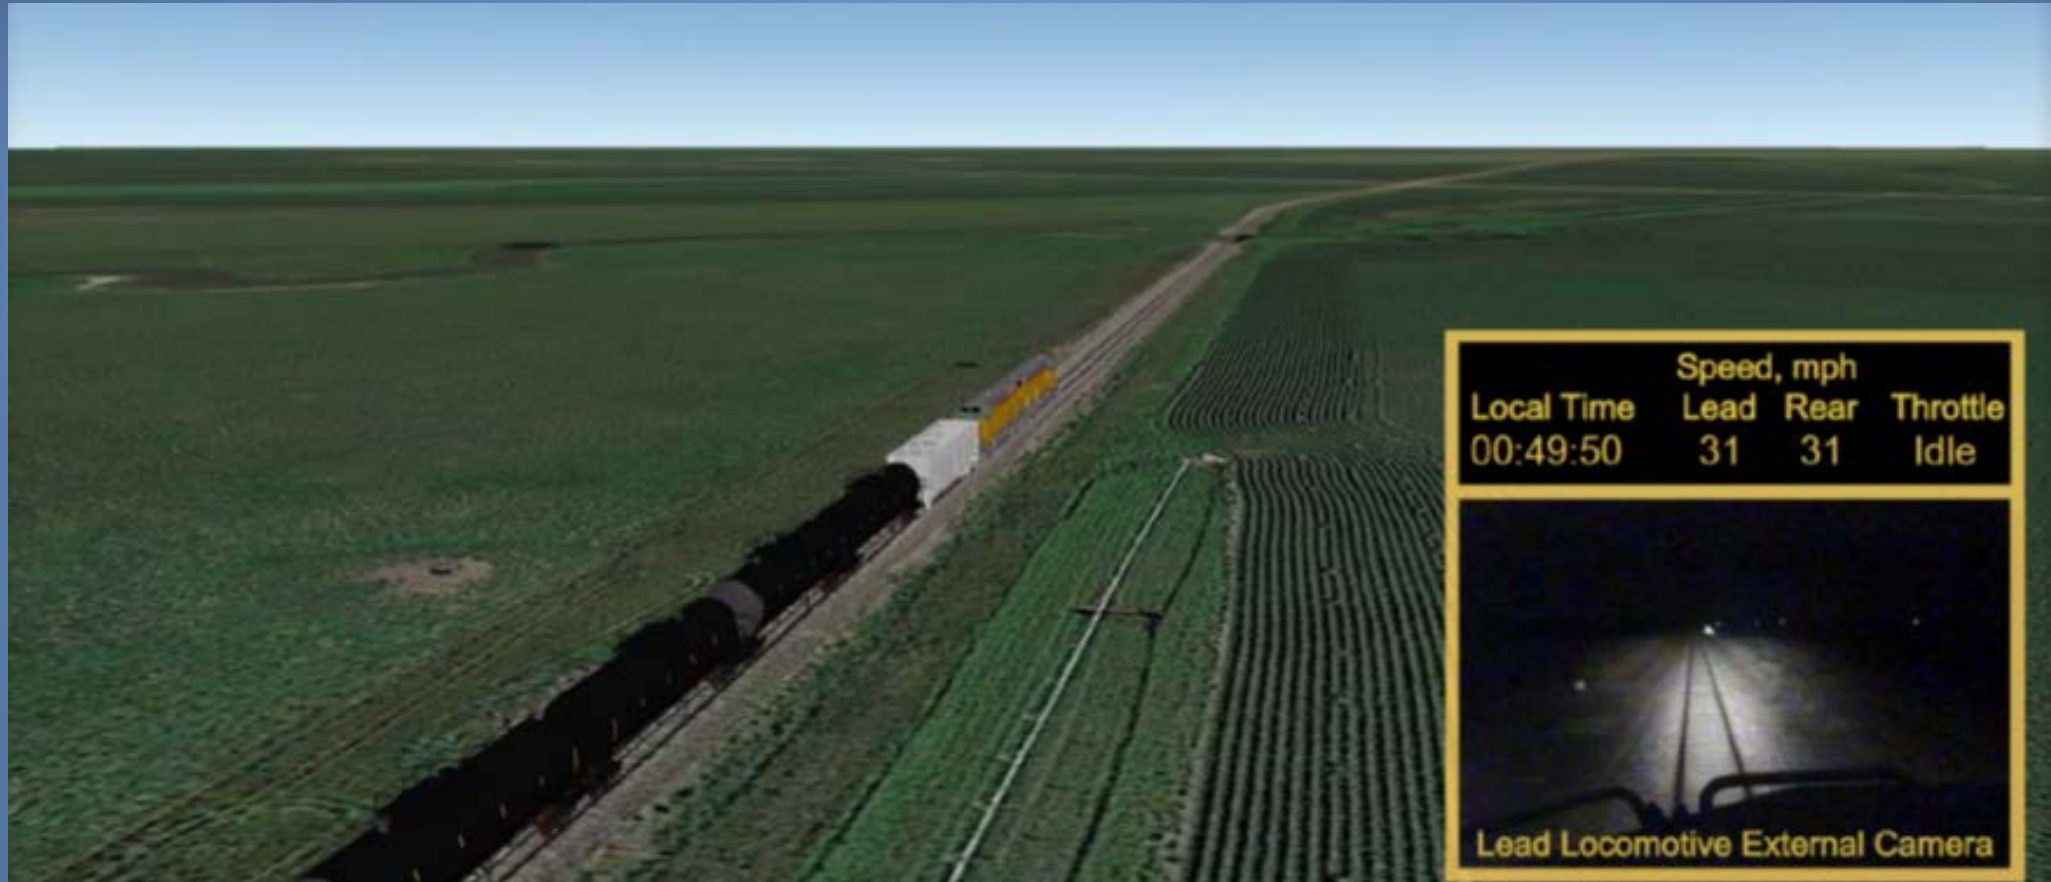
- Legacy DOT-111
- 10 tank cars mechanically breached
- PHMSA developed new standard, DOT-117
- DOT-111 retrofitted or removed from ethanol service by May 1, 2023

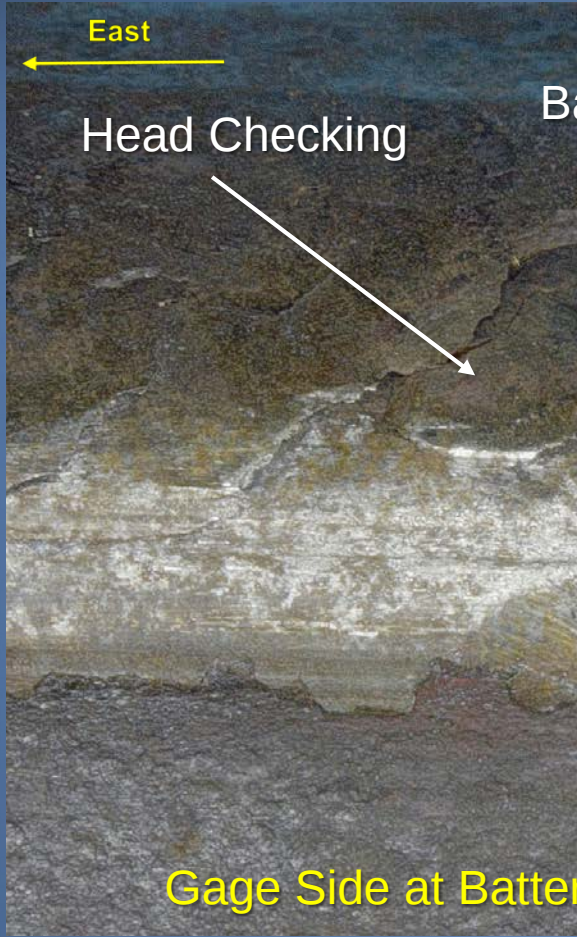
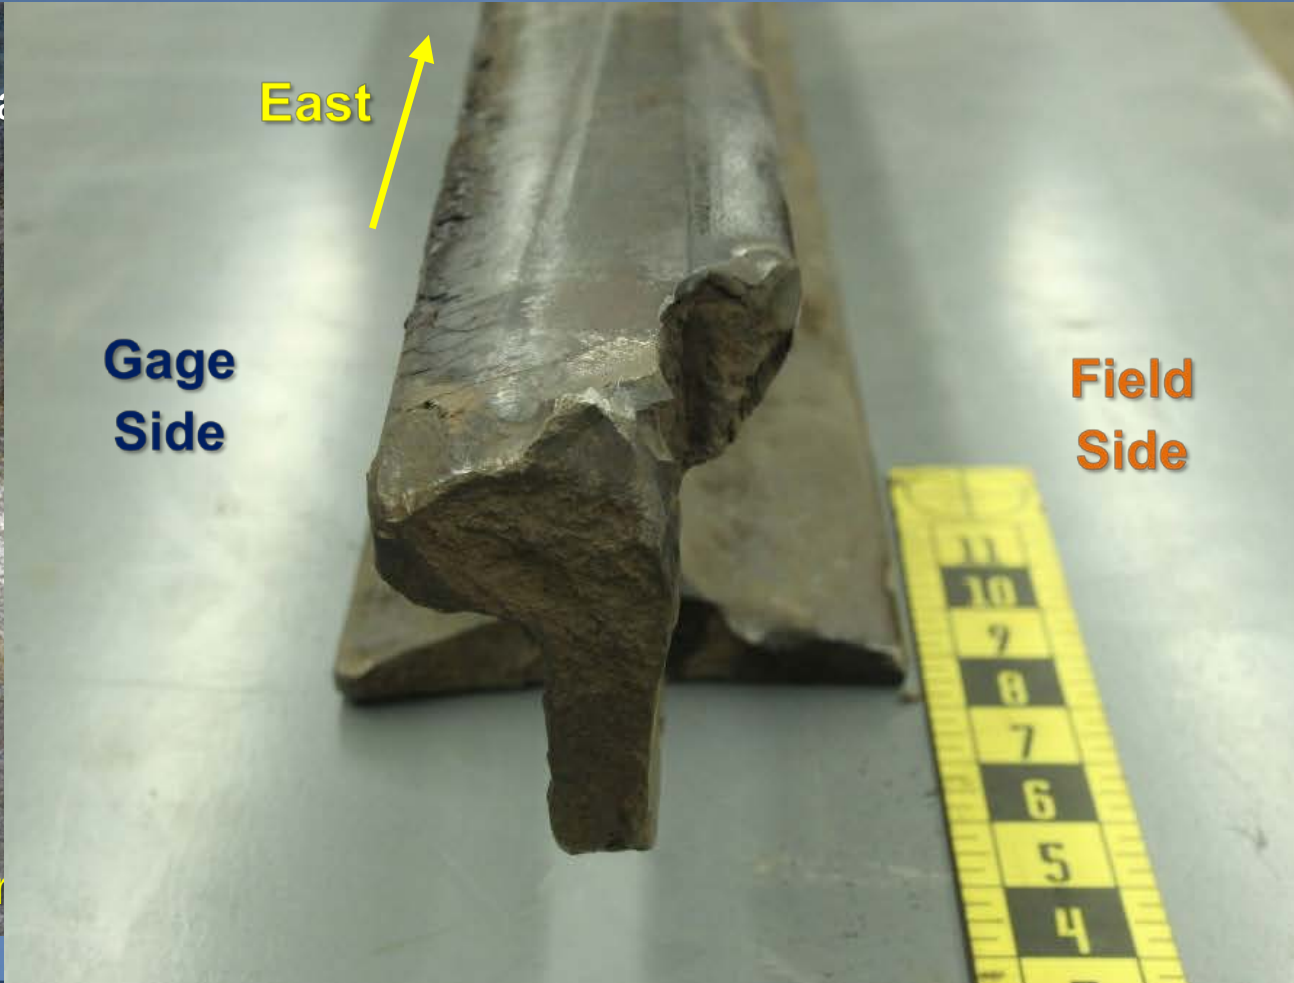
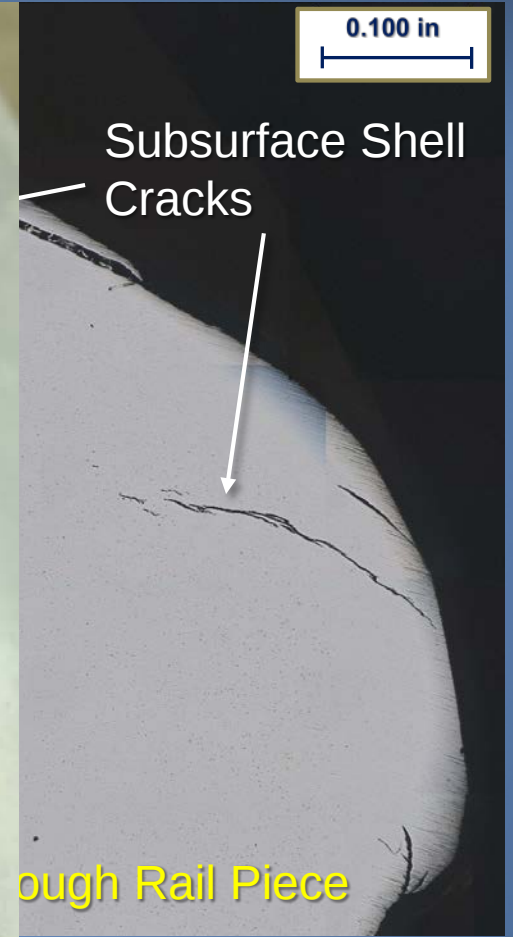
# Metallurgical Examination

- The train derailed at a broken south rail on the west approach prior to the timber bridge
  - Rail fragment recovered was most damaged
  - Located adjacent to largest missing rail section
- Finite element modeling performed on worn 90-lb. rail with varying track support
  - Worn rail with degraded supports leads to higher stress
  - Could increase risk of rail head failure
