# International Investigations

*Global Collaboration with Domestic Impact*

**Materials Laboratory**

**Michael Budinski**

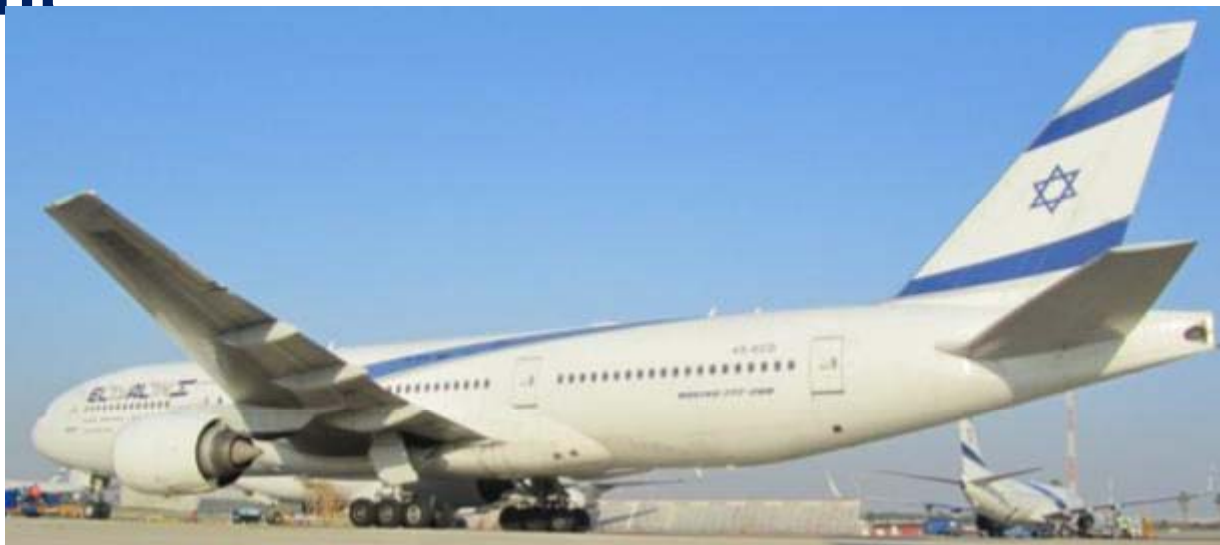
# El Al Flight 027, Boeing 777-200, Tel Aviv, Israel

- Normal takeoff from Ben Gurion International Airport—the left main landing gear (MLG) did not retract
- Aircraft returned to airport and landed without incident

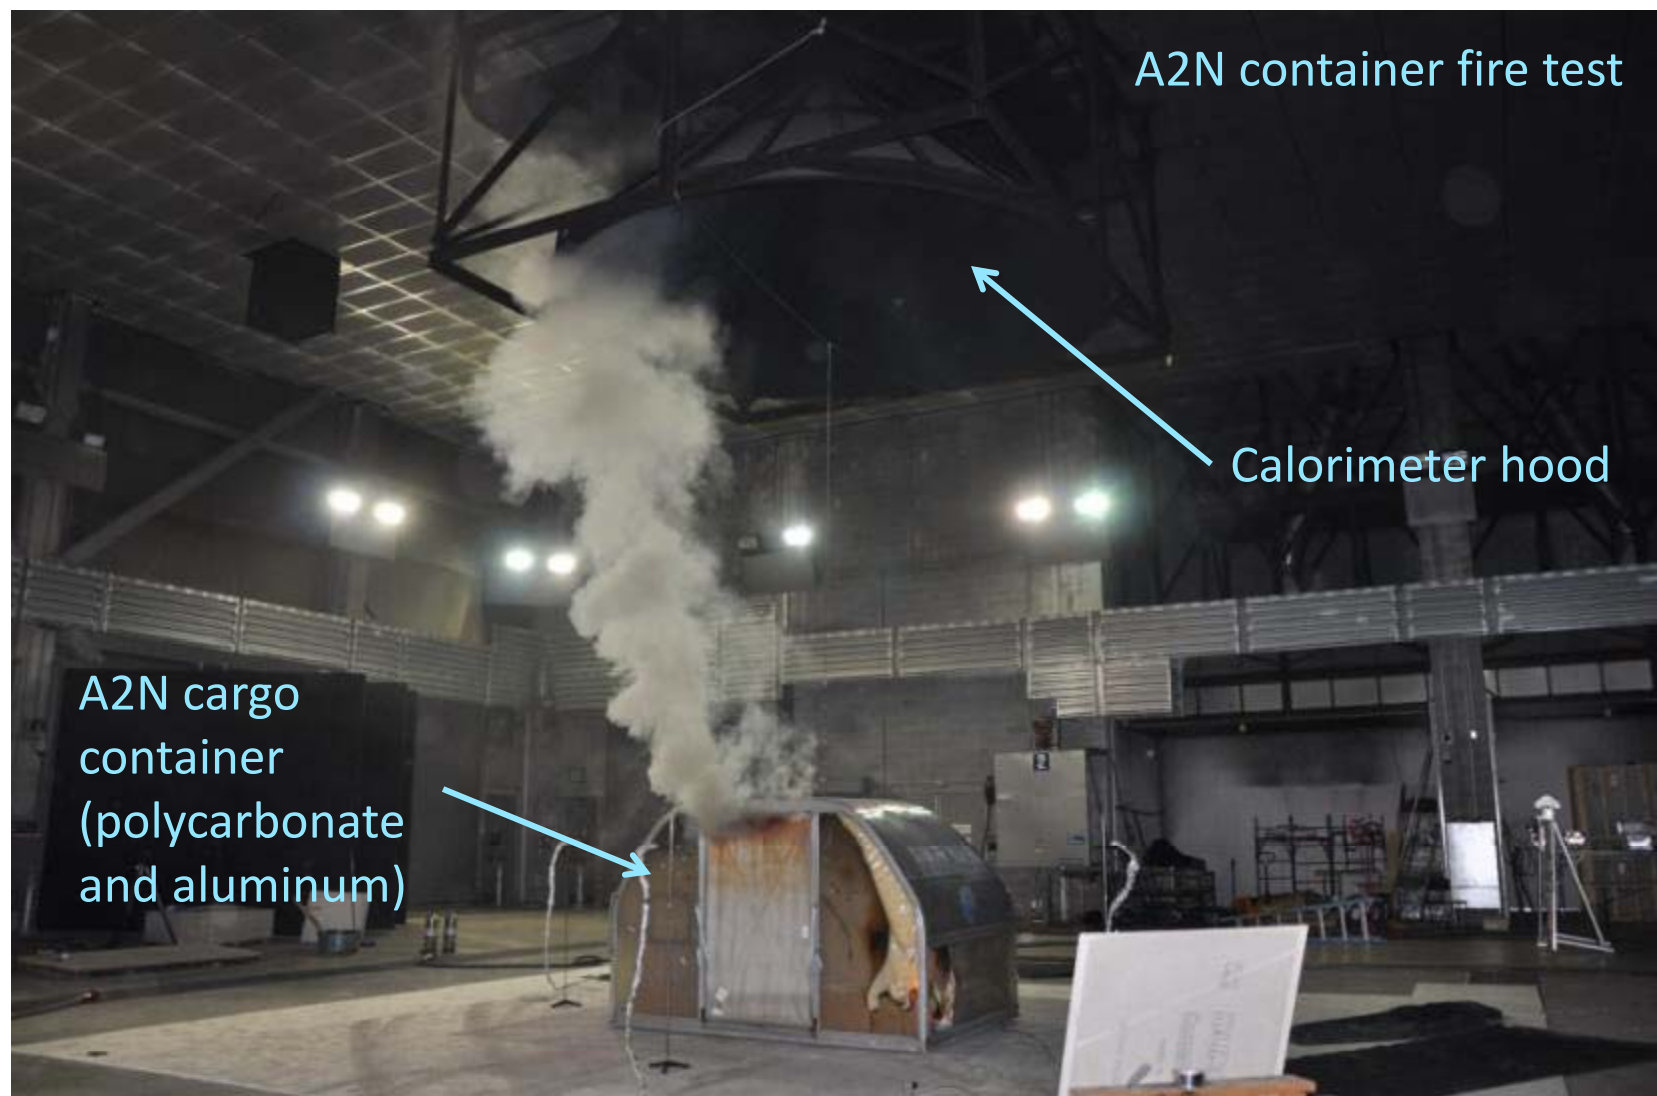
# Cargo Container Fire Experiment

- NTSB Materials Laboratory fire investigator on scene
- Developed a fire test program to understand cargo fires:
  - Quantify the fire load posed by lithium-ion batteries relative to ordinary combustibles
  - Quantify the size and growth rate of a cargo container fire
