NATIONAL TRANSPORTATION SAFETY BOARD

AIRCRAFT ACCIDENT REPORT

PROVINCETOWN-BOSTON AIRLINES
FLIGHT 1039

EMBRAER BANDEIRANTE, EMB-110P1, N96PB
JACKSONVILLE, FLORIDA
DECEMBER 6, 1984

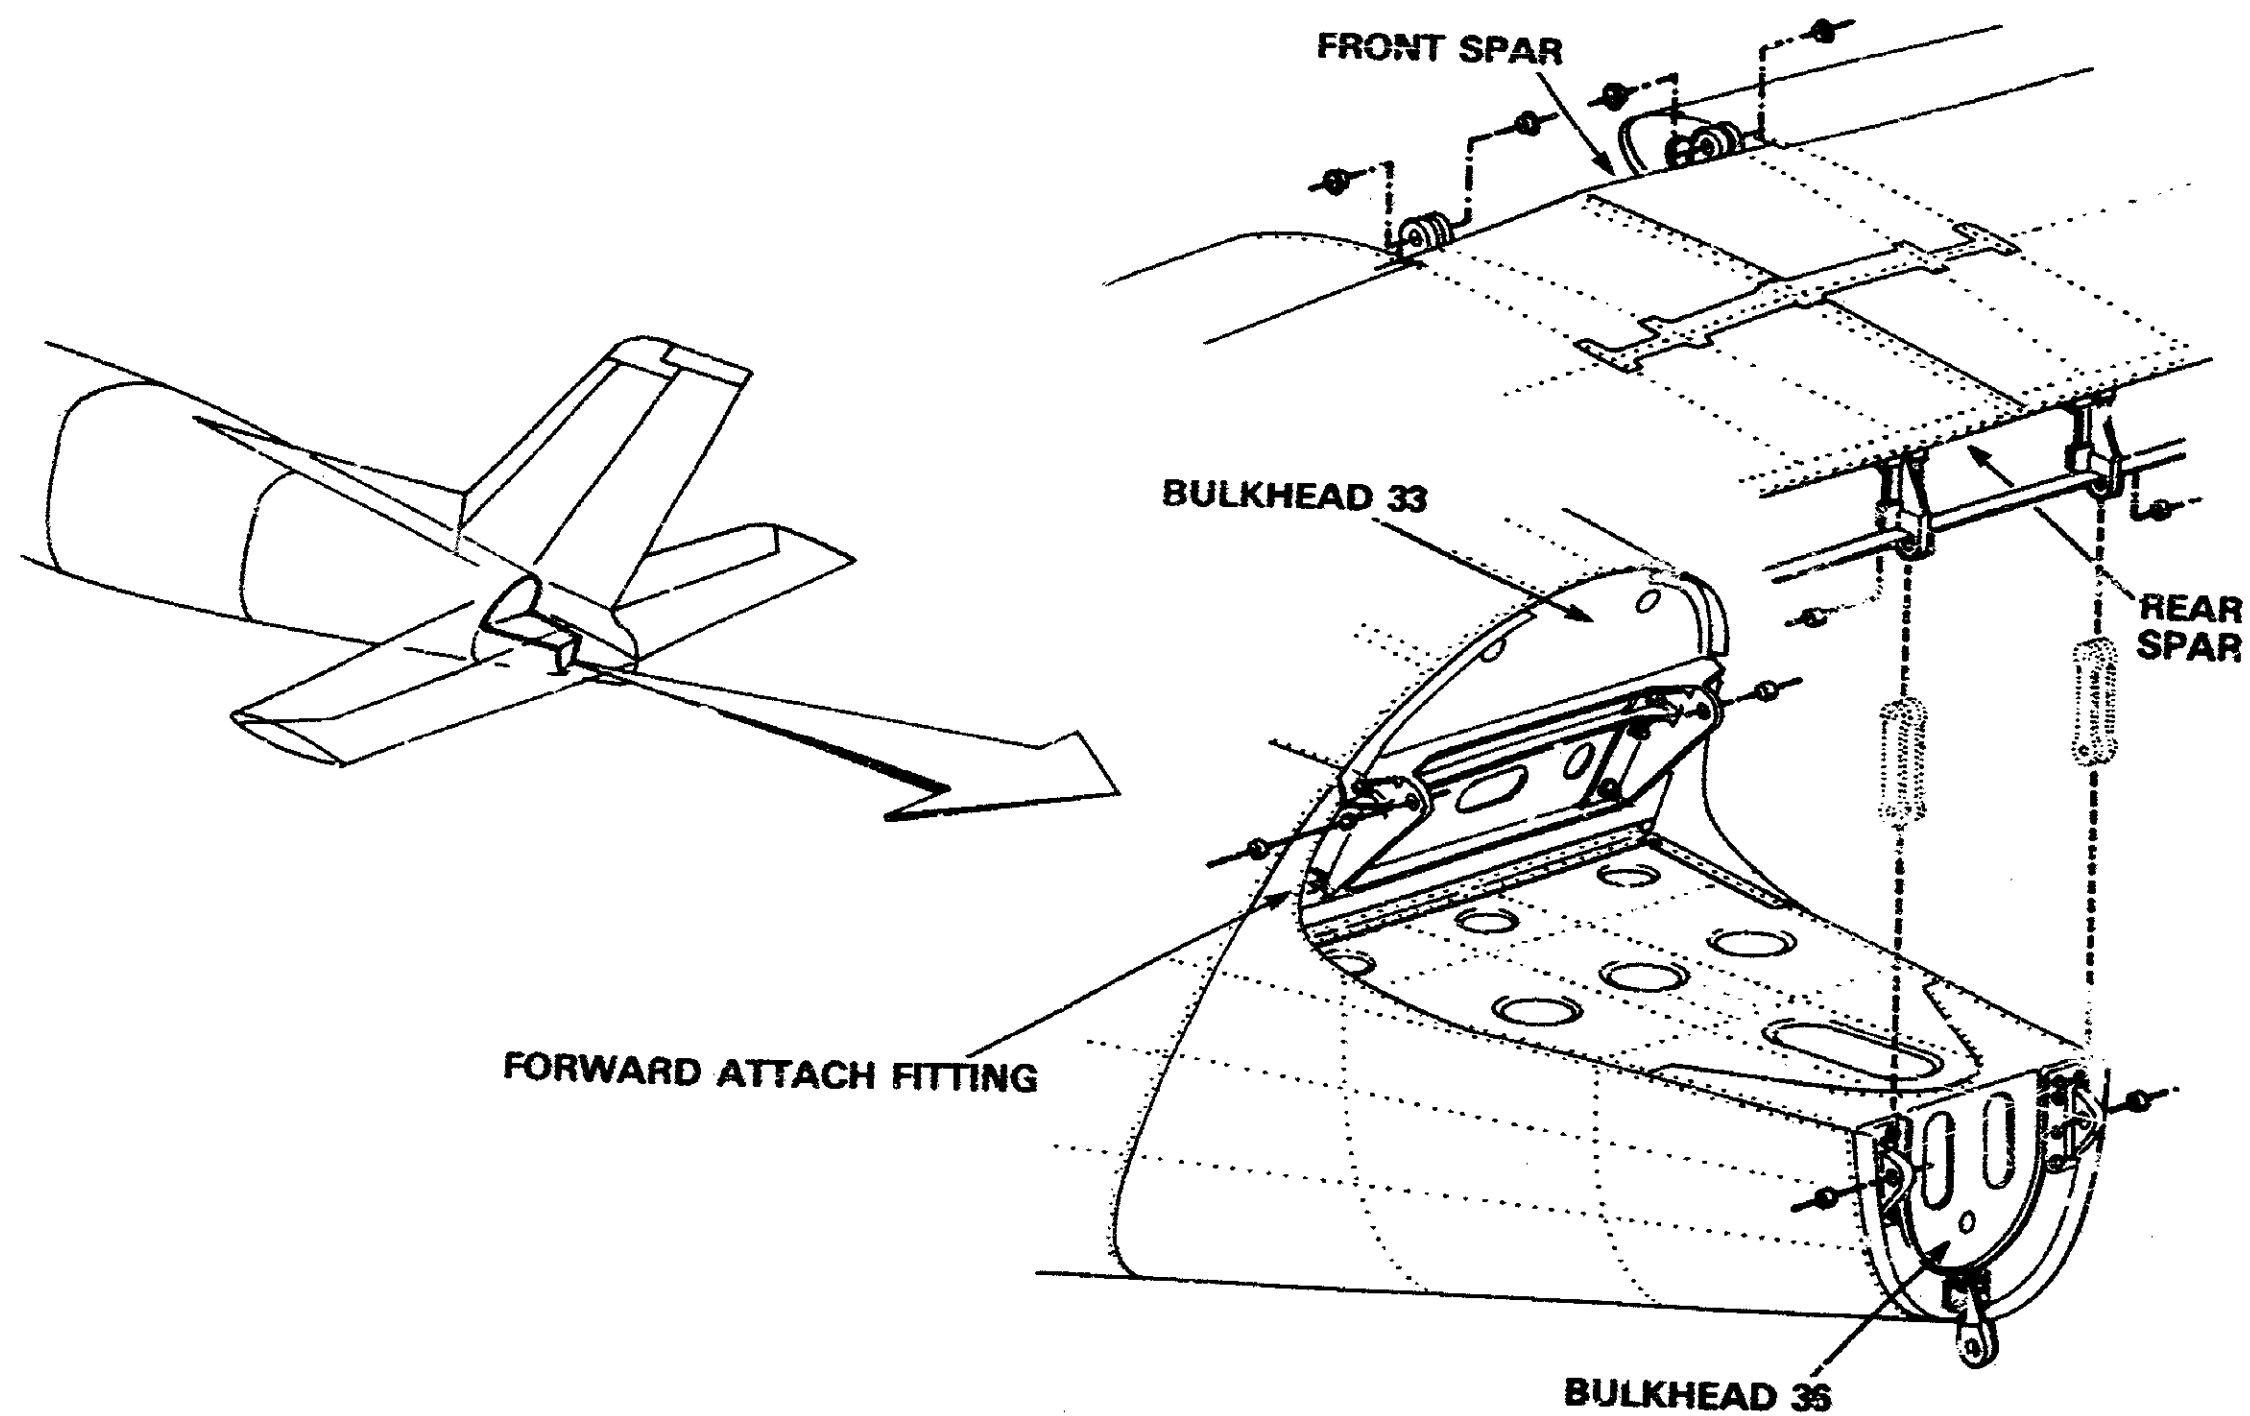
Figure 1.—Bandeirante EMB-110P1 stabilizer/fuselage supports.

The examination of the bulkhead No. 33 structure disclosed fretting around some rivet holes in channels which transmit the loads from the upper right corner of the forward attachment fitting into the fuselage structure forward of the bulkhead. The bulkhead web break contained a small preexisting fatigue crack, 5/16 inch long.

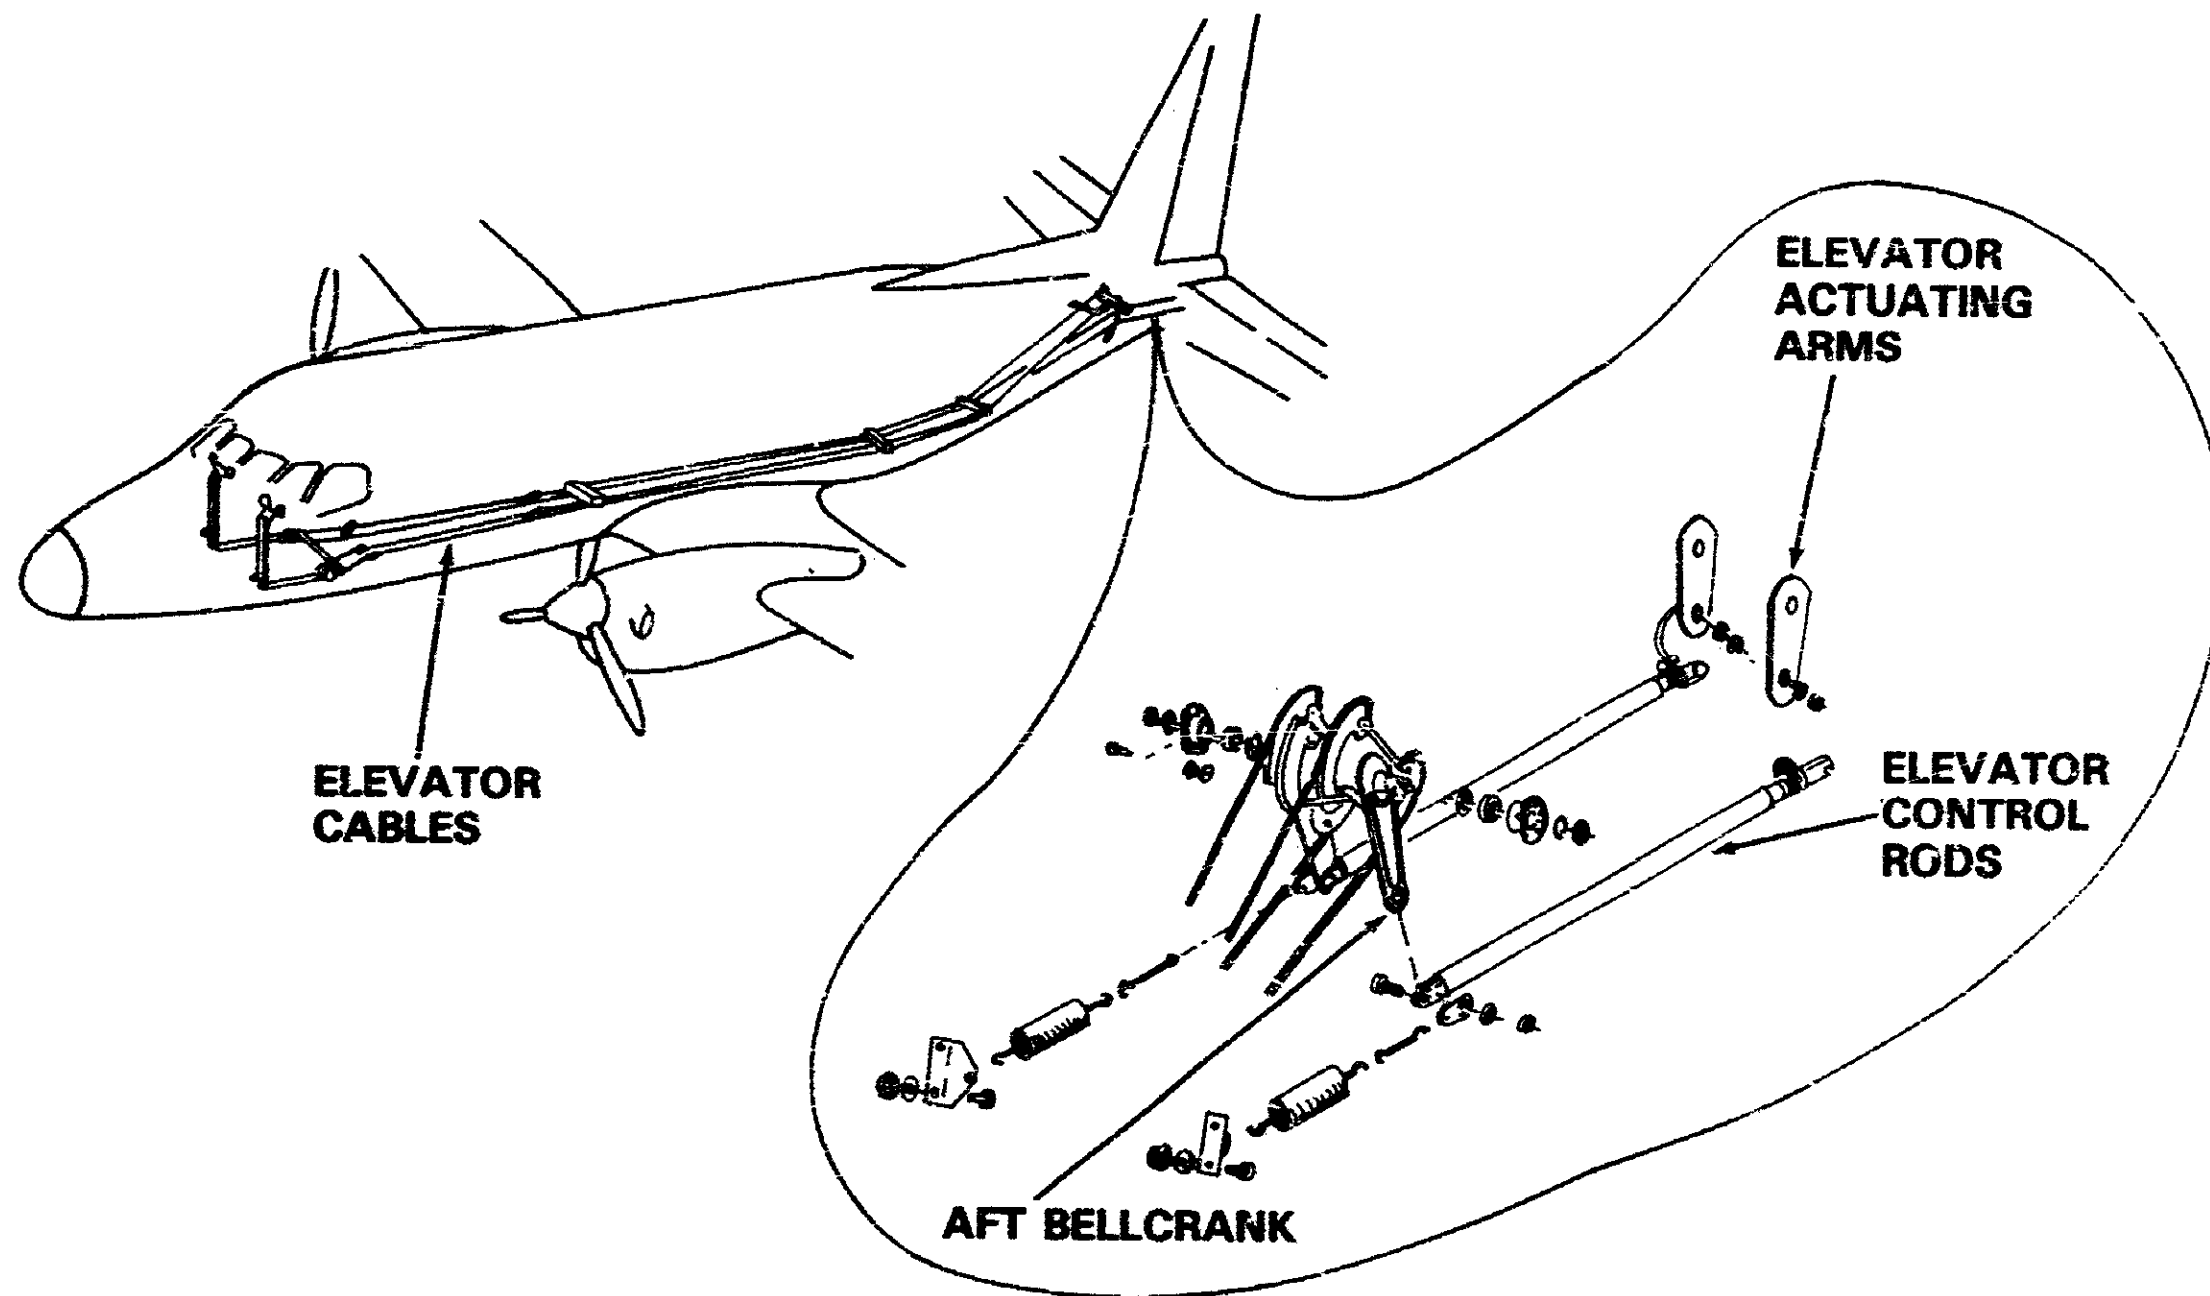
Figure 5.—Bandeirante EMB-110P1 elevator control installation.

The elevator control system of the EMB-110P1 airplane is redundant and consists of the captain's and first officer's control columns, which are interconnected, and independent bellcrank-cable-pulley systems on each side of the airplane. (See figure 5.) The movement of either control column will transmit motion through both cable systems to two aft bellcranks mounted on the forward face of fuselage bulkhead No. 33. These aft bellcranks also are interconnected and they transmit motion through the left and right elevator control rods respectively to the elevator actuating arms which rotate the elevators about their stabilizer hinges. The left and right elevator actuating arms are not interconnected.

As a result of the crash, the captain's control column was found detached from the cockpit floor mounting and no elevator control interconnect components were attached to the column. No scoring or impact marks were observed on the control column attachment surfaces at the points where it contacted the forward and aft travel stops. The first officer's control column was found connected to the cockpit floor mounting. It moved freely from the aft travel stop to the forward travel stop. Both travel stops were wired in place, and there was no evidence of impact with the column. The forward elevator control rod was found attached at its correct location between the first officer's control column and the elevator bellcrank. One control column-to-bellcrank cable had not separated from the turnbuckle, and the safety clip was still in place. However, the other control column-to-bellcrank cable appeared to have been cut about 3 feet from the forward bellcrank. The control rod between the captain's and the first officer's elevator bellcranks was severed about 3 inches from the first officer's bellcrank. Both control columns were bent aft and downward about 12 inches below the yoke attachment bolt.

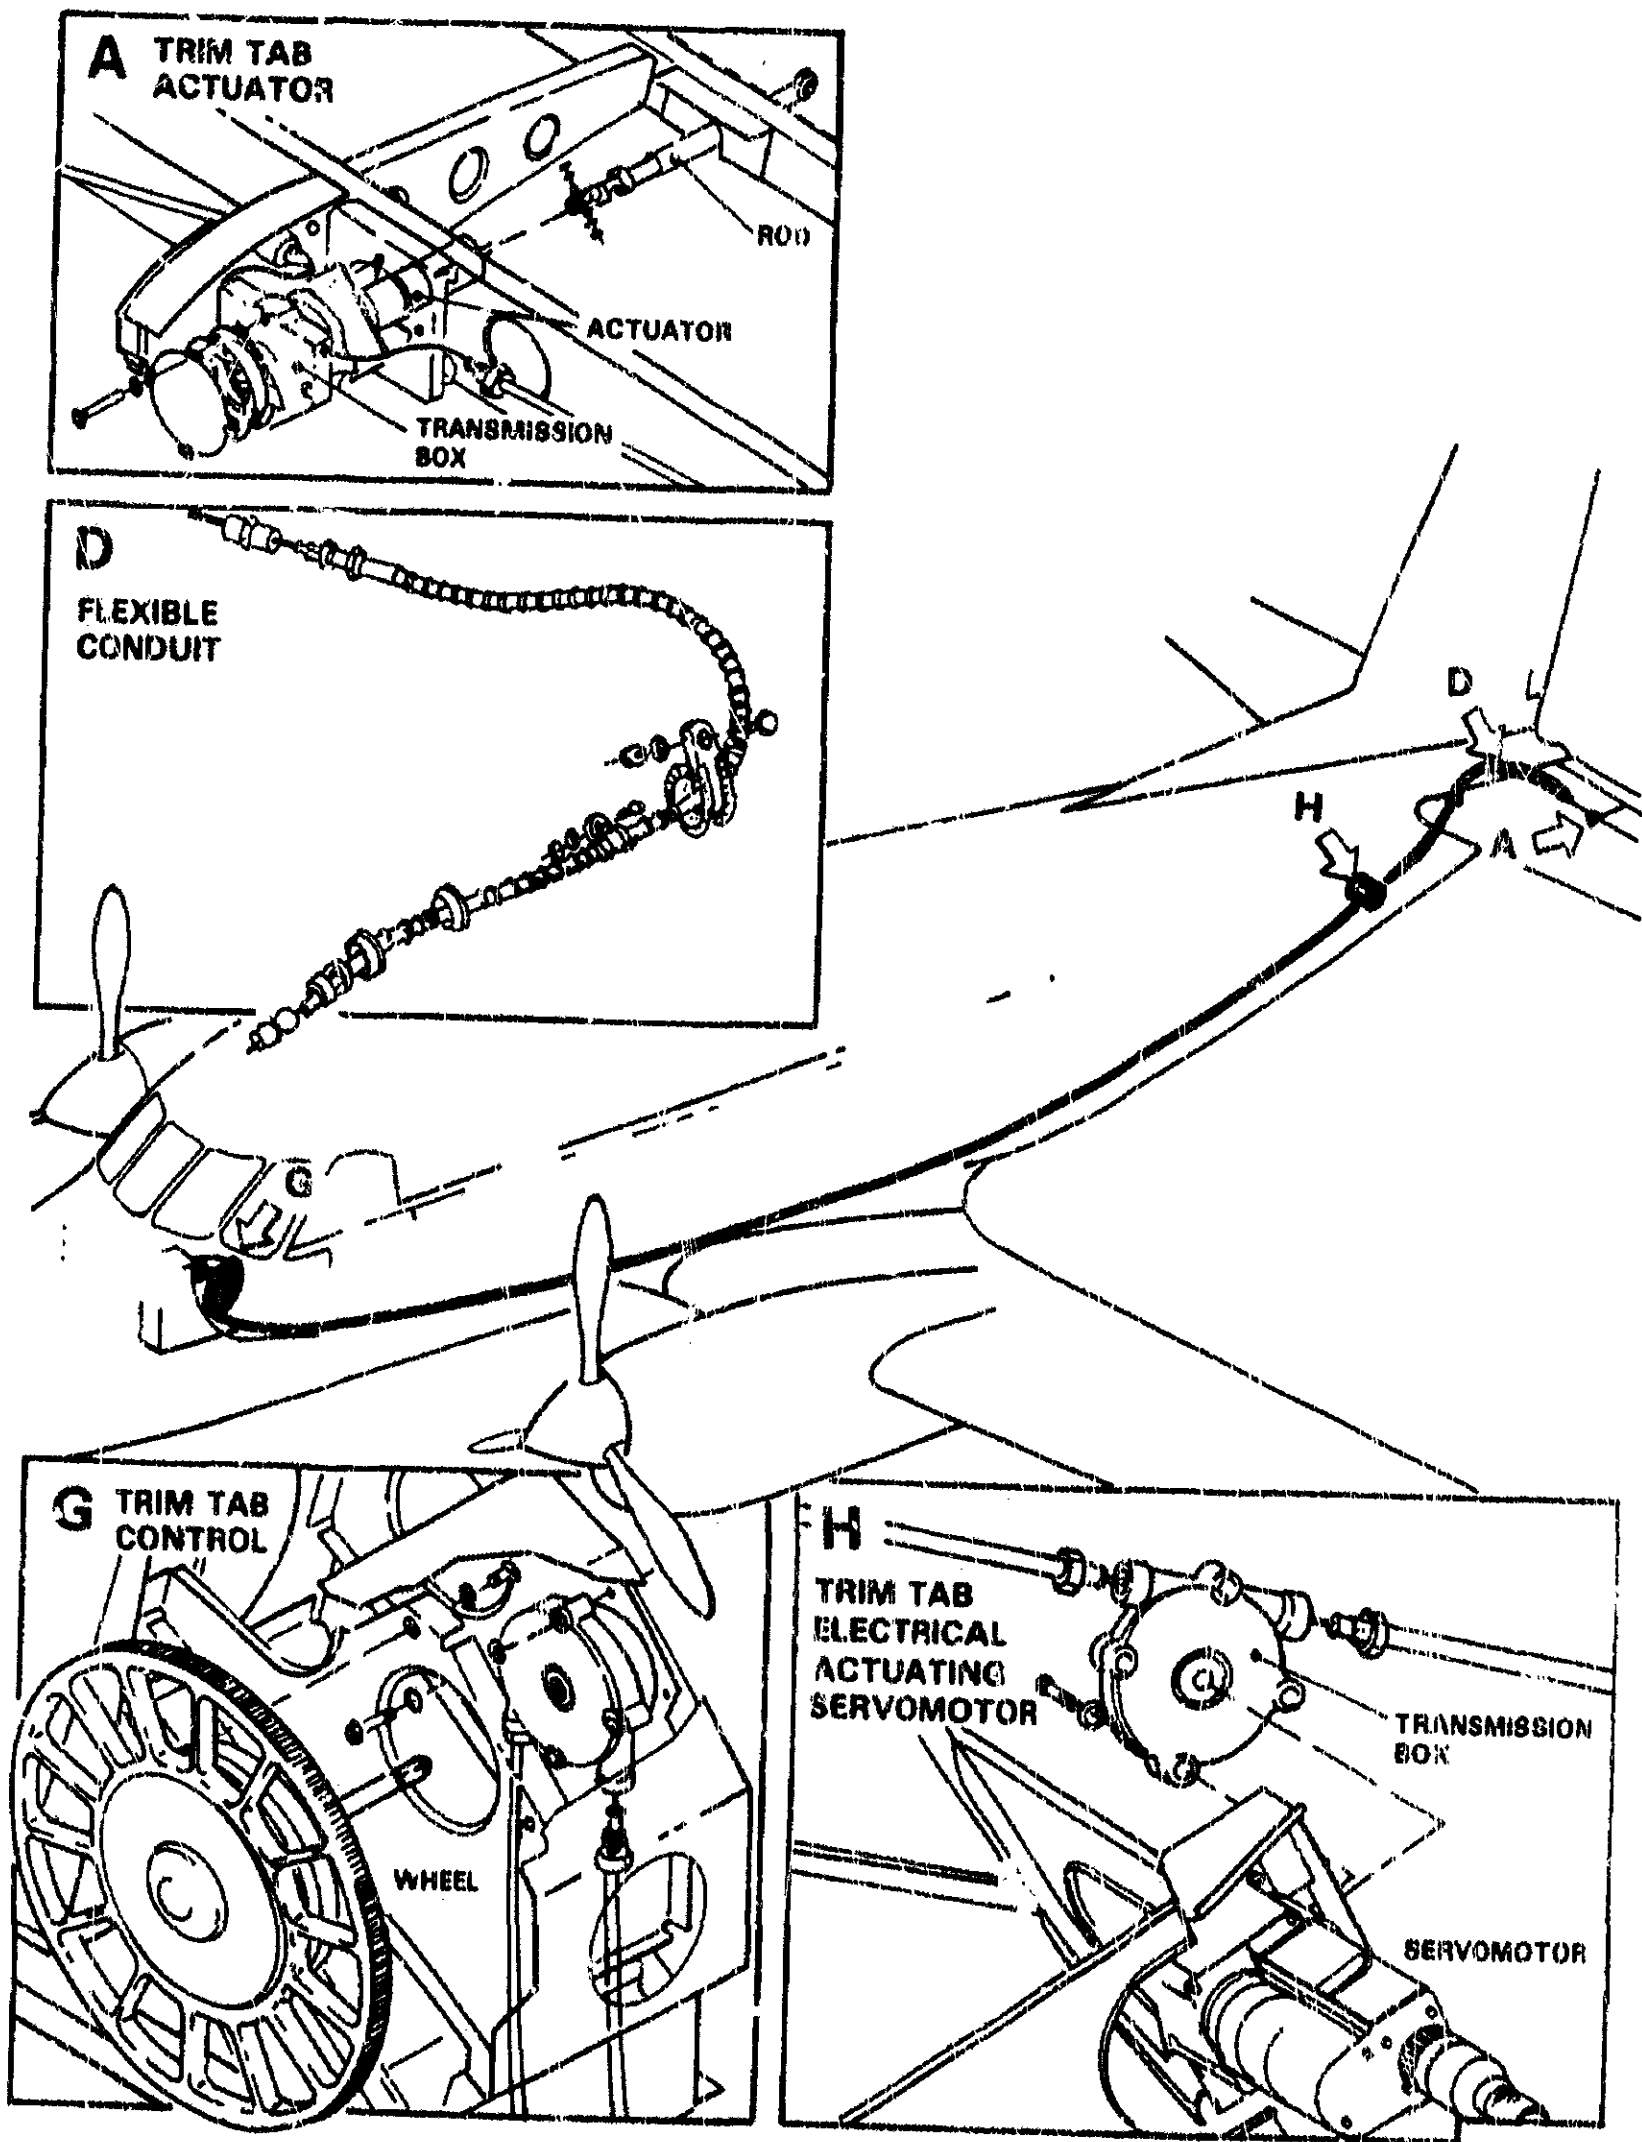
Figure 8.—Bandeirante EMB-110P1 trim tab actuator assembly.

The elevator trim tab was attached to the elevator. Although the piano type hinge wire was deformed, measurements of the hinge and hinge wire indicated that there was no excessive free play. The trim tab actuator housing remained attached to the left elevator spar. The actuator rod was fractured between the actuator and the rod end which remained attached to the trim tab bellcrank. The overstress bending fracture and deformation of the actuating rod matched the damage on the elevator rear spar structure through which the rod passes. The matching damage indicated that the actuator rod was fully extended when it struck the rear spar. The fully extended position of the trim tab actuating rod corresponded to a trim tab trailing edge up deflection (full airplane nose down trim).

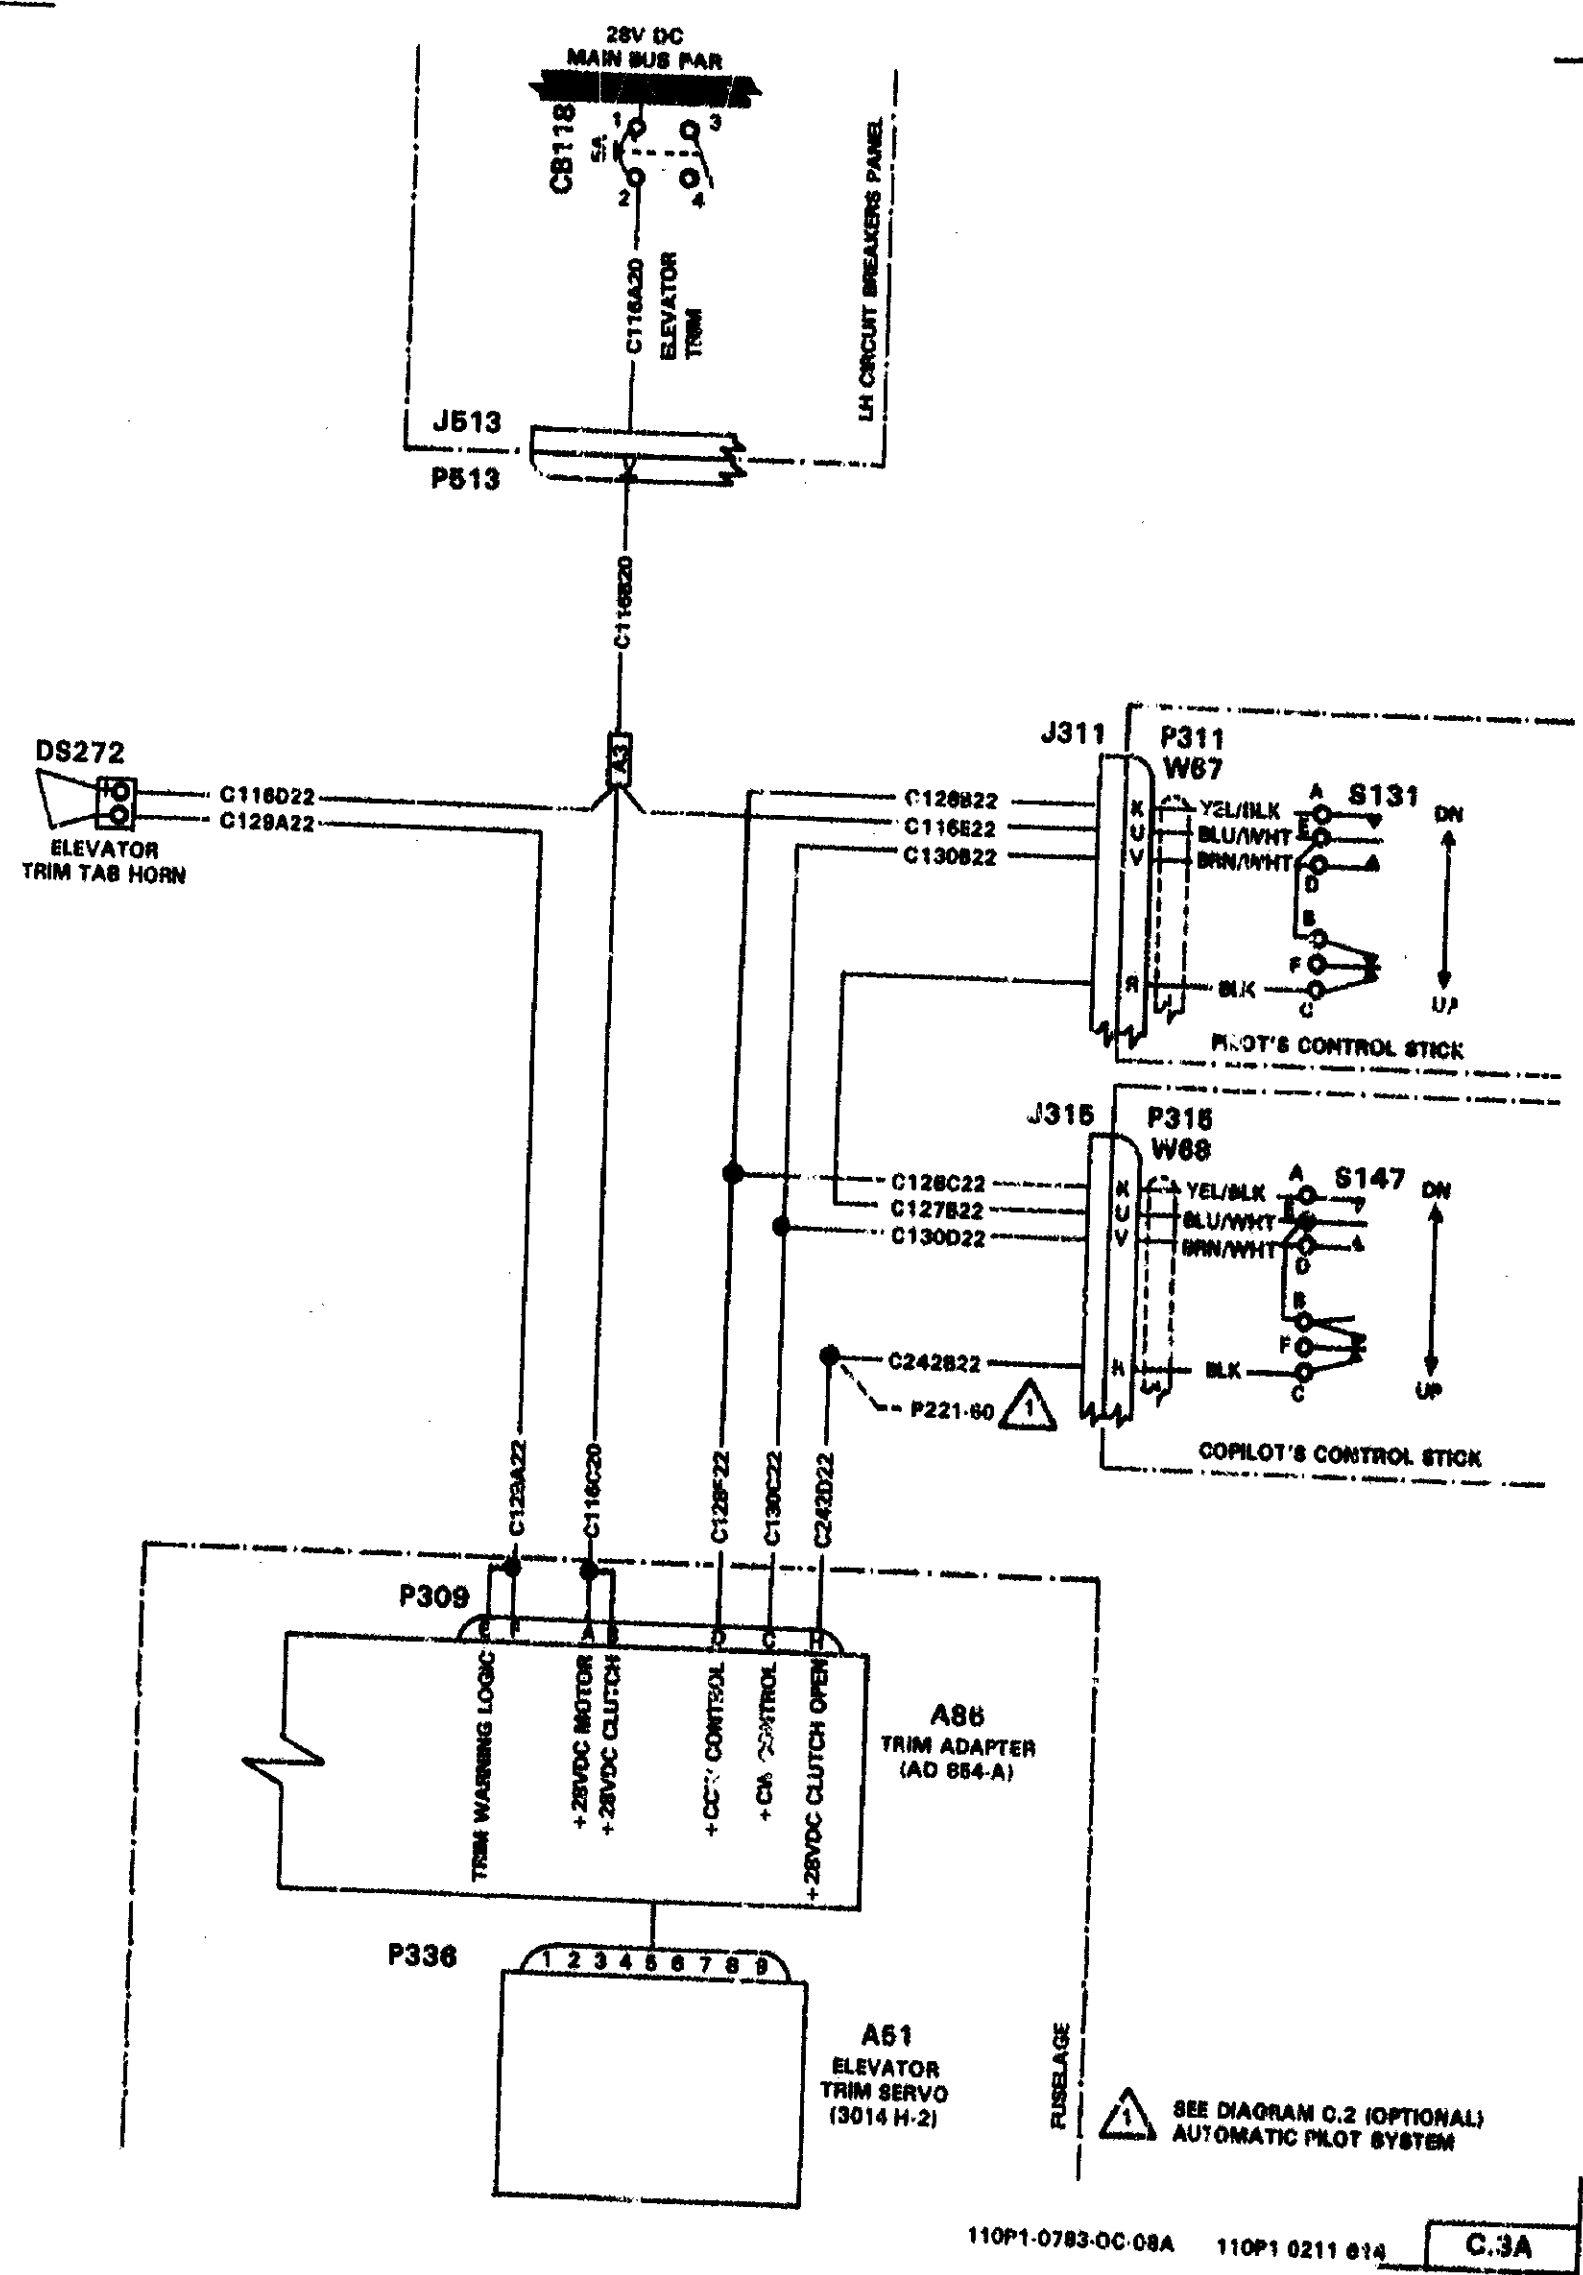
Figure 9.—Elevator trim system wiring diagram.

terminal "E" of the captain's trim switch and shorting of the broken off wire to terminal "A" or terminal "D" of the switch. (See figure 9.) This same failure of the first officer's control wheel mounted trim switch also would produce an uncommanded operation of the trim system; however, the operation of the system would be interrupted by any trim selection at the captain's switch. One of PBA's EMB-110P1 captains testified that he did not remember receiving any training for a runaway trim emergency. He did not know the location of the trim circuit breaker.

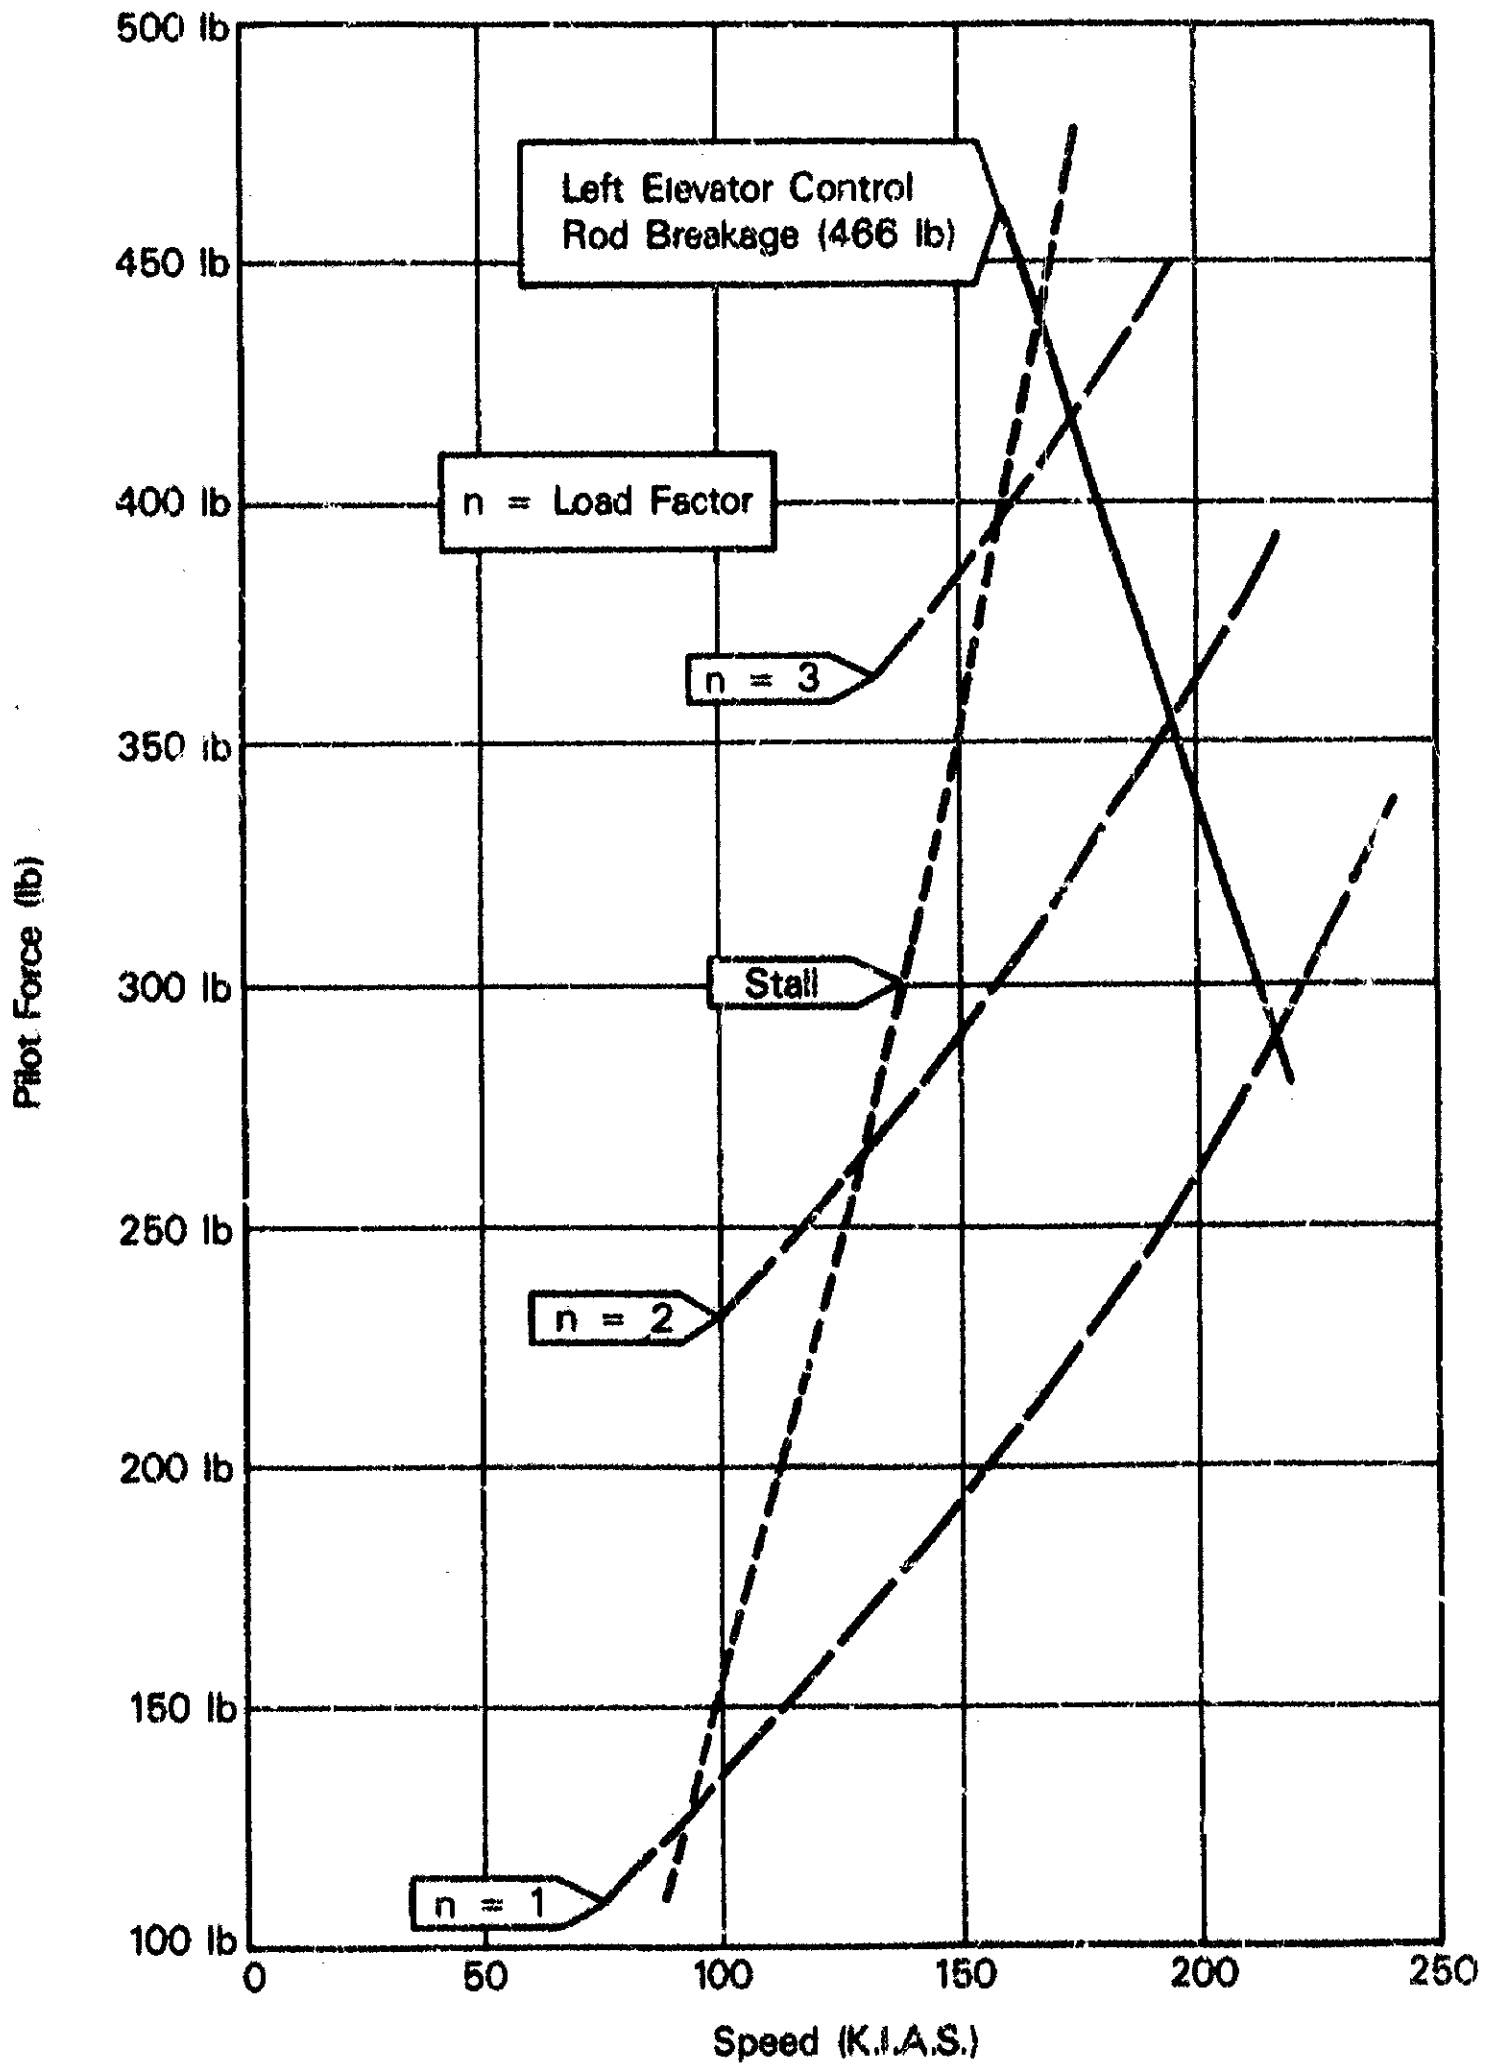
Figure 10.—EMB-110P1 pilot force versus speed.

In response to a Safety Board request, the airplane manufacturer analyzed the envelope of conditions--pilot force, airspeed, and normal load factor--that will result in a 466-pound compression load in the left elevator control rod. The assumptions for the analysis were that the weight and c.g. location were as they existed during the accident and that the elevator trim tab was fully deflected with the trailing edge upward. The full trailing edge up trim tab would result in the highest compression loading of the left elevator control rod for a given pitch-up maneuver. The plot of pilot force versus airspeed shows the pilot force and normal load factor which would be required at a given airspeed to produce a 466-pound destructive compression load in the left elevator control rod. (See figure 10.)

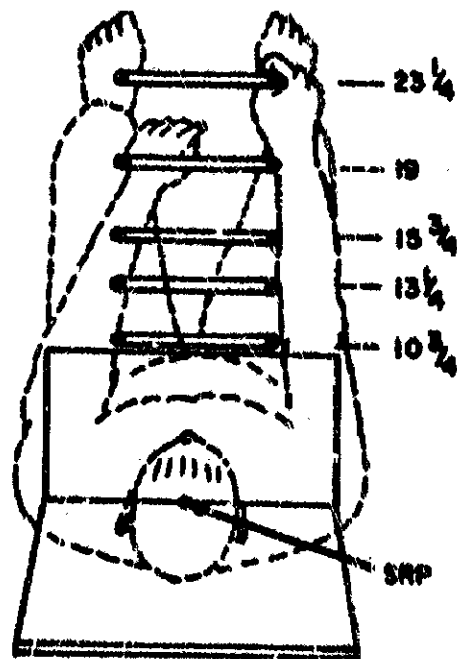
Figure 11.—Maximal static force exerted on an aircraft control stick by seated males.

figure 11. The design criteria for limit control forces specified for compliance with Federal Aviation Regulations Part 23.397(b) for an airplane weighing 13,000 pounds is 238 pounds for an elevator control wheel.

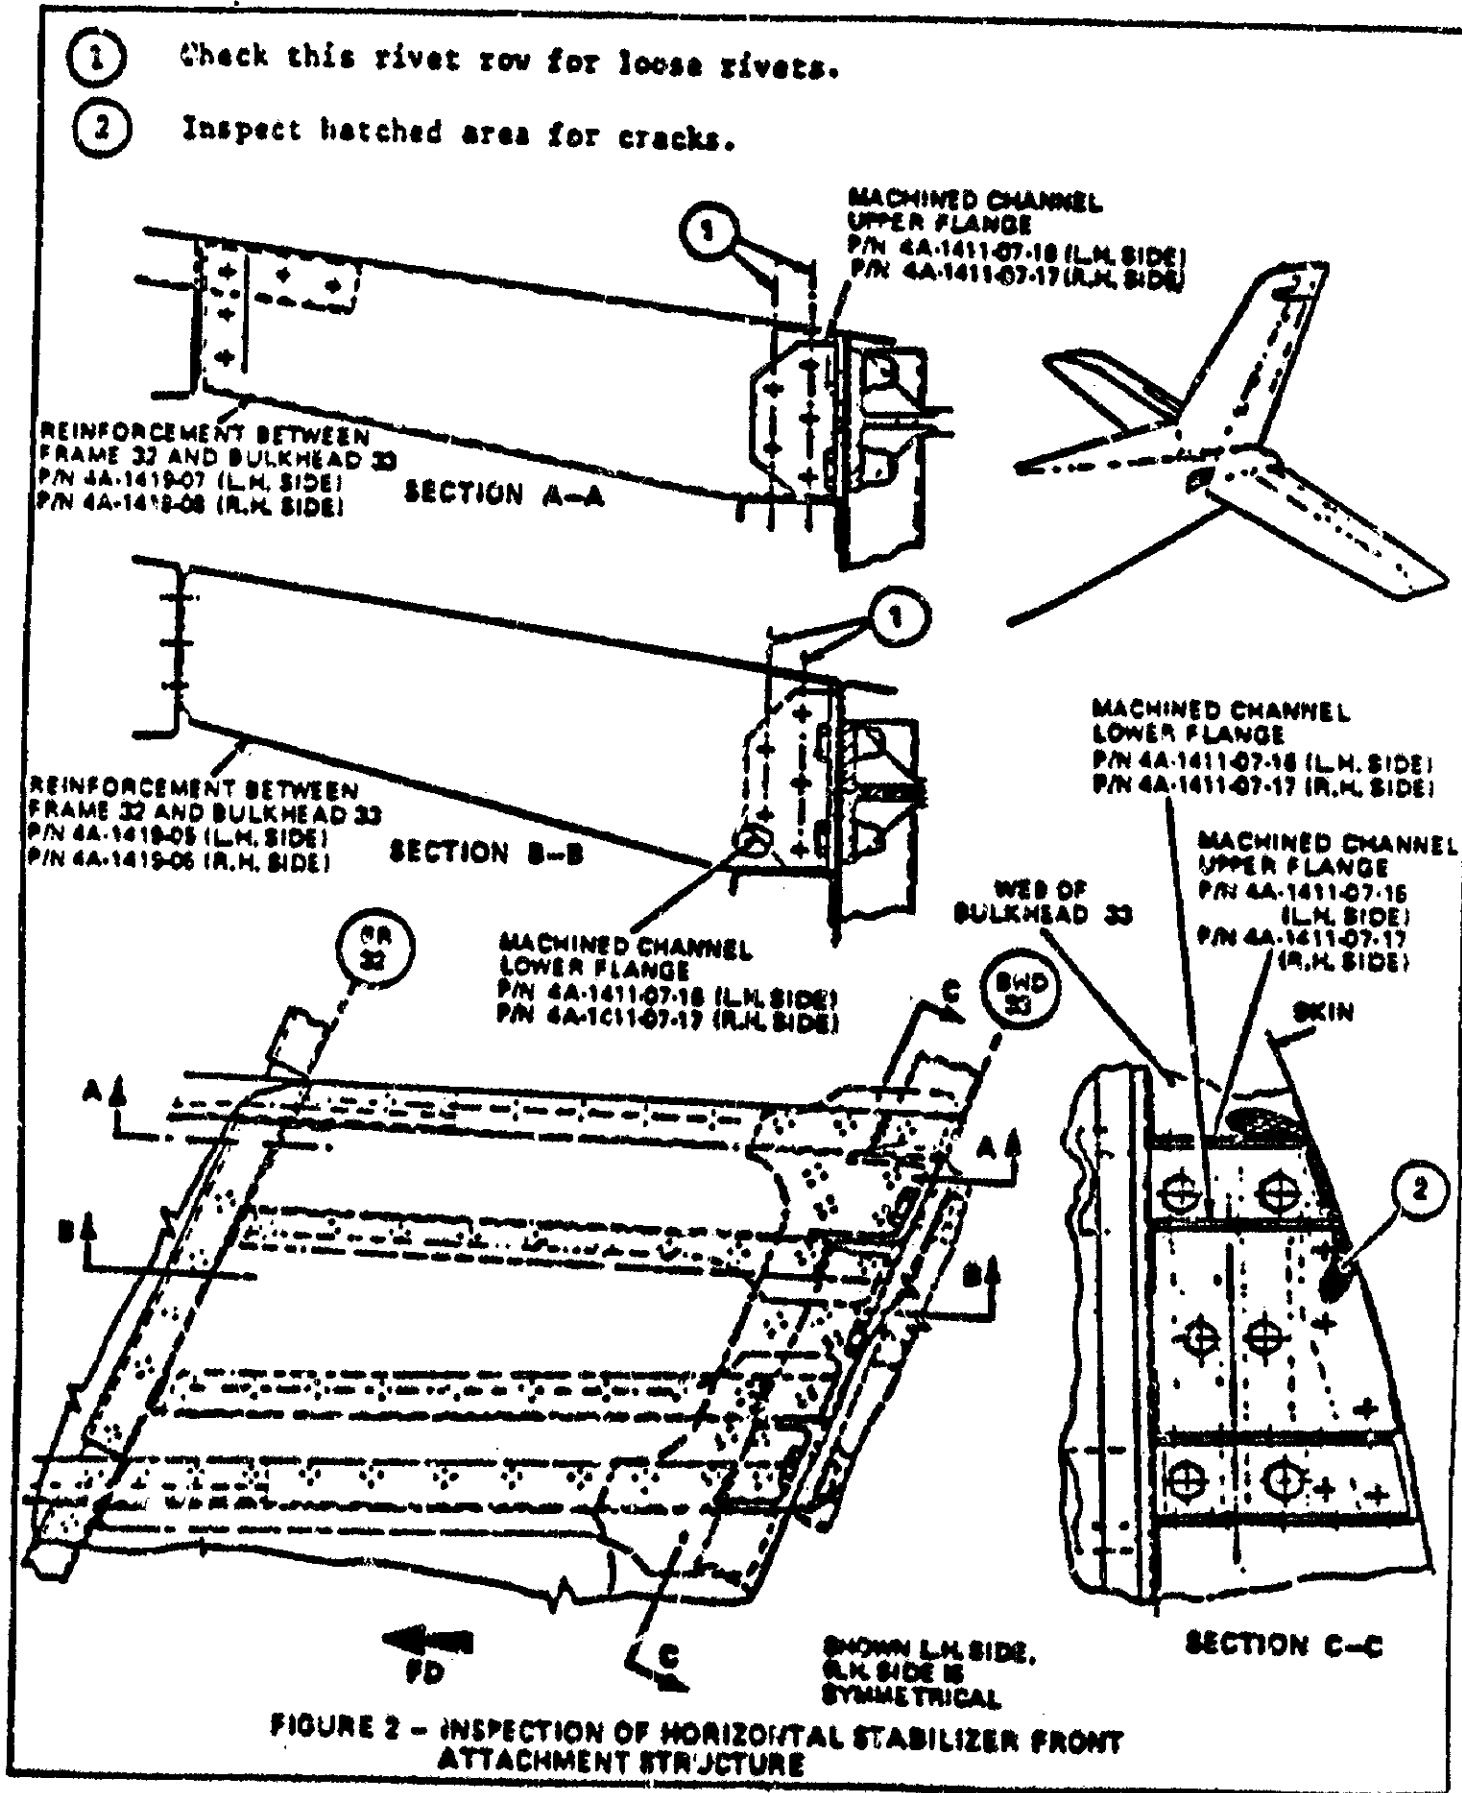
- ① Check this rivet row for loose rivets.
- ② Inspect hatched area for cracks.

2) The rivets (MS20470AD3) that attach the fuselage skin to the "C" channels described in paragraph a) above and the two lower adjacent channels for looseness (see Figure 3 of the SB).
