NATIONAL TRANSPORTATION SAFETY BOARD

AIRCRAFT ACCIDENT REPORT

BAR HARBOR AIRLINES FLIGHT 1808
BEECH BE-99, N300WP
AUBURN-LEWISTON MUNICIPAL AIRPORT
AUBURN, MAINE
AUGUST 25, 1985

NTSB/AAR-86/06

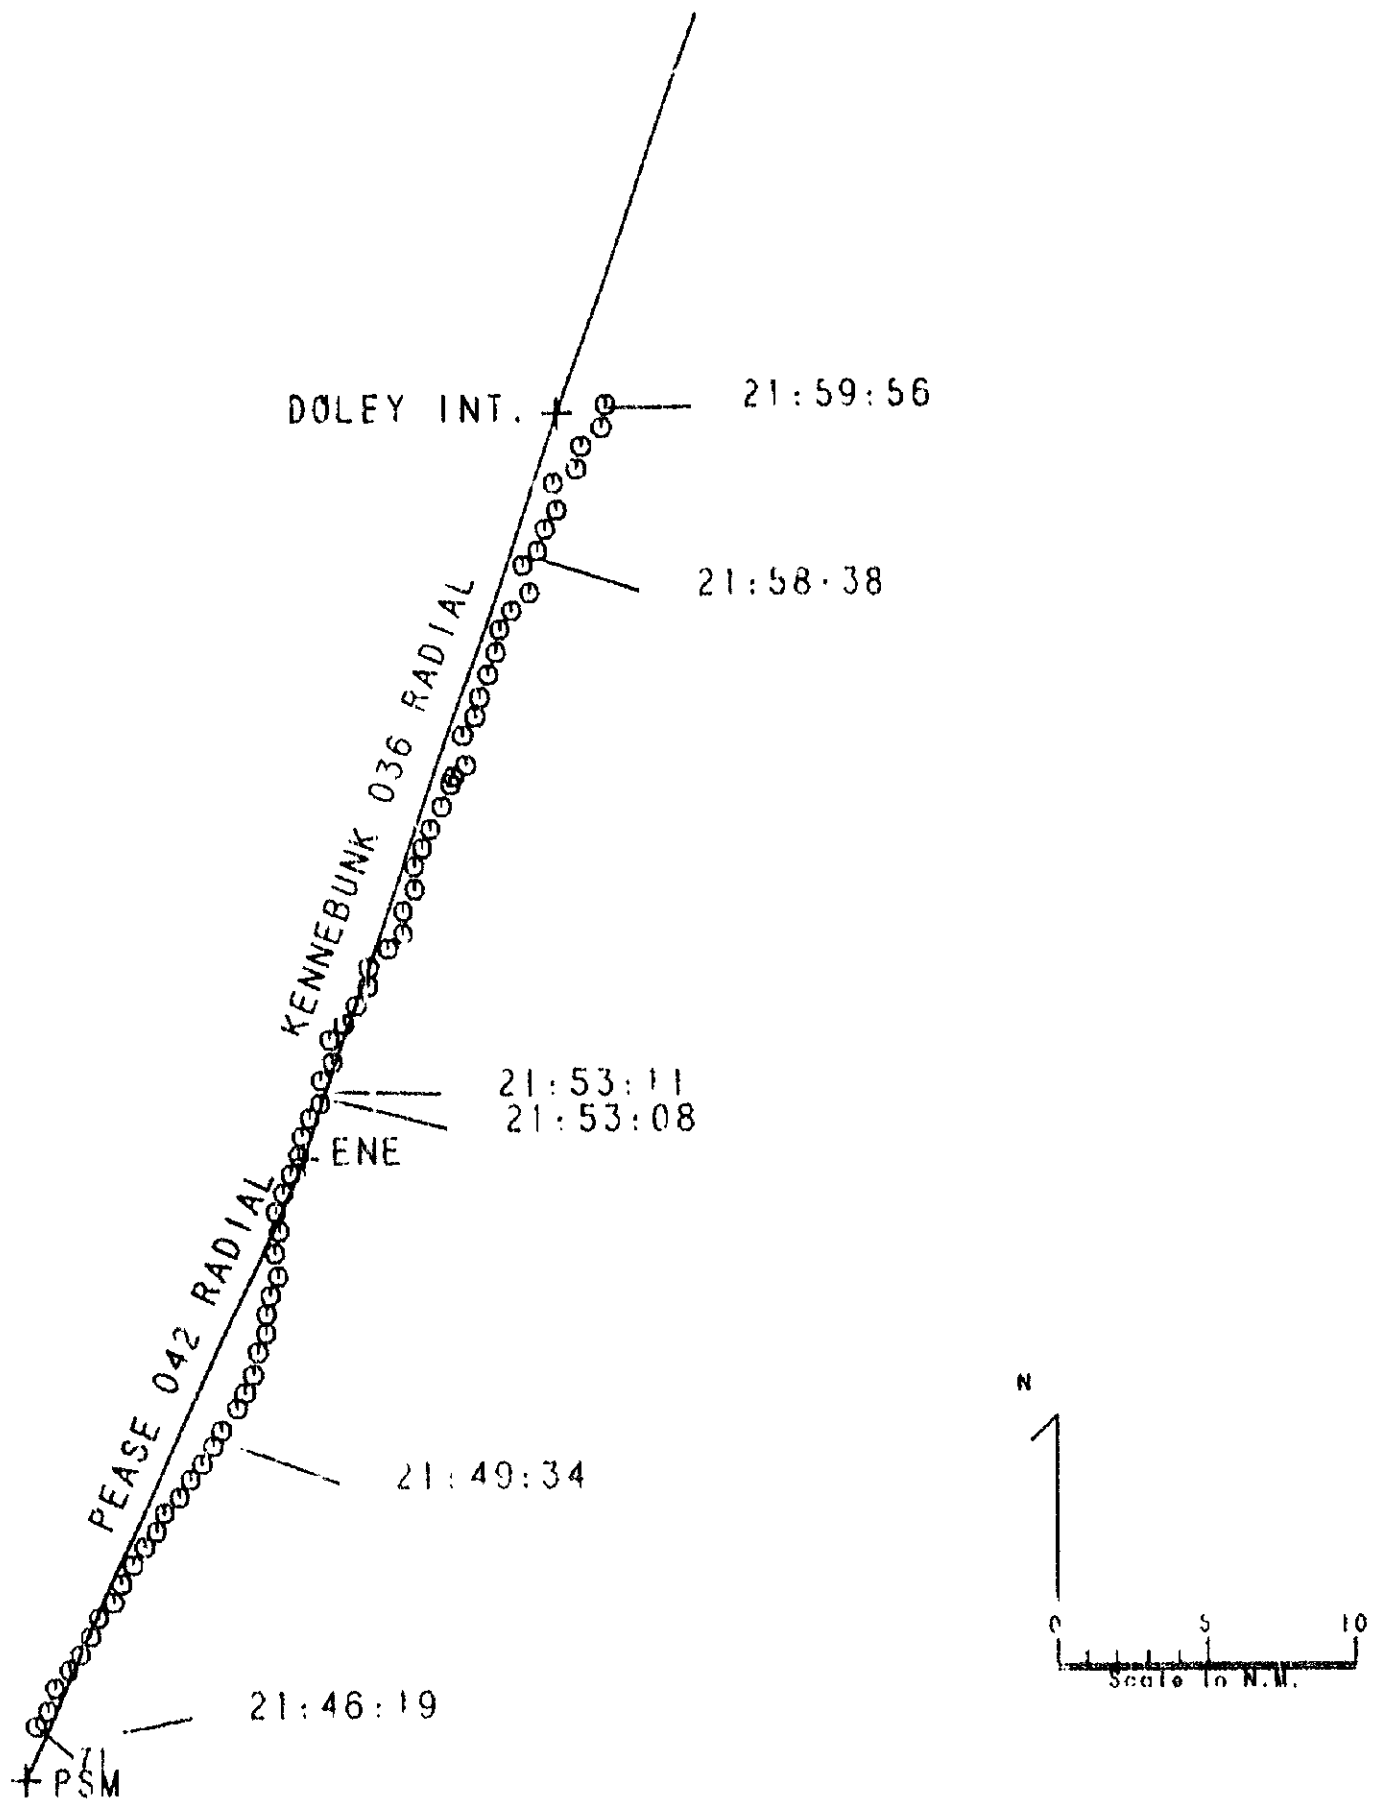
Figure 1.—Radar flight track.

The Air Route Traffic Control Center (ARTCC) data were used to review the airplane's track from Boston to determine if there were any irregularities in navigation that might help explain why the airplane was slightly off course outside the Doley Intersection. (See figure 1.)

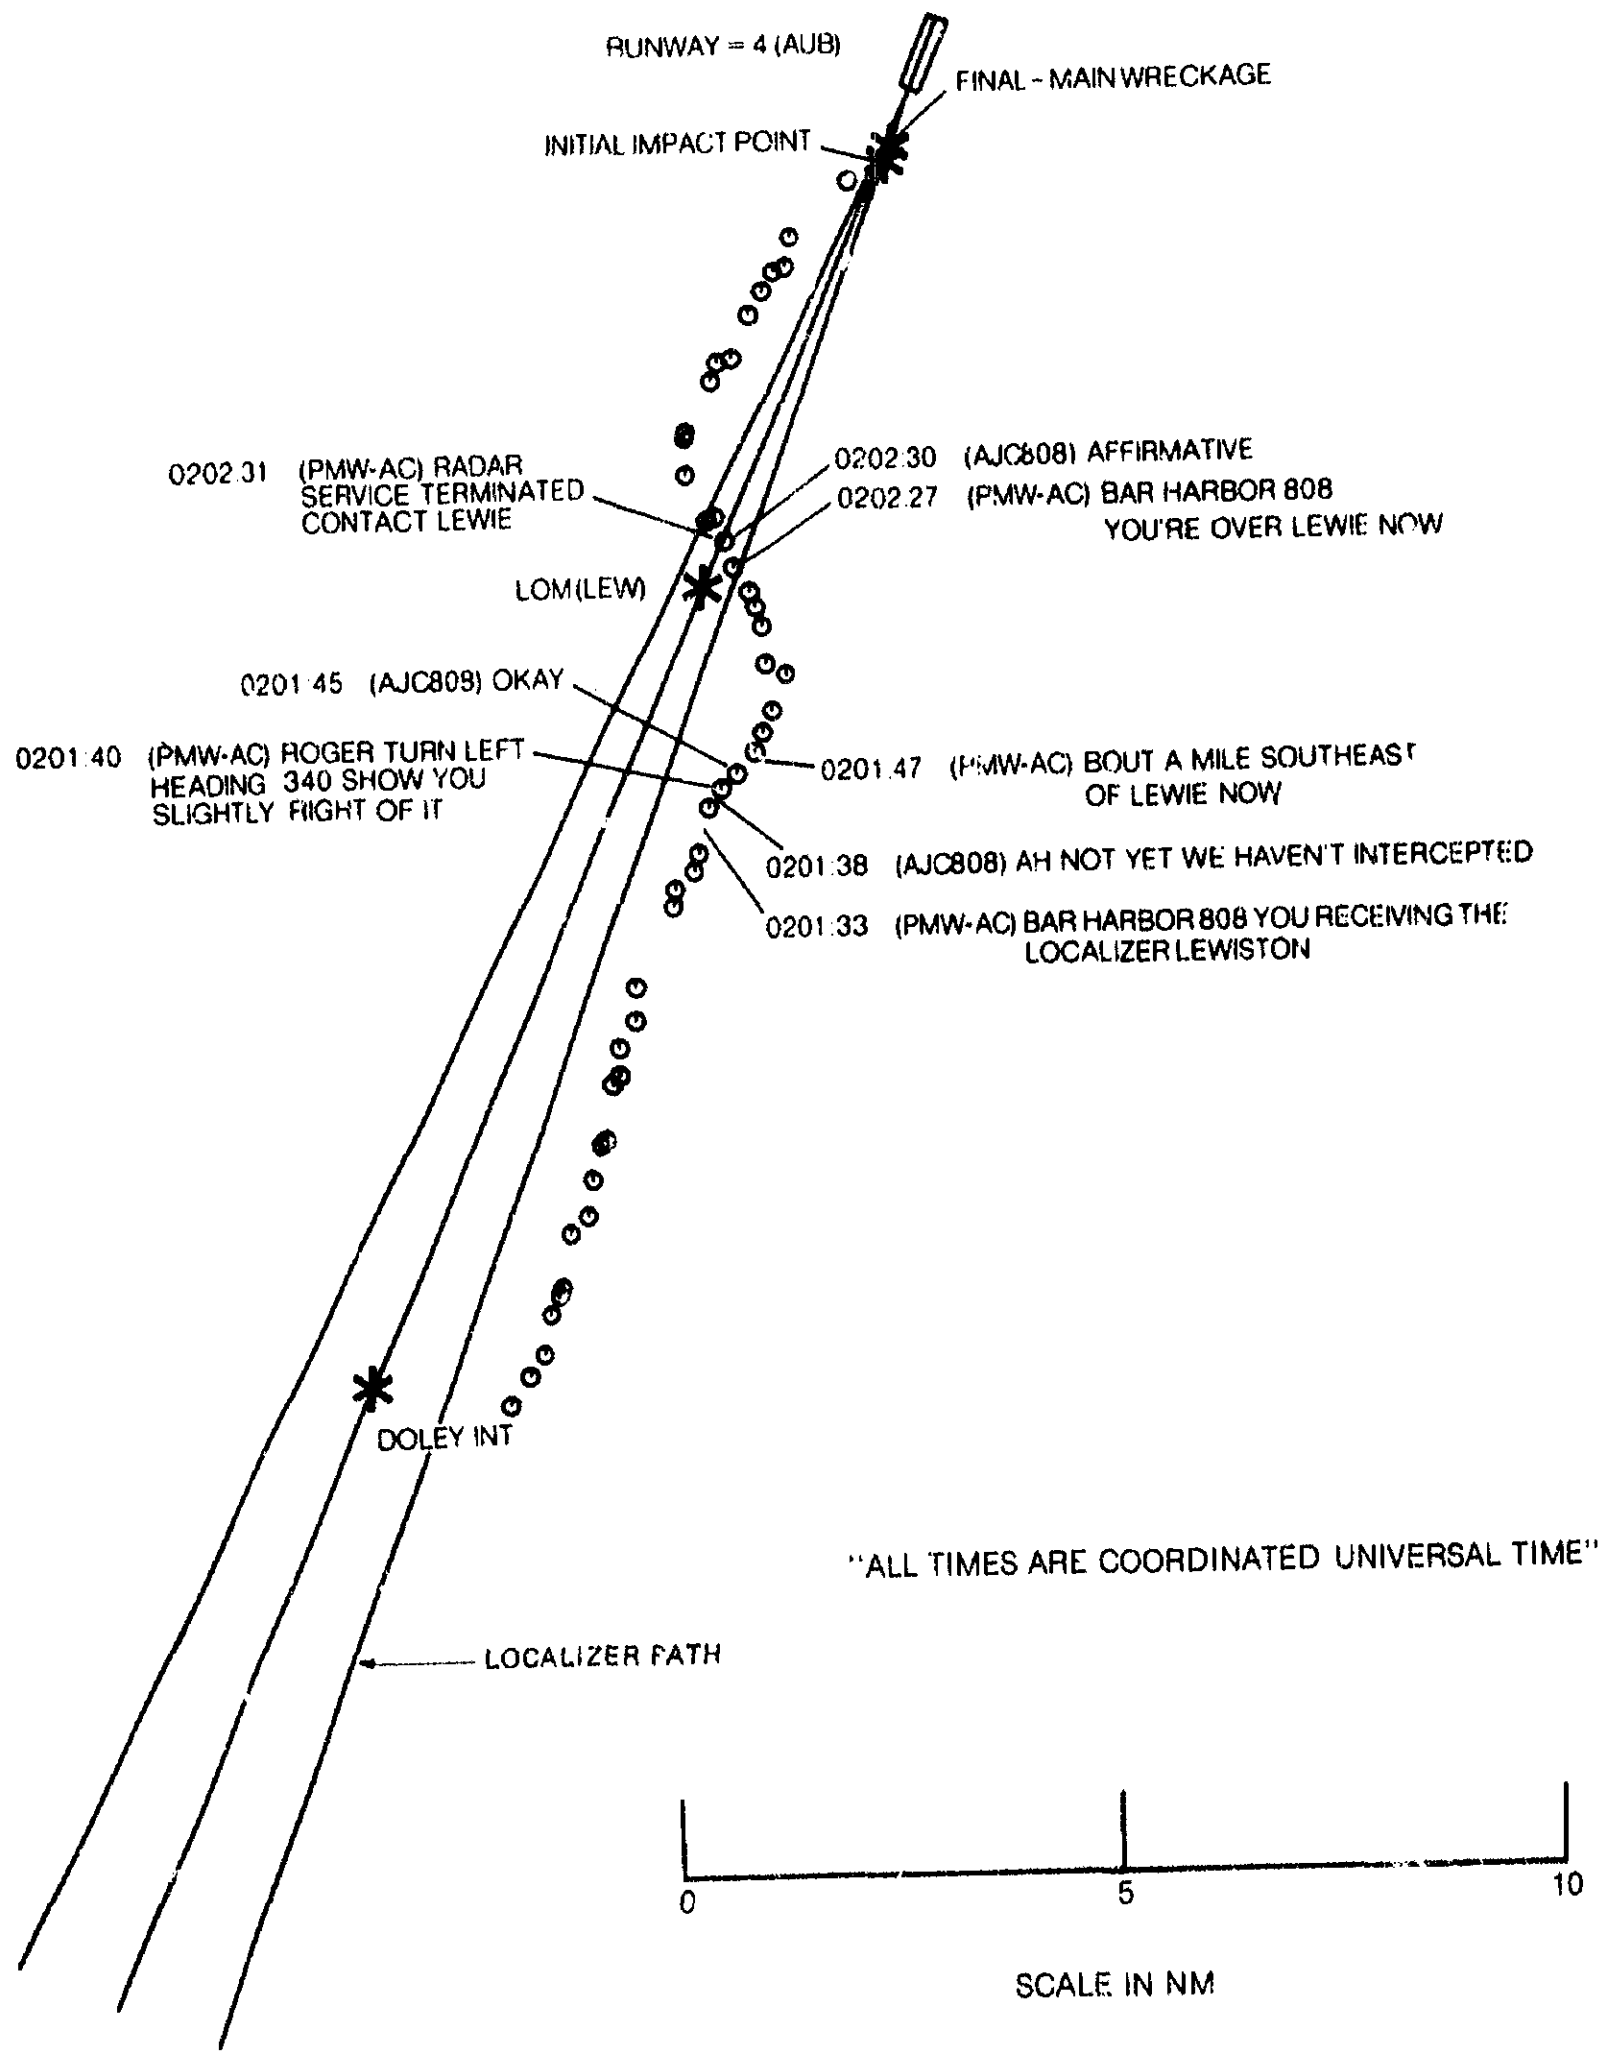
Figure 9.—Radar data reconstructed plan view of the flight track.

The TPX-42 radar data were used to review the airplane's track inside Doley. Measurements of the data were made from the video monitor and converted to nautical miles to align the ARTCC data with the TPX-42 data and to provide a complete radar flight track from Boston to Lewiston. Also, the raw and smoothed TPX-42 data were used for input into a National Aeronautics and Space Administration (NASA) program which estimates performance parameters, such as airspeed, ground speed, roll angles, and acceleration loads. It must be noted that the program calculates "long term" motion parameters of the airplane. "Short term" maneuvers, such as abrupt attitude changes cannot be derived using this program. However, in the following discussion, the "short term" maneuvers were defined more accurately by using the radar data in a manner similar to the computer program, but additional information, such as airplane performance limits and radar data limits, were incorporated into the calculations. The plan view and profile view of the airplane's flightpath are shown in figures 9 and 10.

Review of the radar data indicated that after departing Boston, the airplane turned north and then established itself on the 215° radial of the PSN VOR for 5 minutes before the flight was given a clearance to proceed direct to Augusta via the ENE VOR at

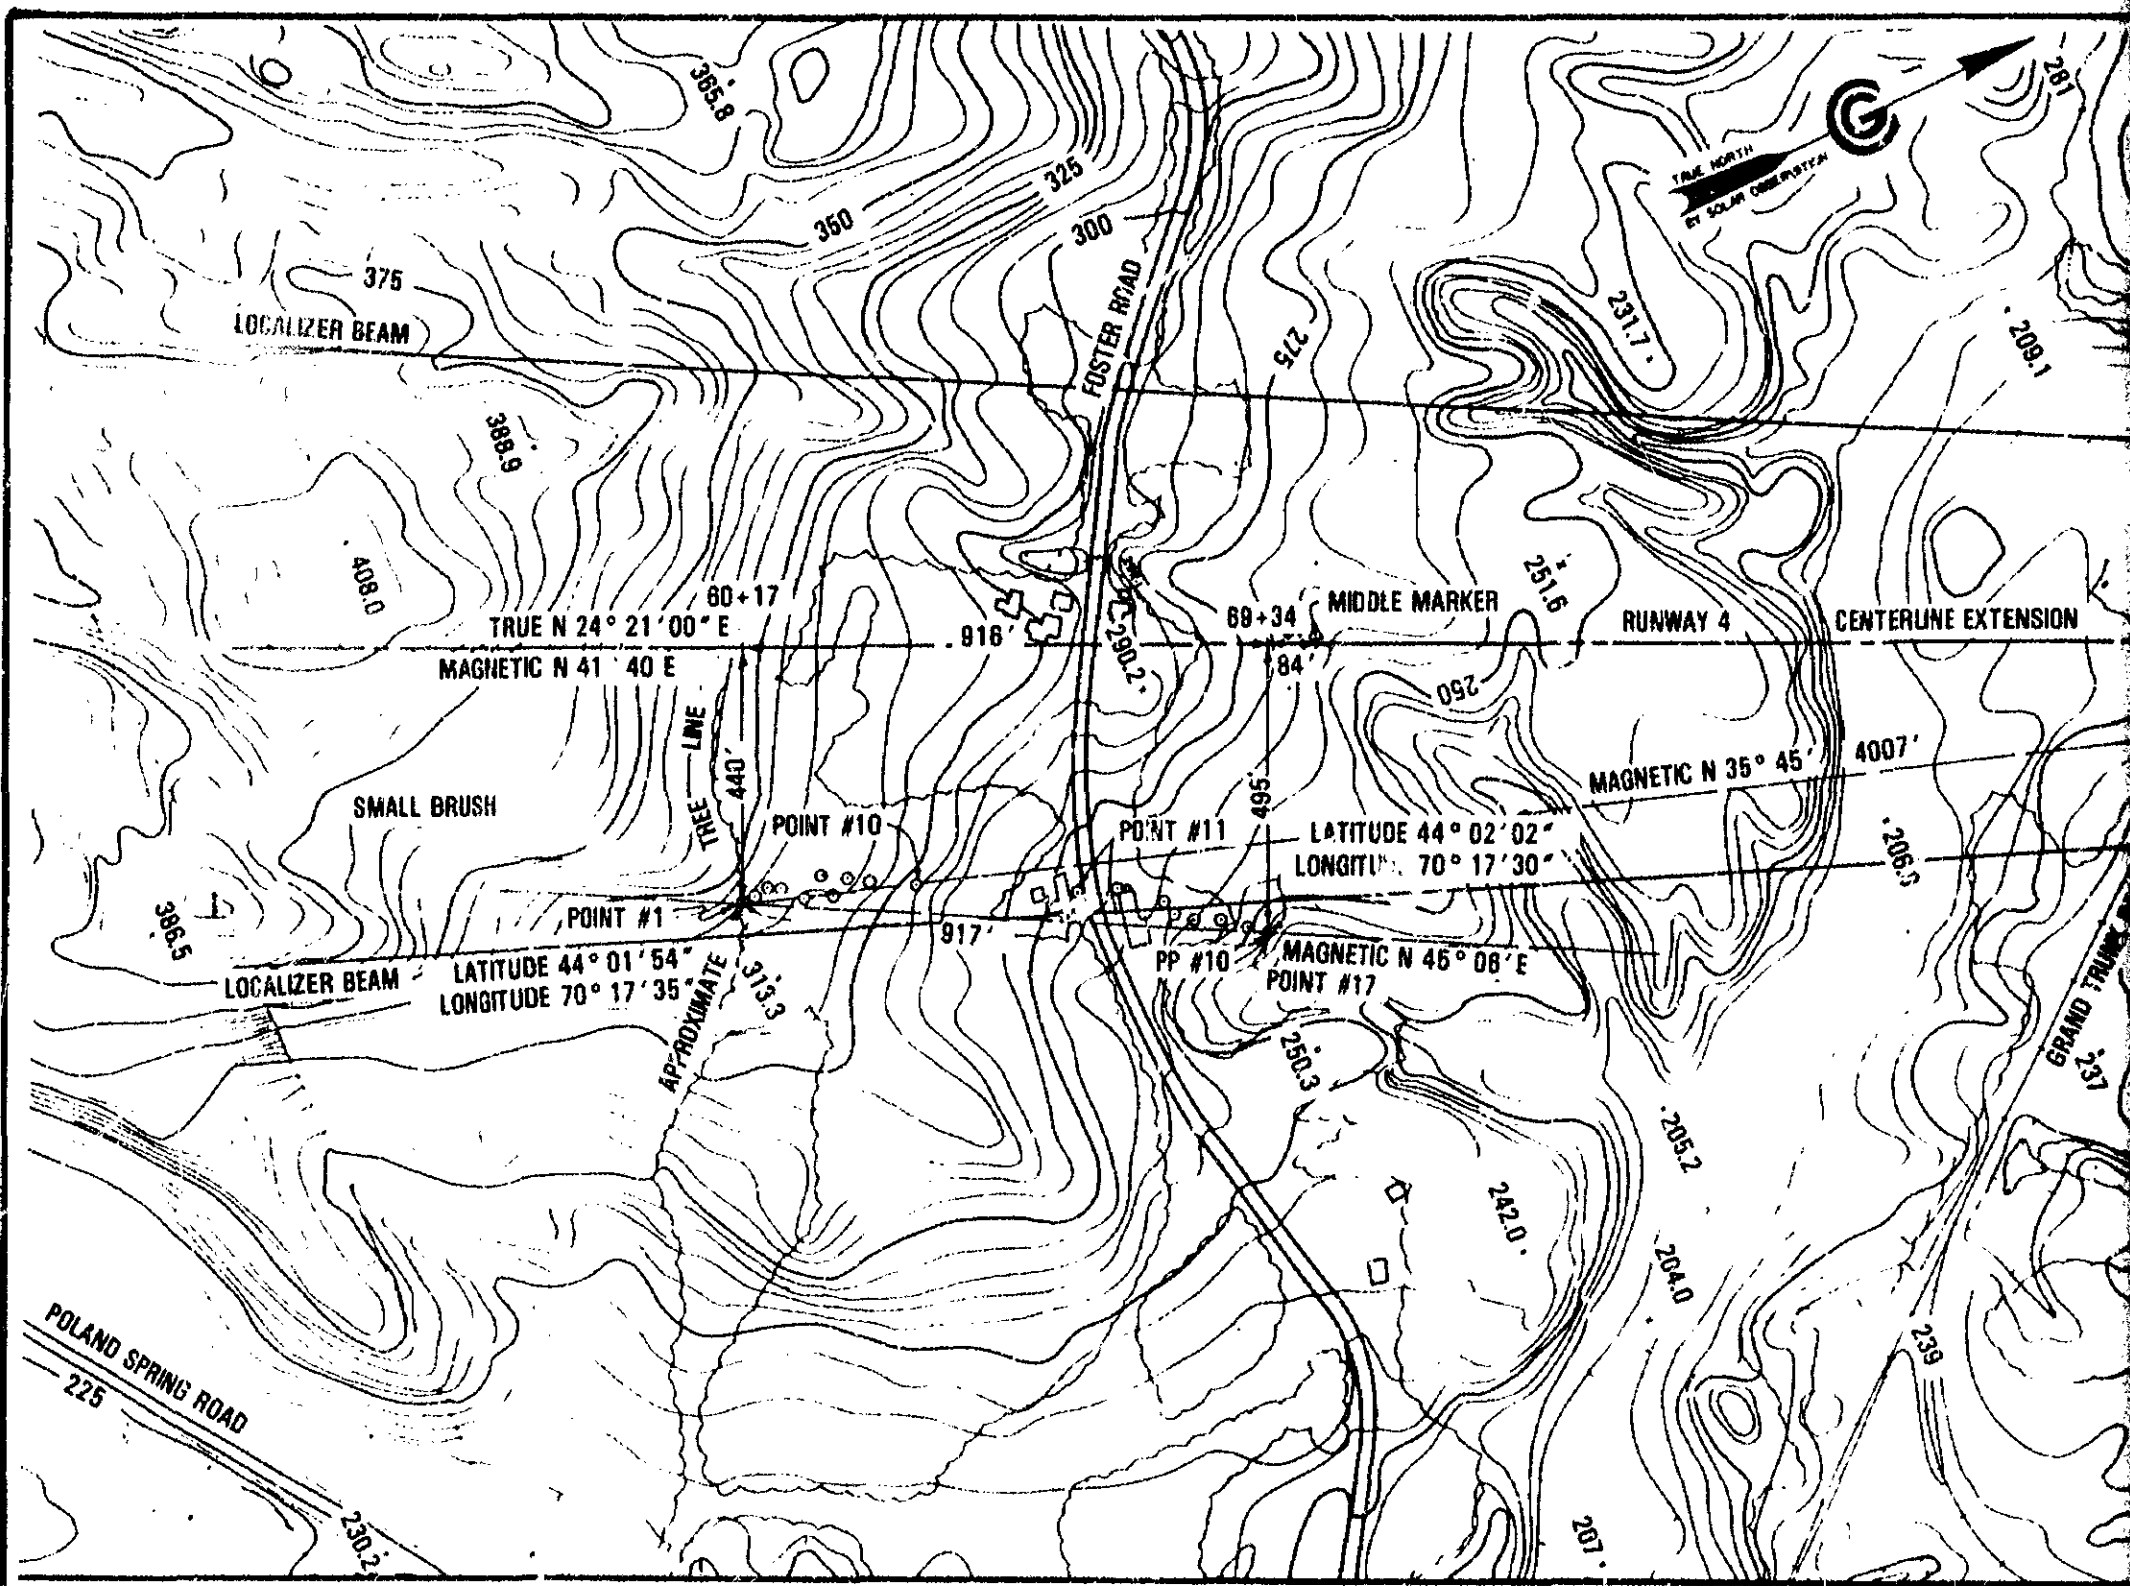
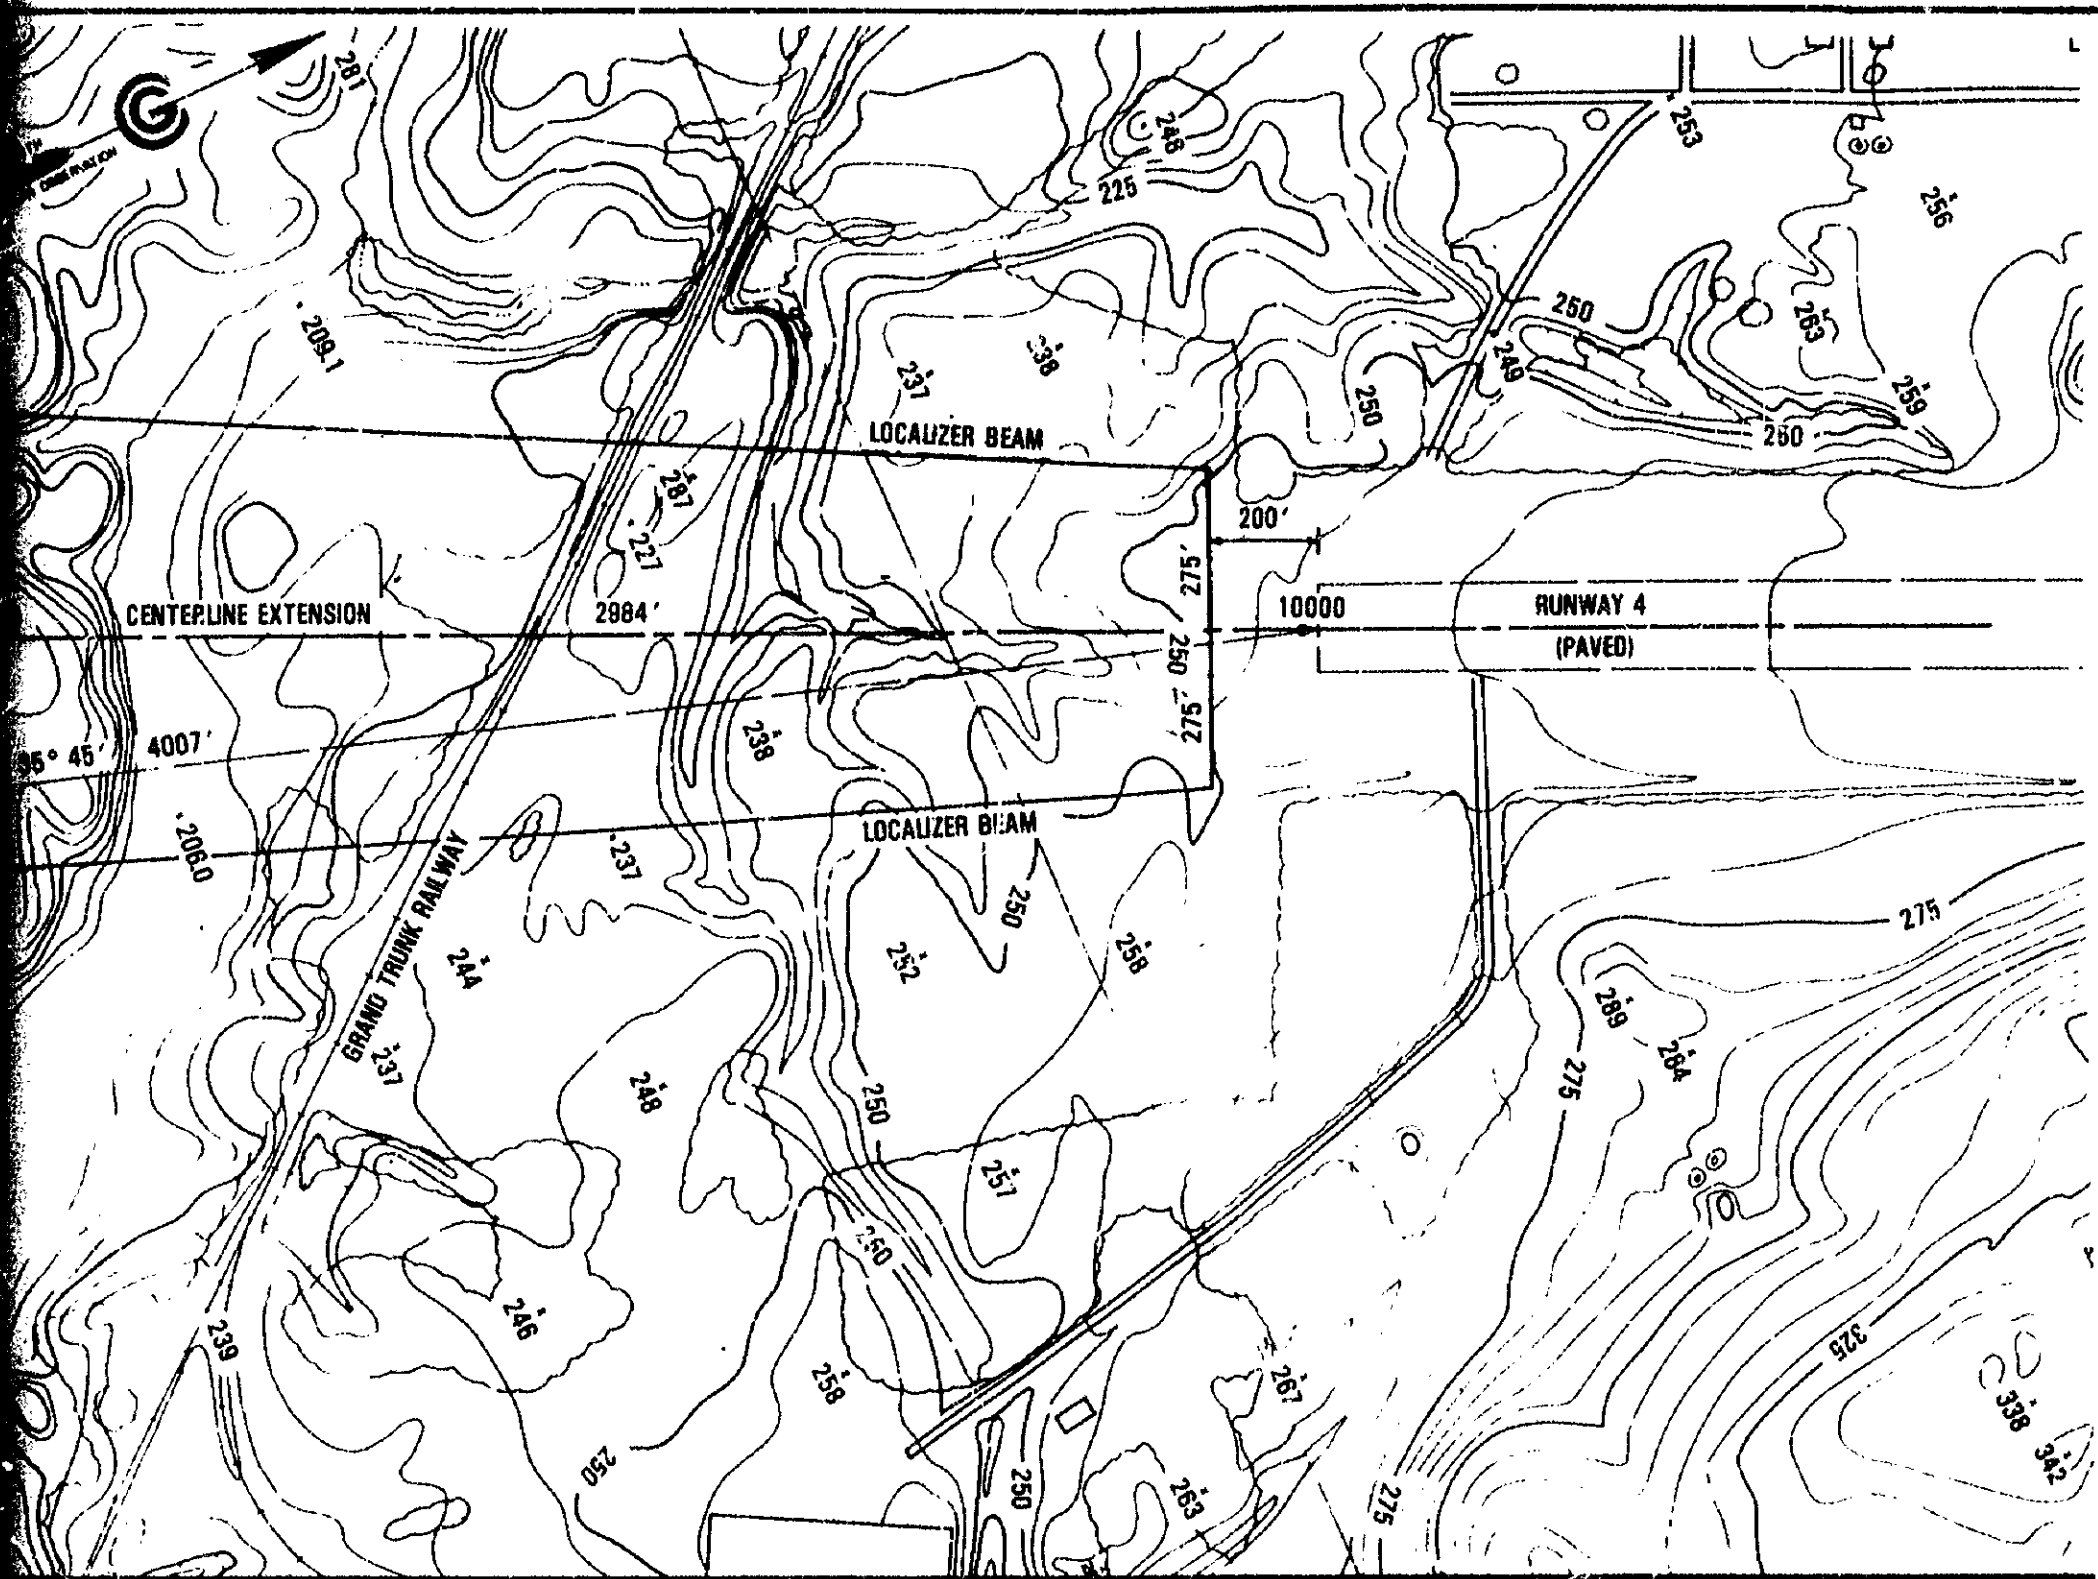
WRECKAGE DISTRIBUTION CHART

POINT DESCRIPTION	STATION	OFFSET	ELEV	REMARKS
1 INITIAL AIRBORNE COLLISION WITH 8" POPLAR	60+17	440'	313.0 348 363	GRADE POINT TREE WAS SEVERED CANOPY
2 INITIAL AIRBORNE COLLISION WITH 9" OAK	60+39	421'	314.5 342 357	GRADE POINT TREE WAS SEVERED CANOPY
3 RIGHT AILERON	60+63	414'	312.2	GRADE
4 RIGHT OUTBOARD WING PANEL AND TIP	60+84	416'	309.5	GRADE
5 LEFT AILERON OUTBOARD SECTION	61+25	433'	310.1	GRADE
6 LEFT OUTBOARD WING SECTION AND TIP	61+54	394'	311.8	GRADE
7 FUEL CAP	61+78	428'	312.6	GRADE
8 OIL COOLER SCOOP	62+02	388'	318.5 358	GRADE CANOPY
9 LEFT AILERON INBOARD SECTION	62+39	405'	307.0	GRADE
10 RIGHT INBOARD LEADING EDGE	63+23	411'	204.6 355	GRADE CANOPY
11 BROKEN LIMBS IN TOP OF 20" PINE TREE NEXT TO POSTER ROAD	66+02	419'	269.8 377 338	GRADE APPROXIMATE POINT OF IMPACT CANOPY
12 BROKEN LIMBS IN 14" MAPLE NEXT TO HOUSE	66+71	422'	266.8 297 312	GRADE APPROXIMATE POINT OF IMPACT CANOPY
13 INITIAL GROUND IMPACT	67+54	441'	260.3	GRADE

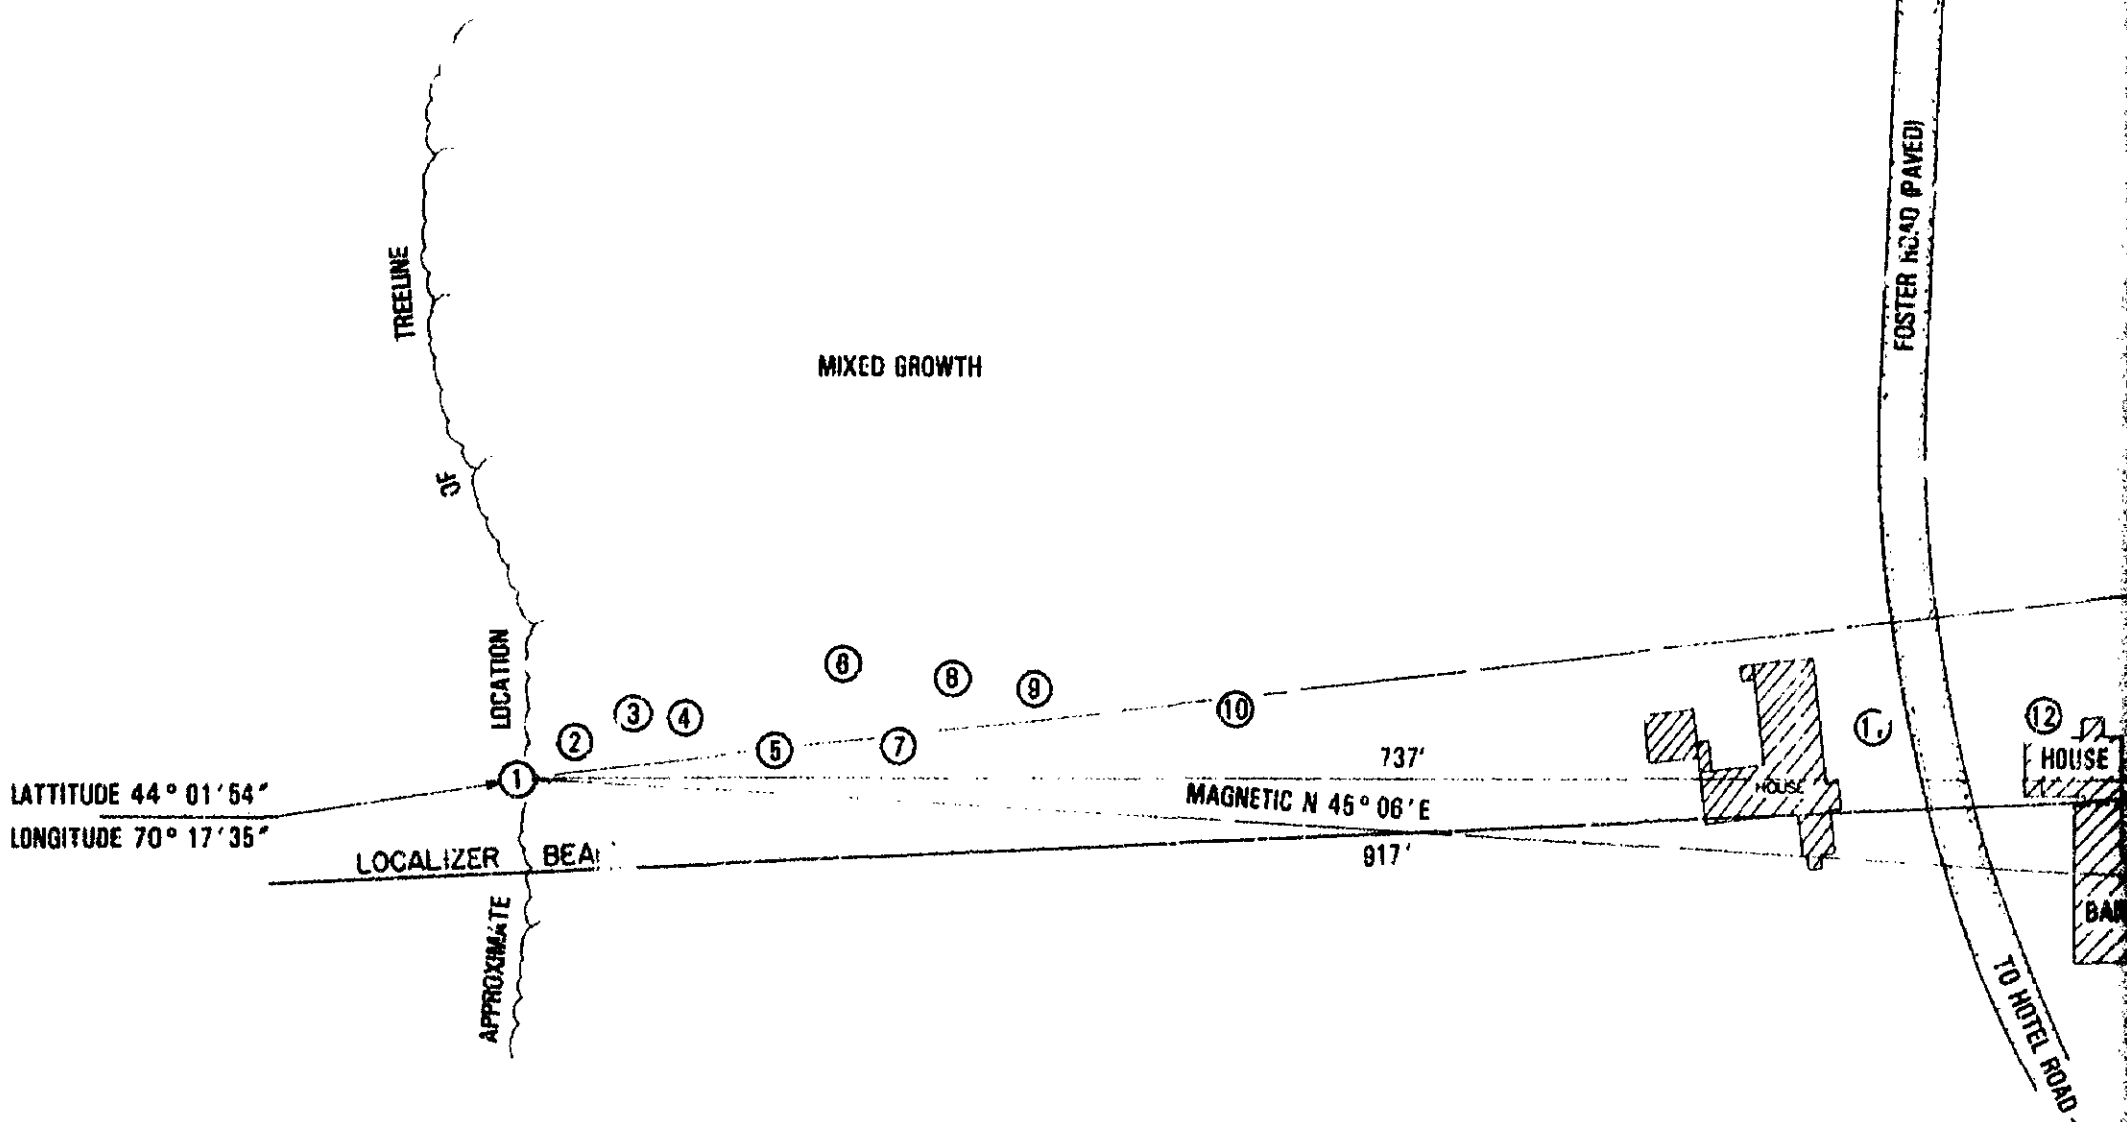
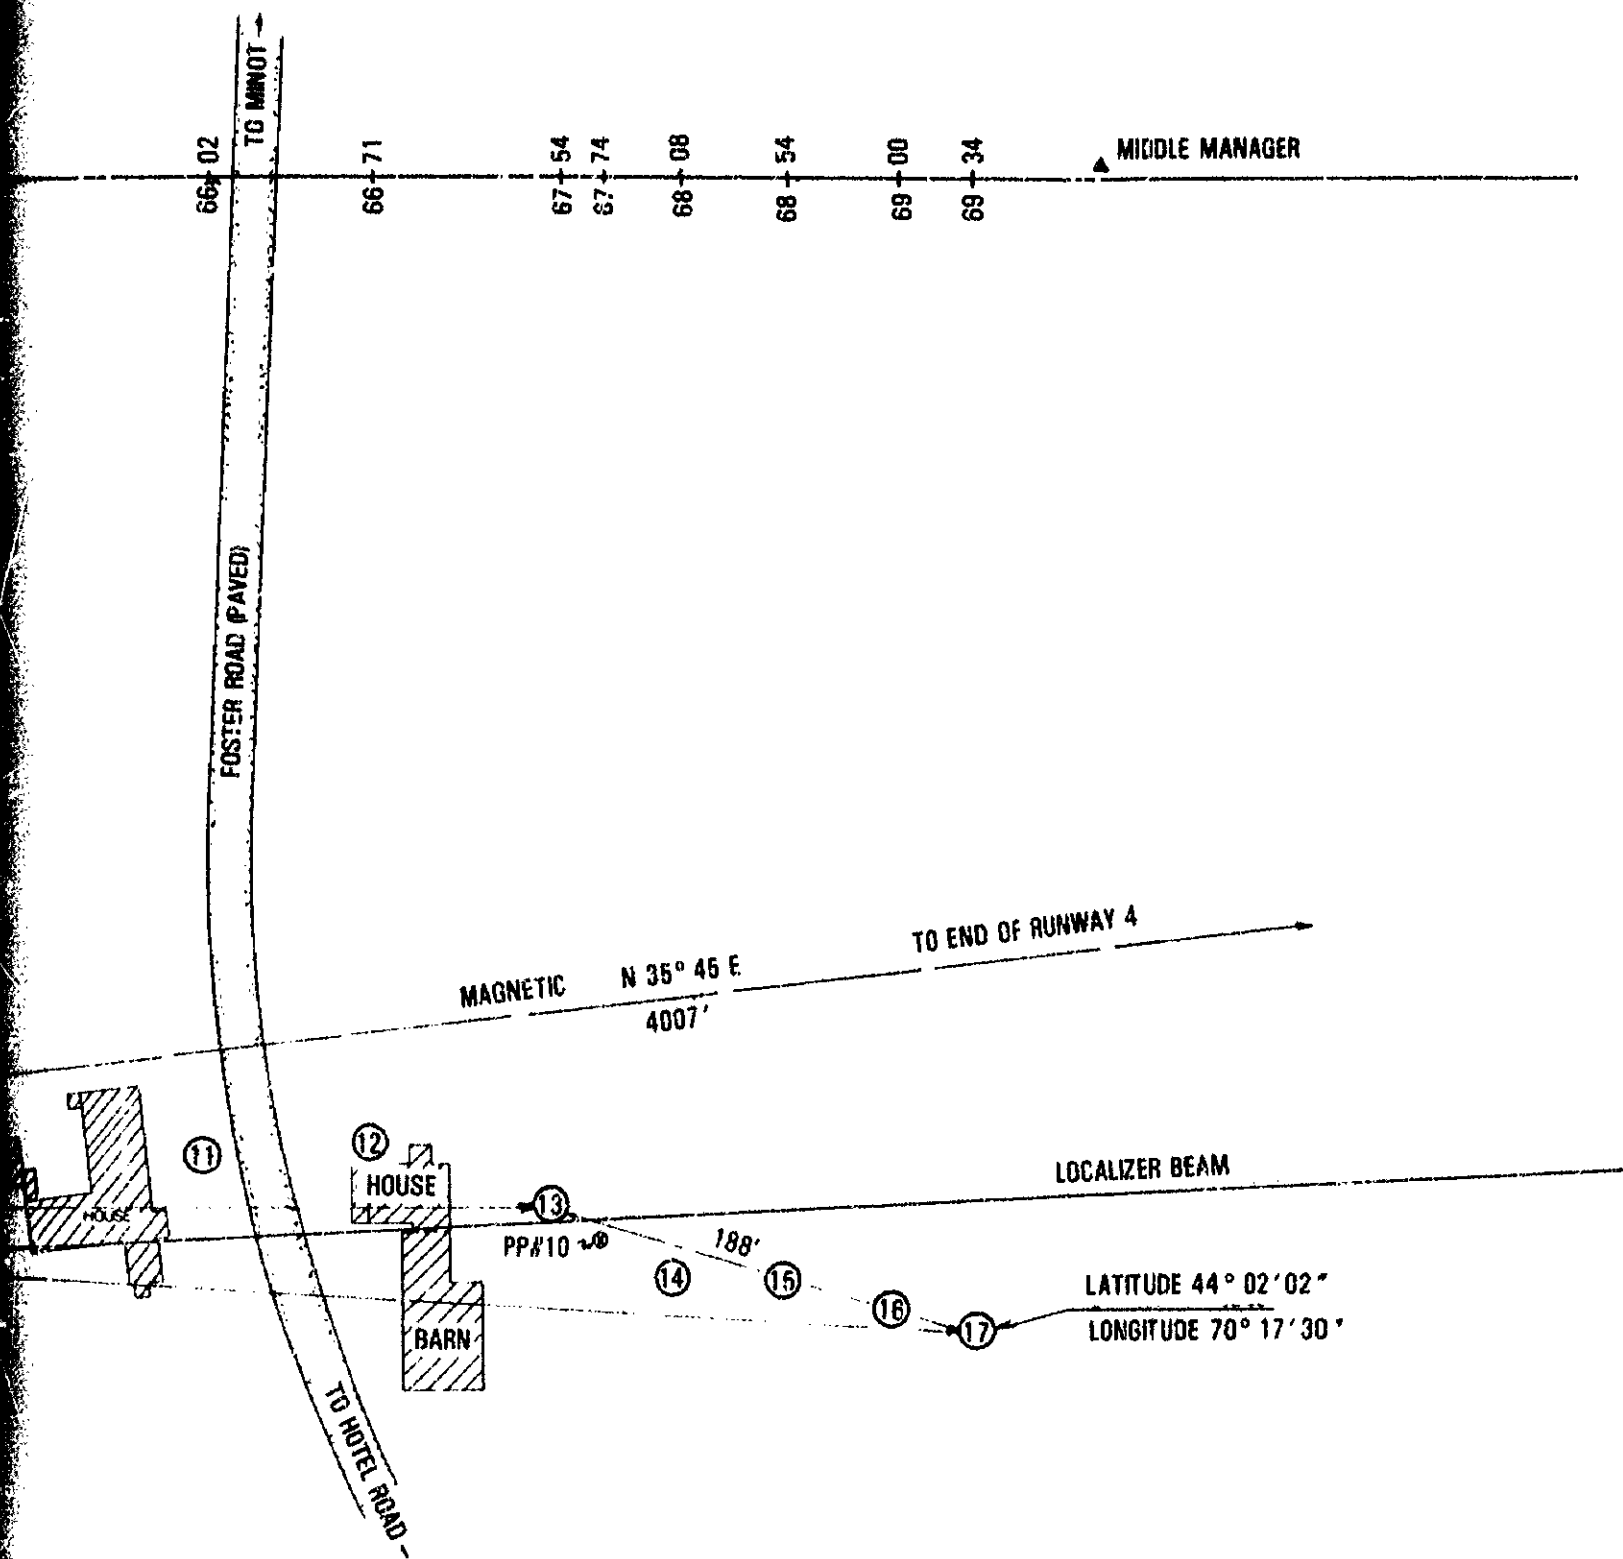
WRECKAGE DISTRIBUTION CHART

POINT DESCRIPTION	STATION	OFFSET	ELEV.	REMARKS
1 INITIAL AIRBORNE COLLISION WITH 8" POPLAR	60+17	440'	313.0 348 370	GRADE POINT TREE WAS SEVERED CANOPY
2 INITIAL AIRBORNE COLLISION WITH 9" OAK	60+39	427'	314.5 342 365	GRADE POINT TREE WAS SEVERED CANOPY
3 RIGHTAILERON	60+63	414'	312.2	GRADE
4 RIGHT OUTBOARD WING PANEL AND TIP	60+84	416'	309.5	GRADE
5 LEFTAILERON OUTBOARD SECTION	61+25	433'	310.1	GRADE
6 LEFT OUTBOARD WING SECTION AND TIP	61+54	394'	311.9	GRADE
7 FUEL CAP	61+78	428'	312.6	GRADE
8 OIL COOLER SCOOP	62+02	398'	318.5 358	GRADE CANOPY
9 LEFTAILERON INBOARD SECTION	62+39	405'	307.9	GRADE
10 RIGHT INBOARD LEADING EDGE	63+23	411'	294.6 335	GRADE CANOPY
11 BROKEN LIMBS IN TOP OF 20" PINE TREE NEXT TO FOSTER ROAD	66+02	419'	269.6 327 338	GRADE APPROXIMATE POINT OF IMPACT CANOPY
12 BROKEN LIMBS IN 14" MAPLE NEXT TO HOUSE	66+71	422'	268.8 287 312	GRADE APPROXIMATE POINT OF IMPACT CANOPY
13 INITIAL GROUND IMPACT	67+54	441'	260.3	GRADE
