PB90-910402
NTSB/AAR-90/02

AIRCRAFT ACCIDENT REPORT

**EVERGREEN INTERNATIONAL AIRLINES
McDONNELL DOUGLAS DC-9-33F, N931F
SAGINAW, TEXAS
MARCH 18, 1989**

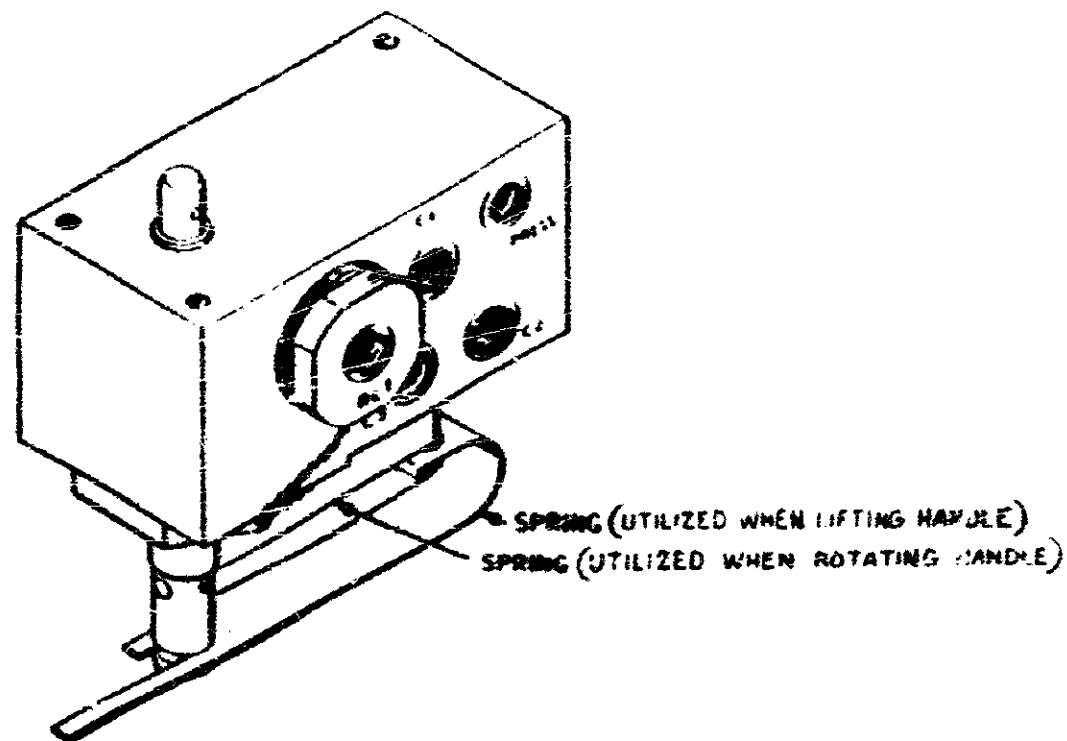
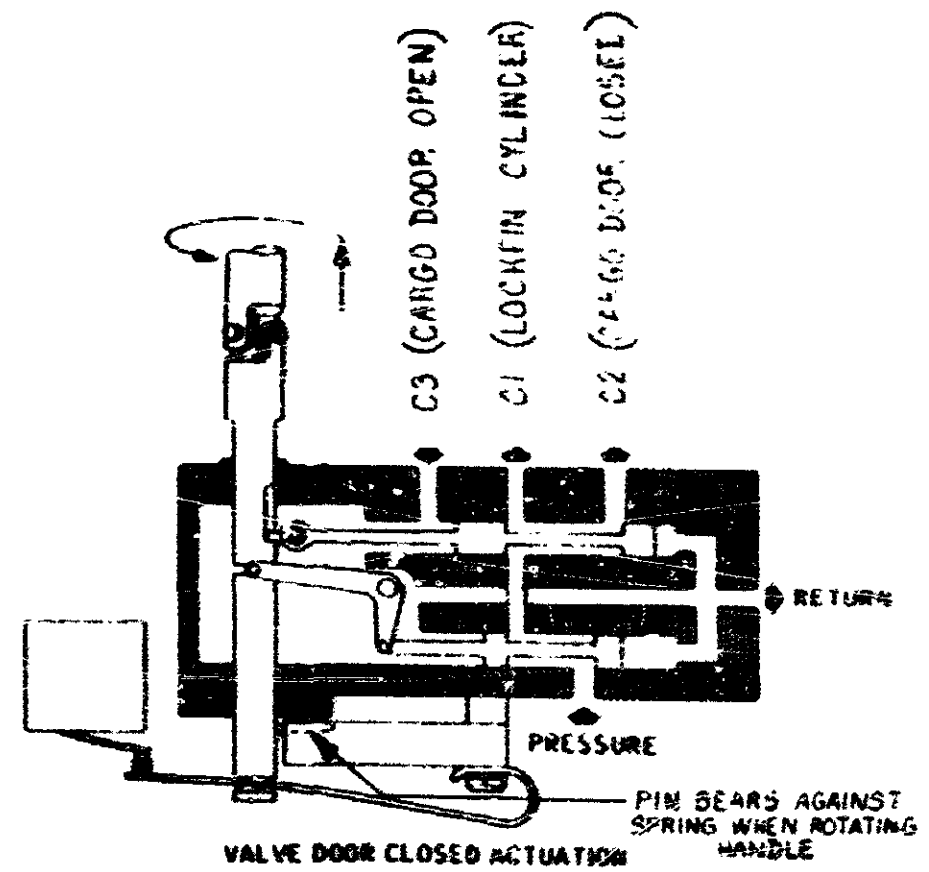
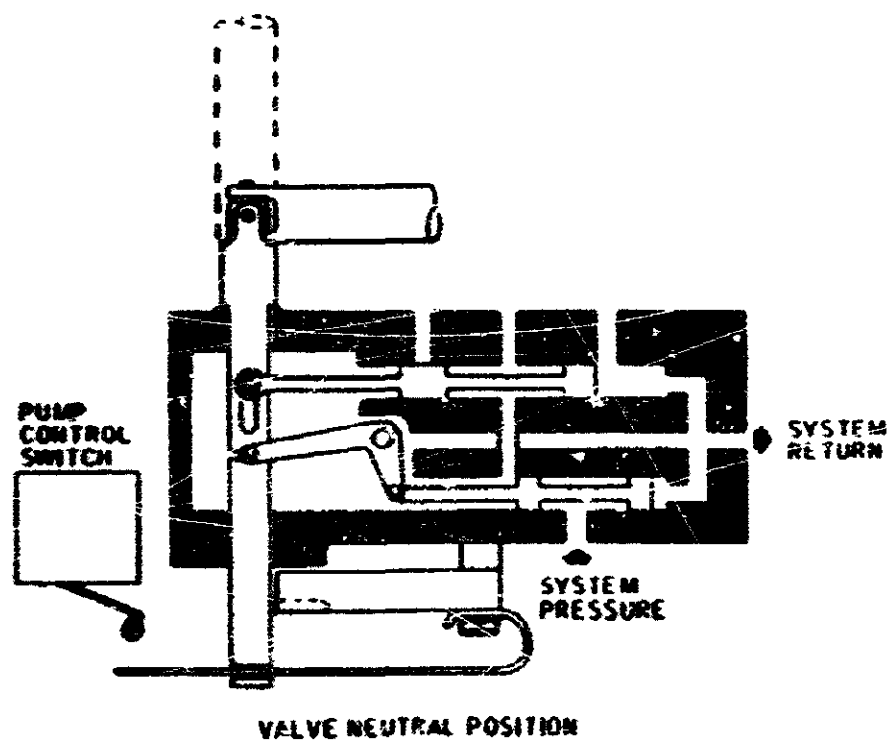
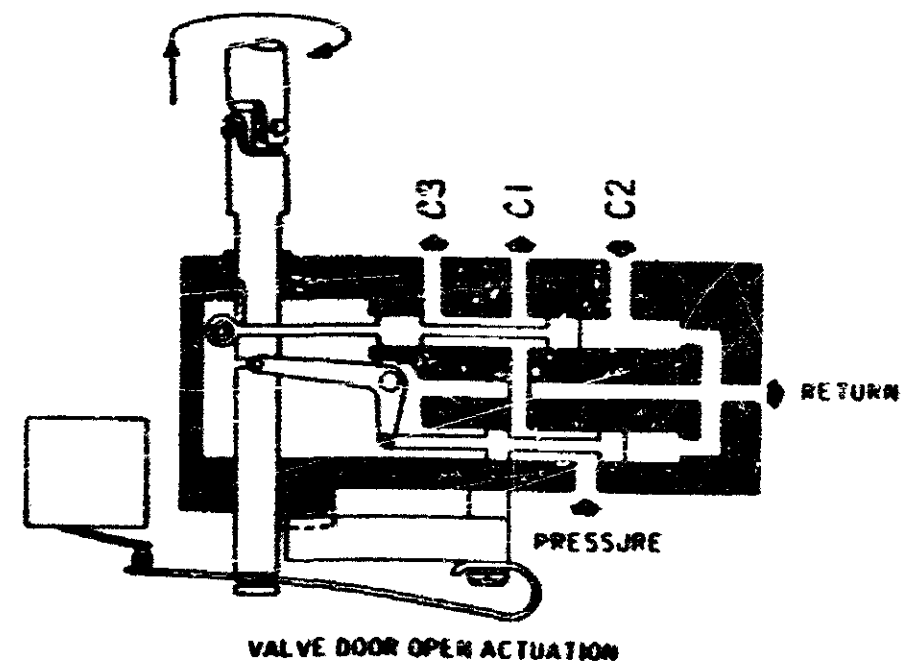
Figure 2.--Main cargo door components.

The open or closed status of the cargo door is also displayed by a cockpit warning light. The original 28 volt dc electrical circuit to illuminate the light consists of two switches wired in parallel. Both of the switches are spring loaded to the closed position. One is opened by mechanical actuation when the door lowers against the door jamb and the other is opened mechanically when the lockpin pushrod moves to a position where the lockpins are engaged in the latching hooks. Since the lockpins can engage only when the latching hooks are fully rotated over the door sill spools, an open switch indicates that the door is latched and locked. With either of the switches closed, the cockpit warning light is illuminated. When the door is properly closed, both switches open and the light is extinguished. The airplane manufacturer issued a service bulletin describing a modification to the cargo door warning circuit but the modification had not been accomplished on N931F as discussed in section 1.6.4. (See figures 1 and 2.)

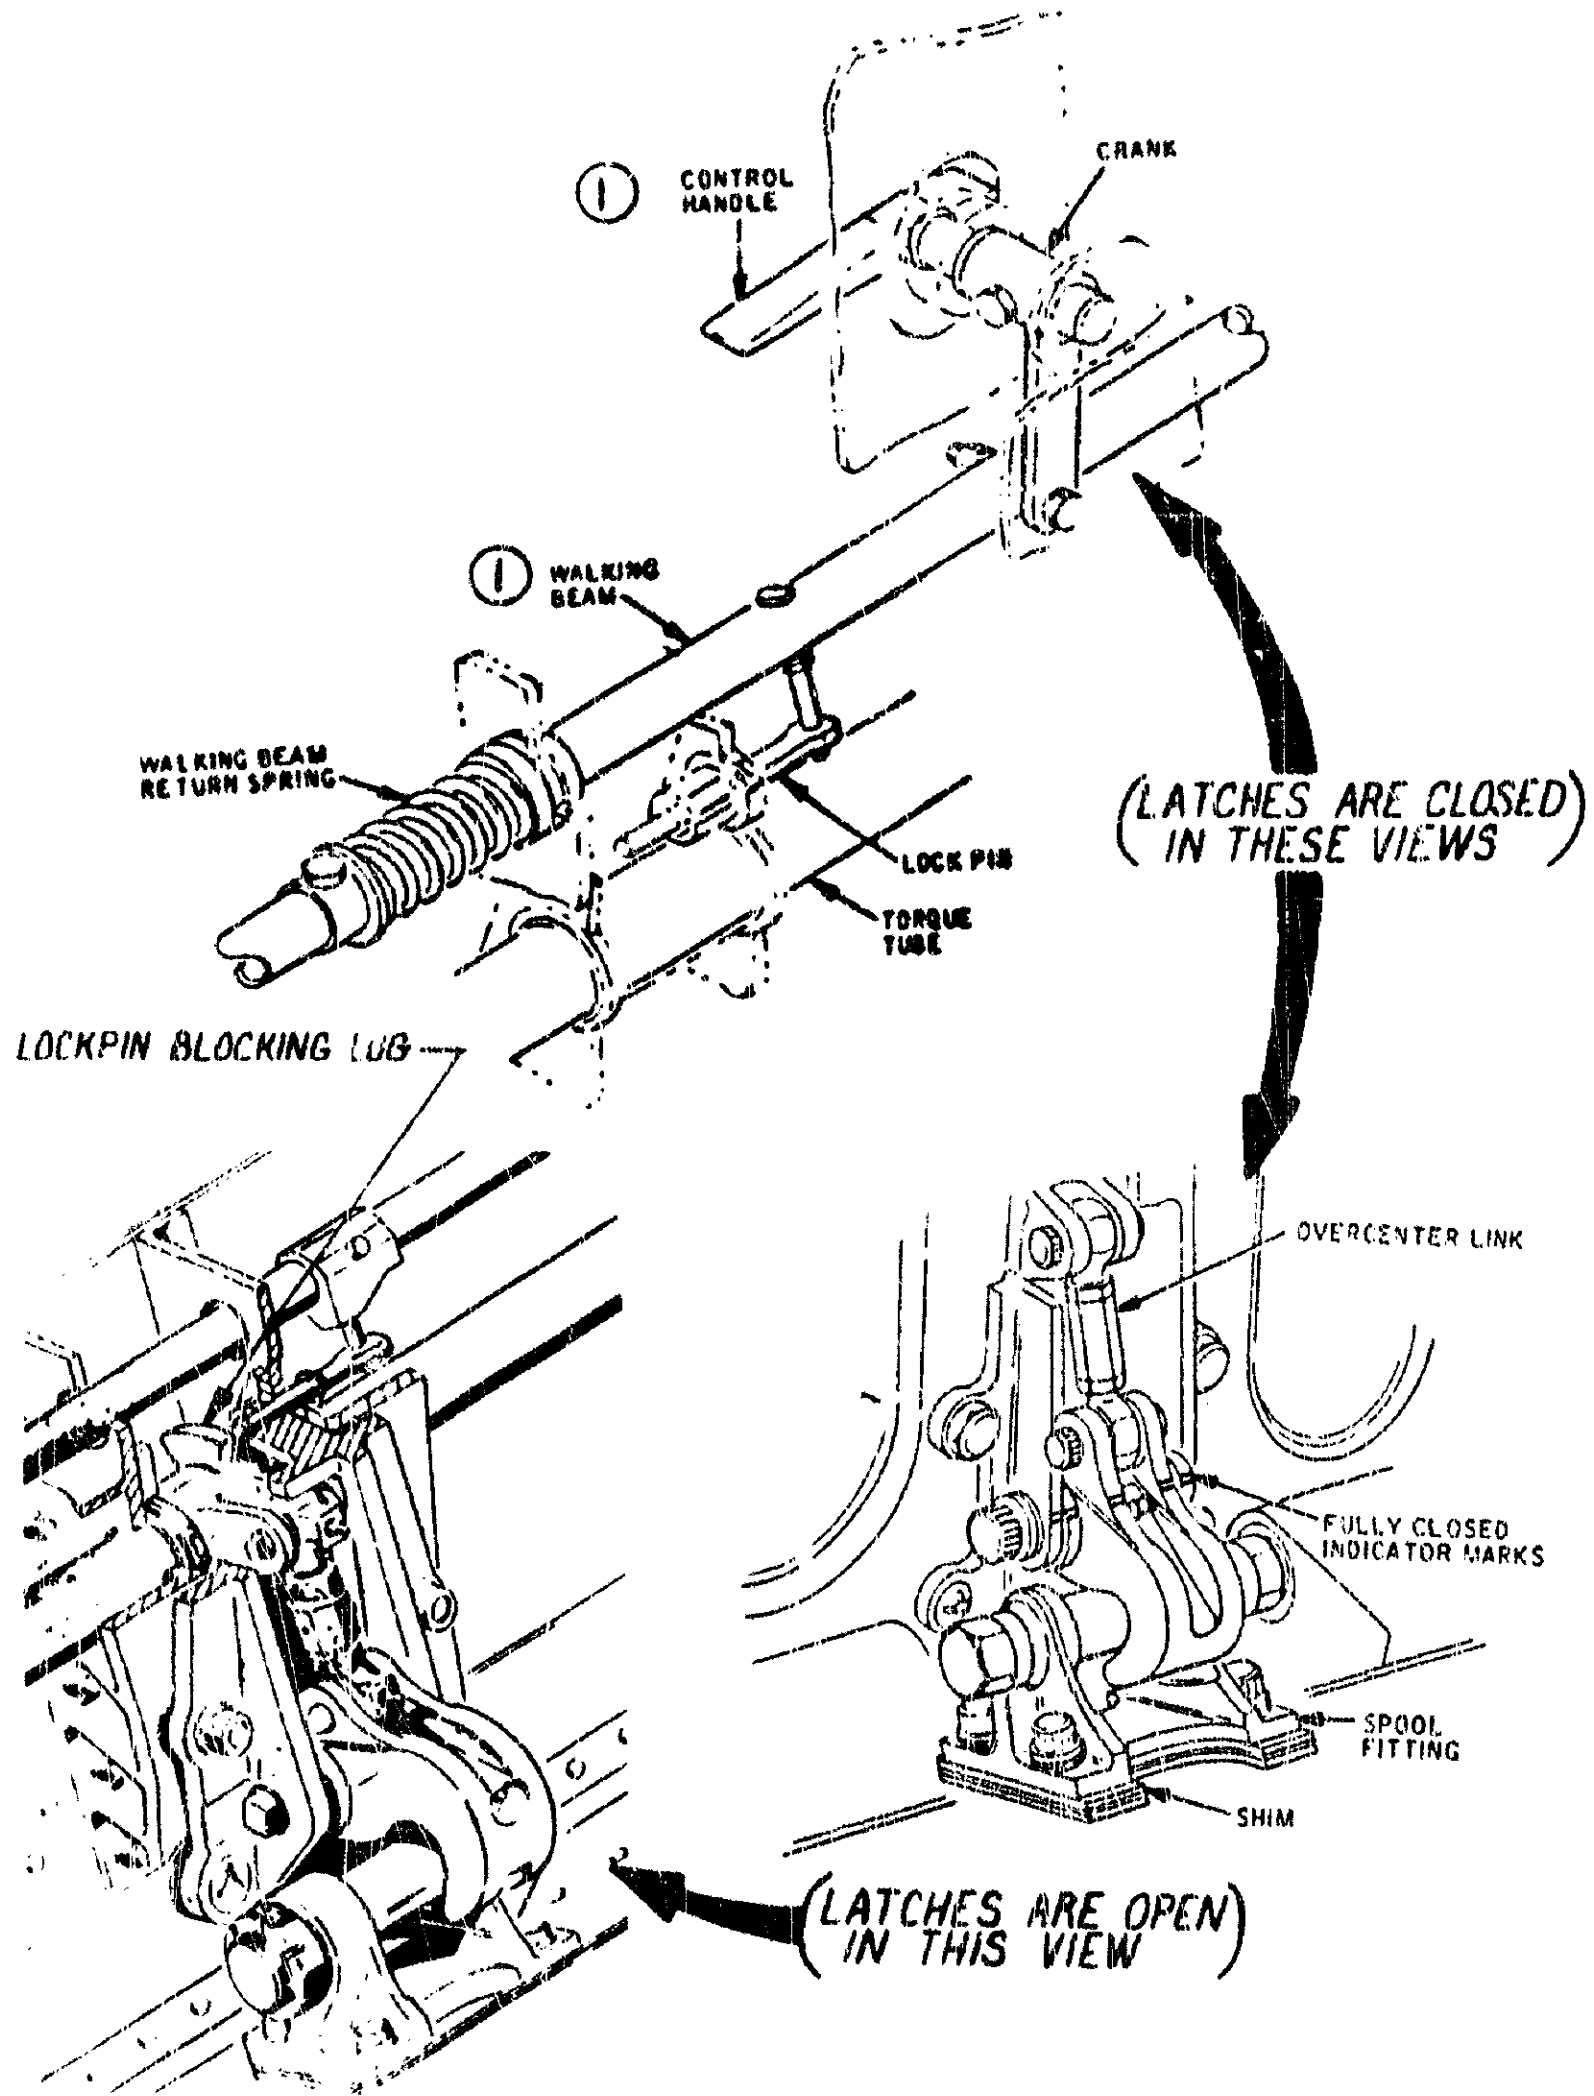
Figure 2.--(continued)

shaft freedom of movement check had been accomplished earlier by KLM on December 23, 1975, according to KLM engineering order No. 18689. No pieces of the access door or phenolic spacer were found in the wreckage.
