PB91-910404
NTSB/AAR-91/04

AIRCRAFT ACCIDENT REPORT

AVIANCA, THE AIRLINE OF COLUMBIA
BOEING 707-321B, HK 2016
FUEL EXHAUSTION
COVE NECK, NEW YORK
JANUARY 25, 1990

**ADOPTED: APRIL 30, 1991
NOTATION: 5255B**

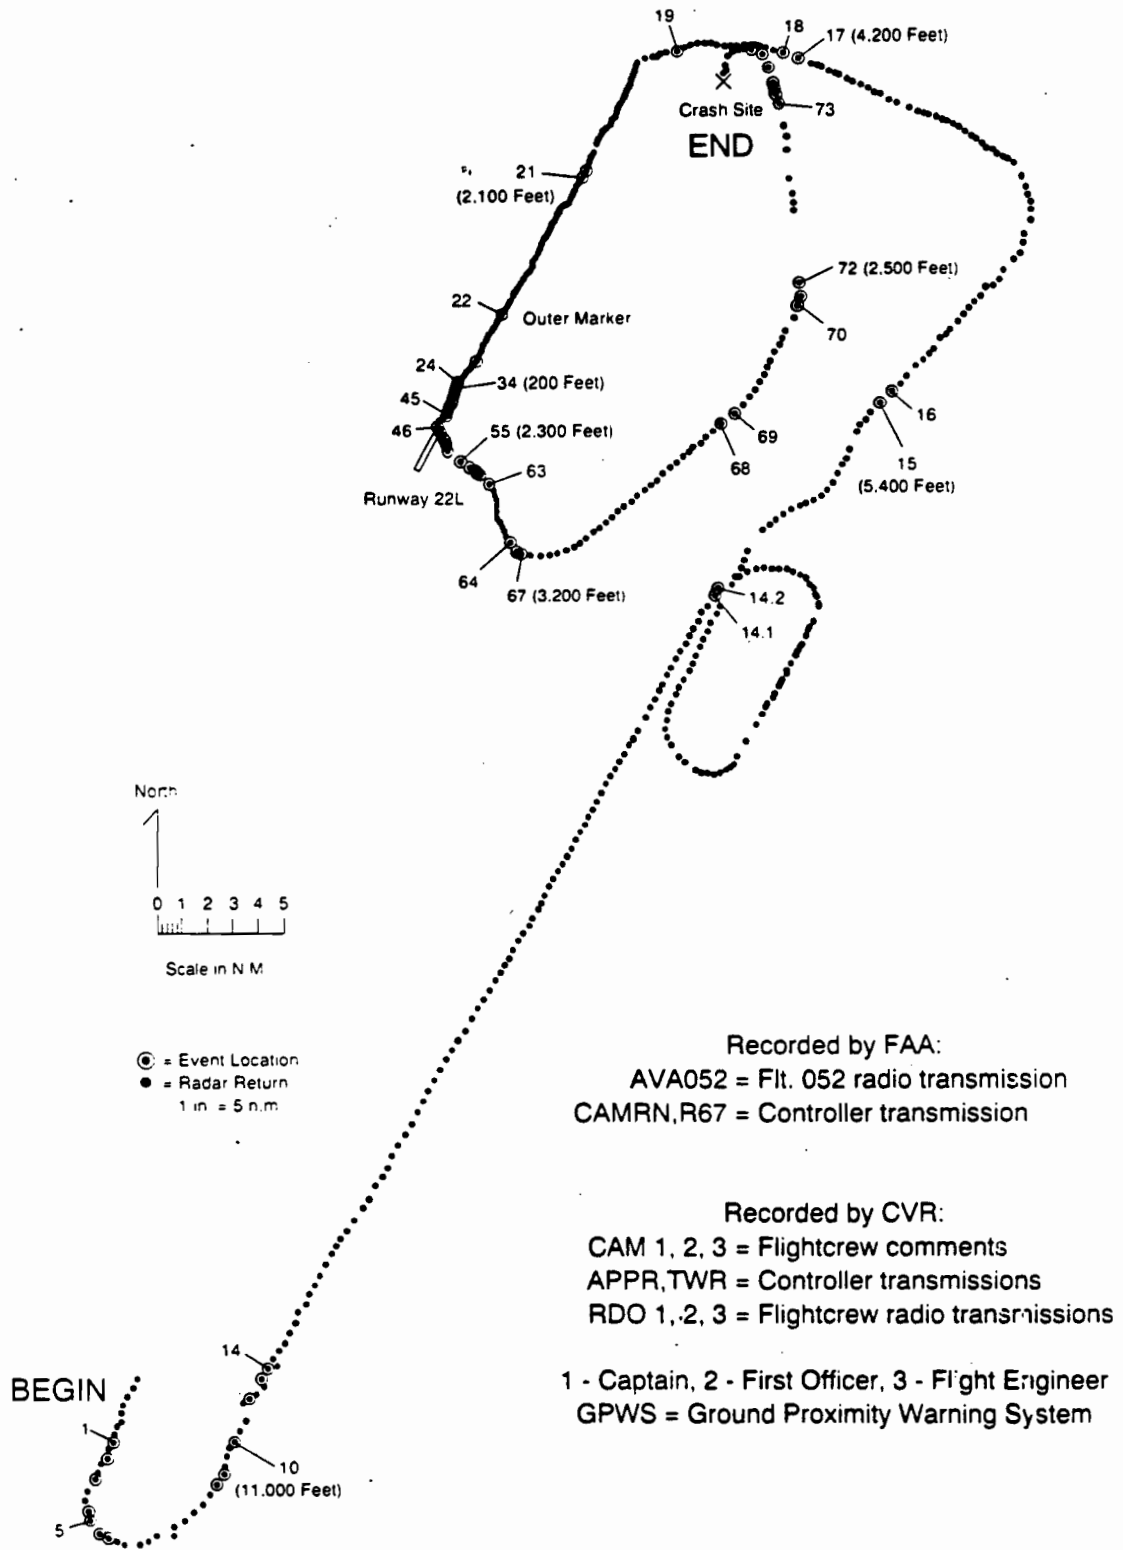
Between the ORF and CAMRN intersections, AVA052 was cleared to descend to several lower altitudes. The flight entered the holding pattern at CAMRN, at 14,000 feet mean sea level (msl). The flight was subsequently descended to 11,000 feet while in the holding pattern. Figure 1 depicts the track of AVA052 beginning at 2042:59.

Figure 1.--AVA052 flight reconstruction based on CVR, ATC radar data, and ATC communications.

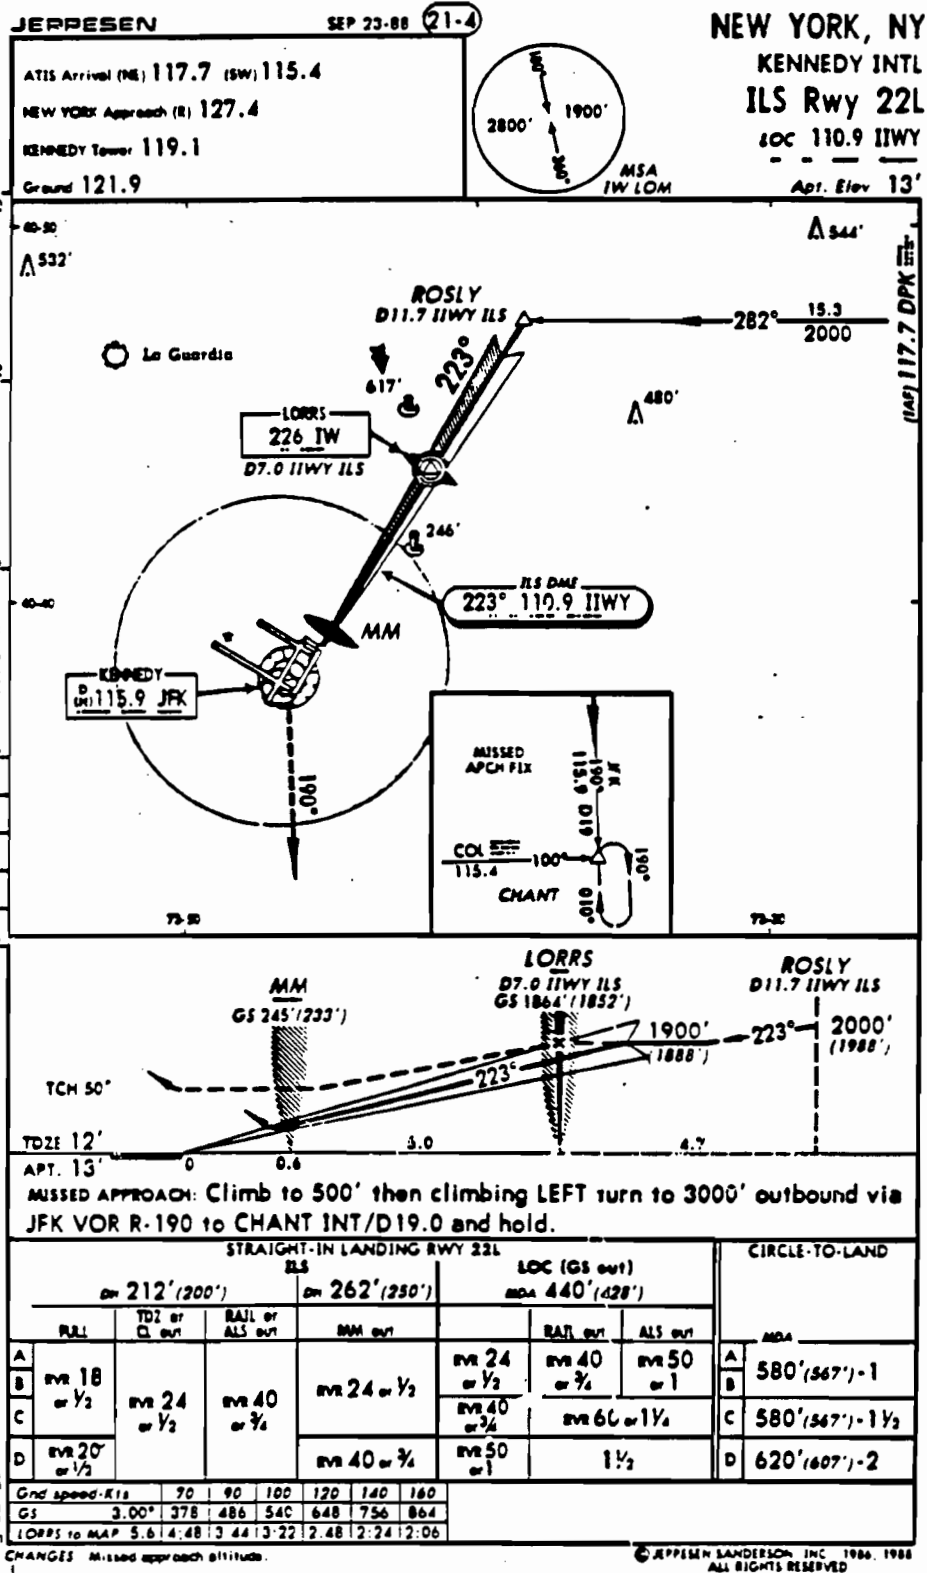
At 2111:07, the final controller stated, "...you are one five miles from the outer marker maintain two thousand until established on the localizer cleared ILS two two left." Figure 2 depicts the ILS runway 22L approach chart.

Figure 2.--Jeppesen Approach Plate of ILS to runway 22 left at JFK.

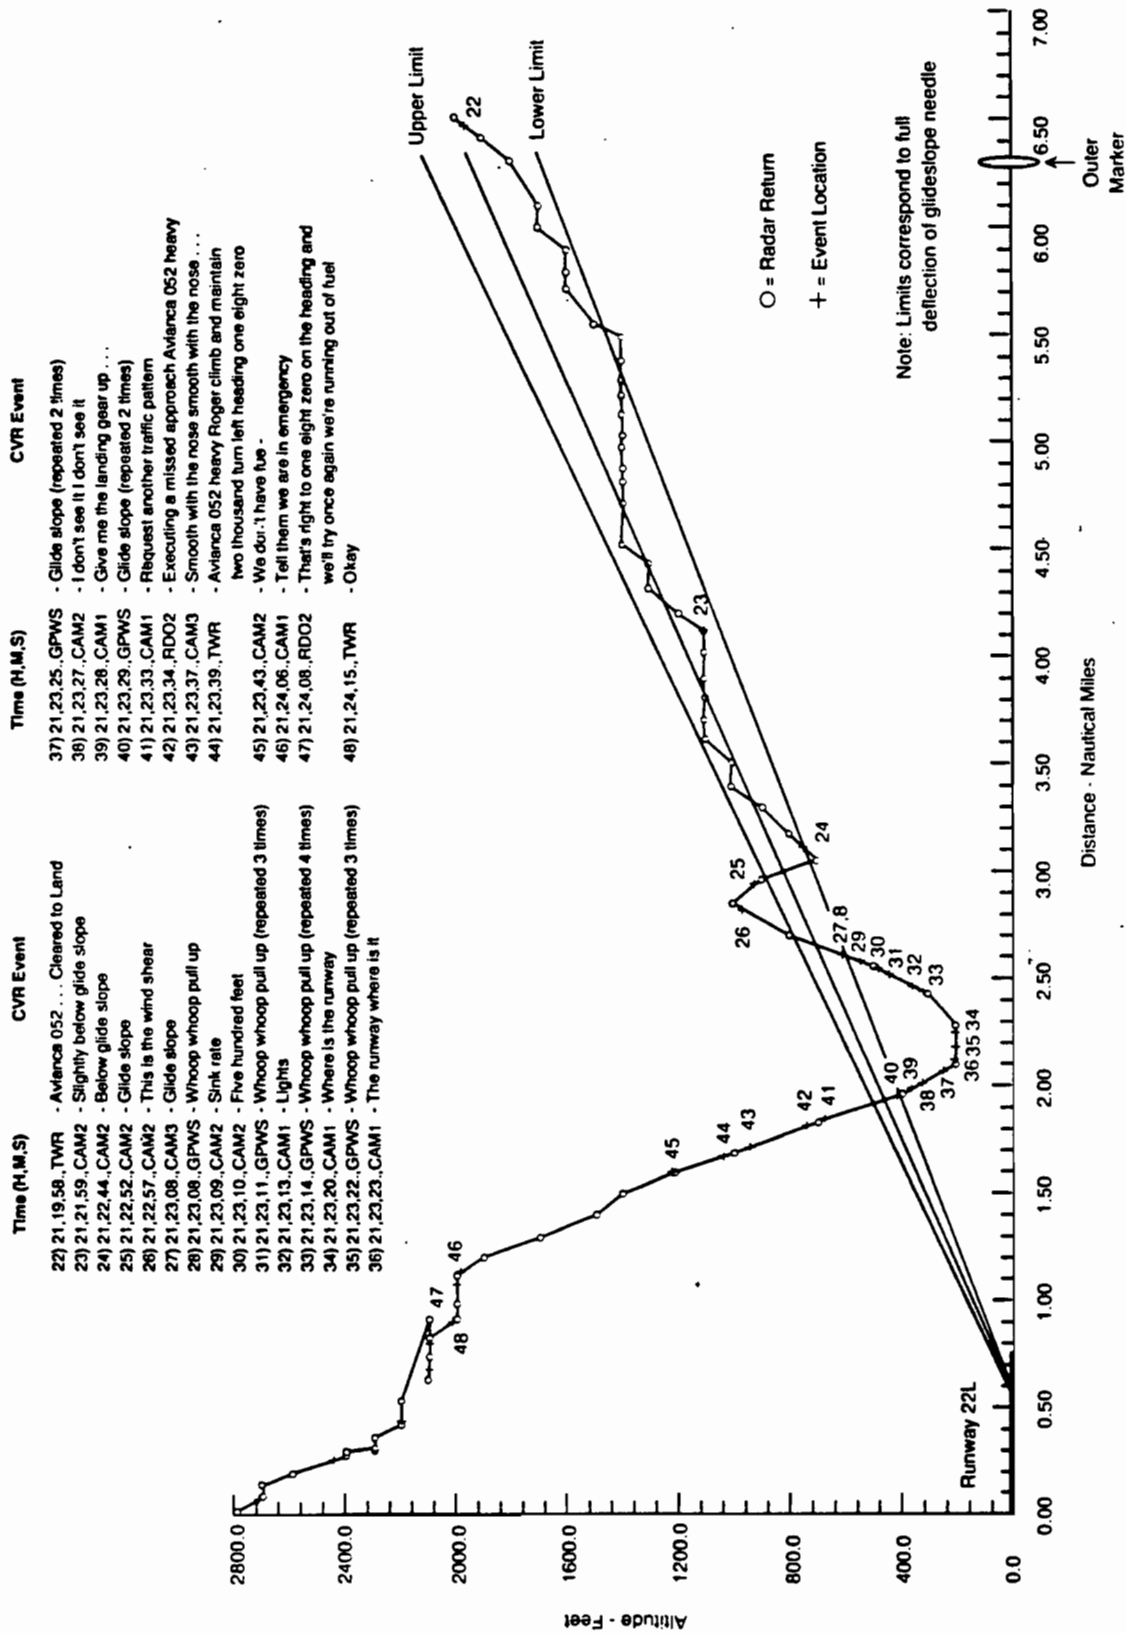
Between 2123:08 and 2123:23 (CVR), there were 11 "whoop pull up" voice alerts from the airplane's ground proximity warning system (GPWS).⁷ Between 2123:25 and 2123:29, there were four "glideslope" deviation alerts from the GPWS. At 2123:23 (CVR), the captain asked "the runway where is it?" At this time, AVA052 was 1.3 miles from the approach end of runway 22 left at an altitude of 200 feet. At 2123:27 (CVR), the first officer said, "I don't see it I don't see it." At 2123:28 (CVR), the captain said, "give me the landing gear up landing gear up." Figure 3 depicts the profile view of AVA052's ILS approach path and go-around.

Figure 3.--AVA052 ILS approach--profile view.
