PB91-910410
NTSB/AAR-91/09

AIRCRAFT ACCIDENT REPORT

**RYAN INTERNATIONAL AIRLINES
DC-9-15, N565PC
LOSS OF CONTROL ON TAKEOFF
CLEVELAND-HOPKINS INTERNATIONAL AIRPORT
CLEVELAND, OHIO
FEBRUARY 17, 1991**

**Adopted: November 16, 1991
Notation 5499A**

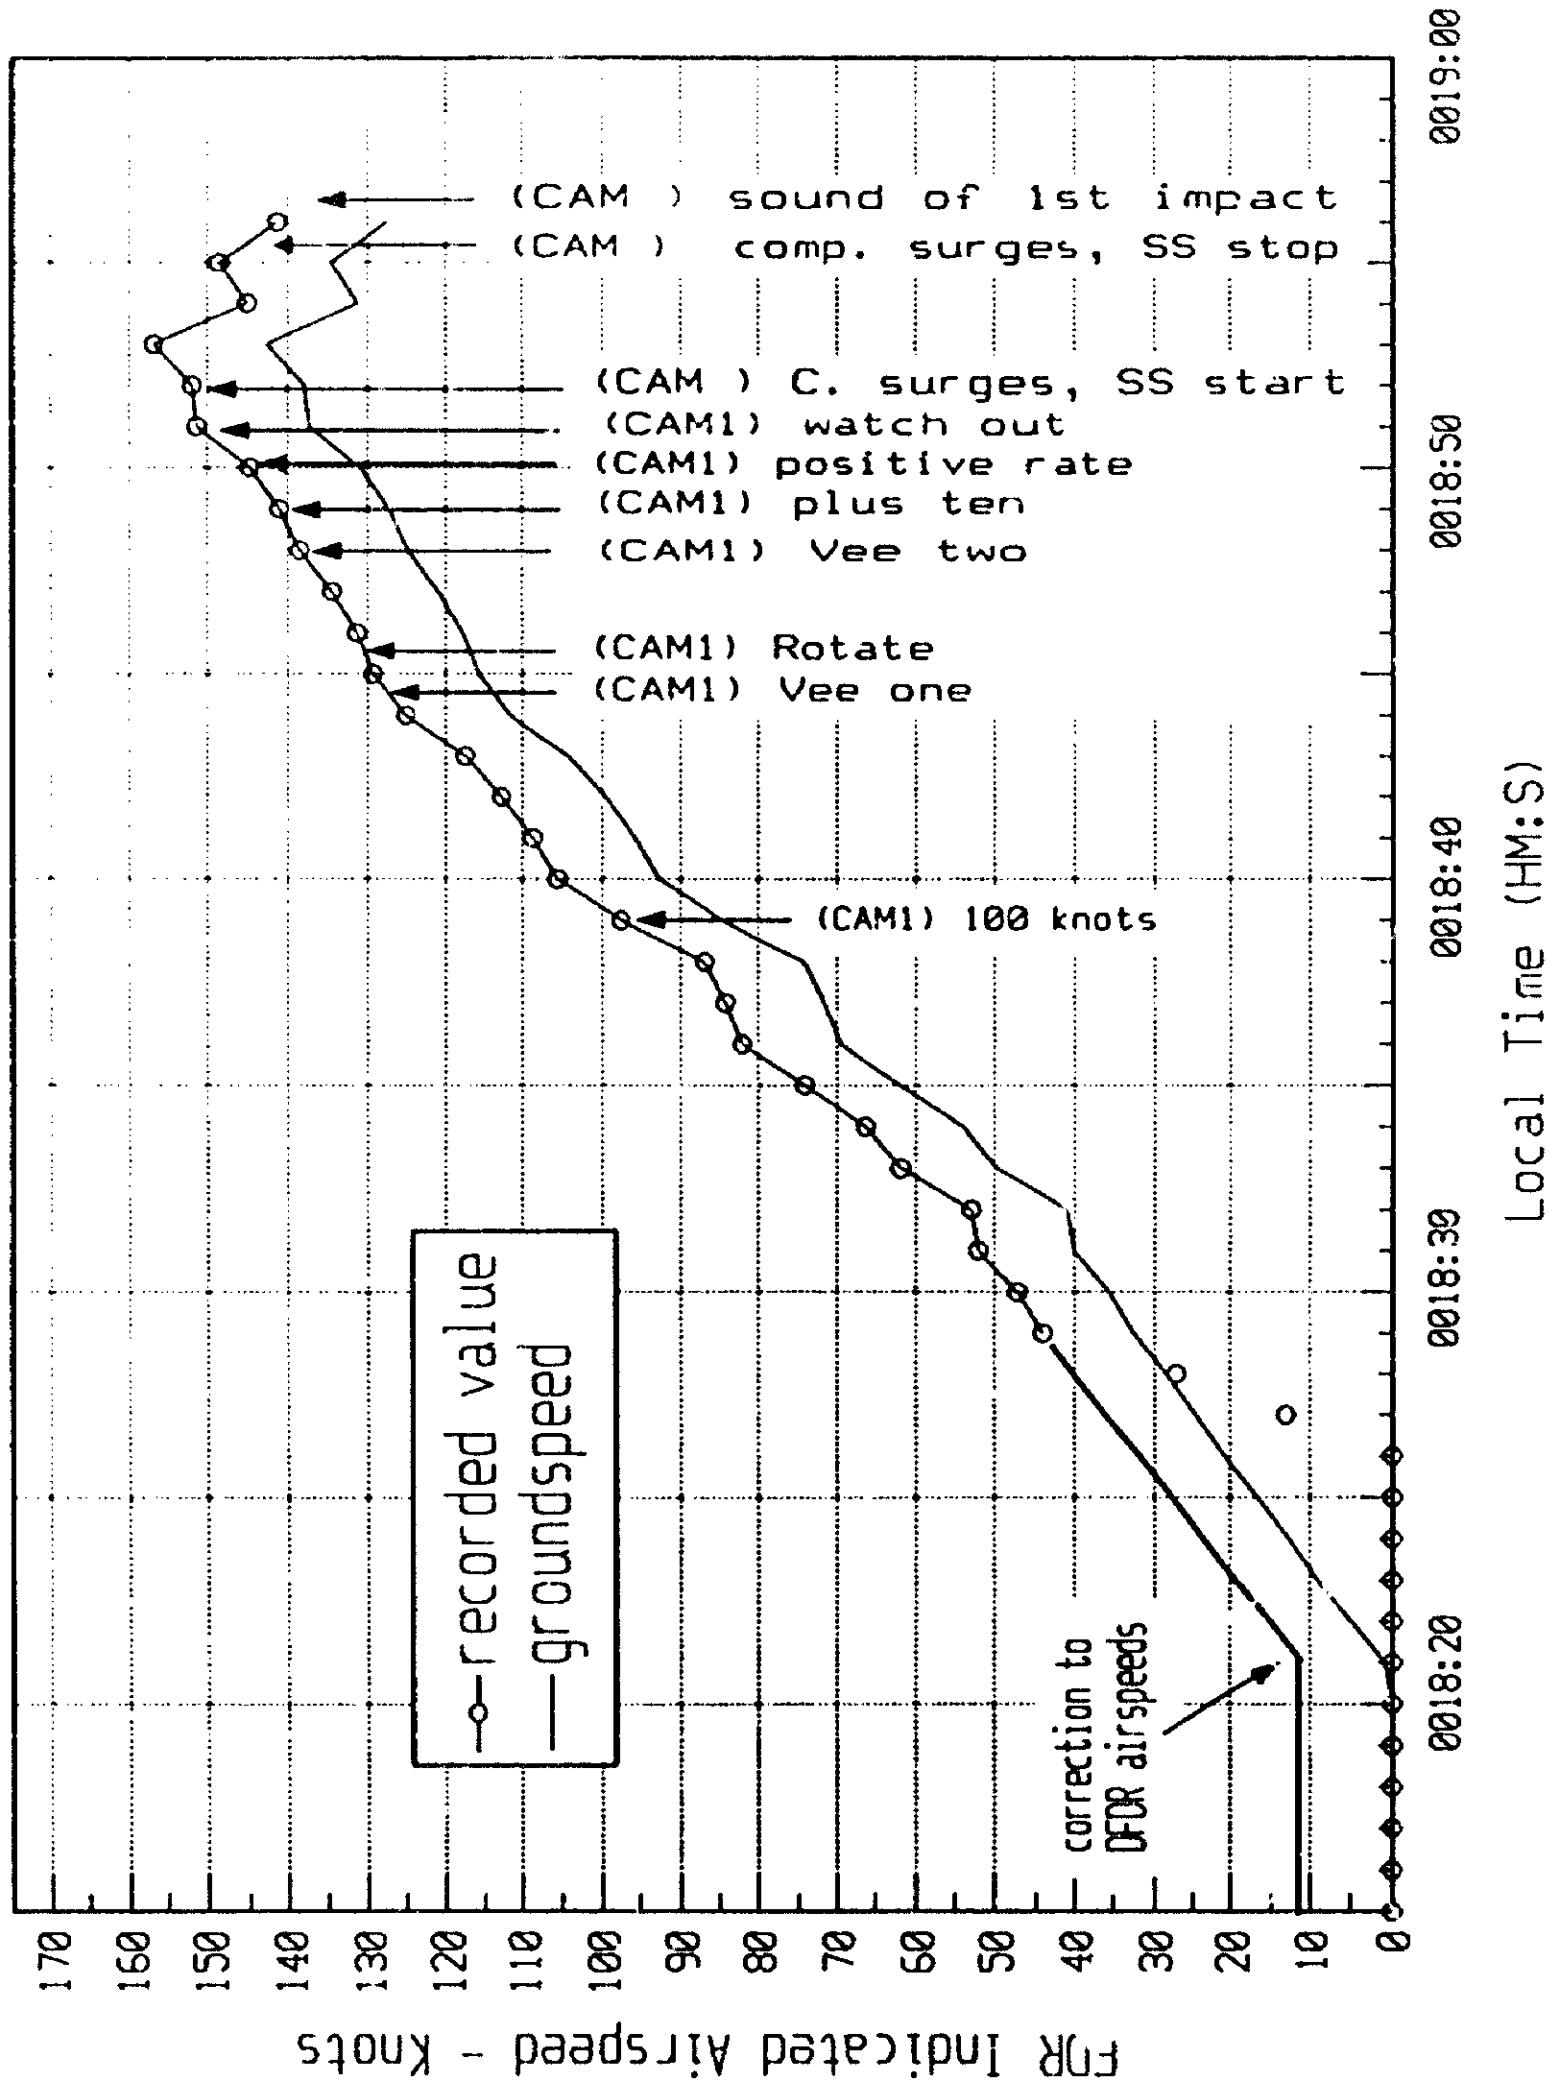
RYAN AIRLINES DC-9-15 TAKEOFF ACCIDENT

The resulting correlation of airspeed, pressure altitude, normal acceleration, and airplane heading as a function of the common time reference is shown in figures 2 through 5 respectively. It is noted in figure 4 that the scatter of the normal acceleration values recorded on the FDR made the data difficult to interpret and of limited reliability. Consequently, a moving average technique was used to smooth this data. The resulting normal acceleration plot was considered as the best one obtainable for evaluation of the airplane's flight performance.

The data from figures 2 through 5 were evaluated to determine the path and distance travelled by the airplane as a function of the various events that occurred from the beginning of the takeoff roll to the point of initial ground impact. The recorded airspeed values were converted to groundspeed using the headwind component determined from the airport LLWAS wind measurement of 11 knots. Both groundspeed and heading were integrated to develop the correlation of airplane position and key events shown in figure 6.

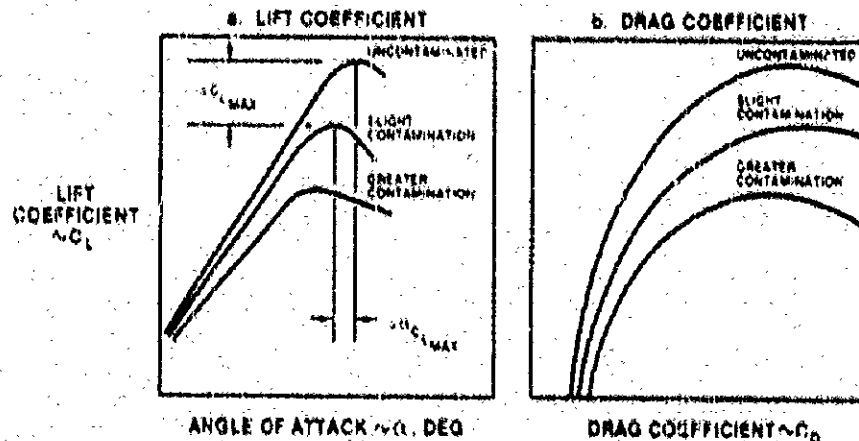
Figure 3. Effect of Wing Ice Contamination on Lift and Drag Coefficients

The normal variation of lift with angle of attack can be significantly altered by ice contamination. As shown in Figure 3a, the typical effect is to alter the variation of lift with angle of attack, reduce the maximum lift capability of the wing, and cause

the wing to stall at a lower than normal angle of attack. As will be shown shortly, these effects can be quite large.

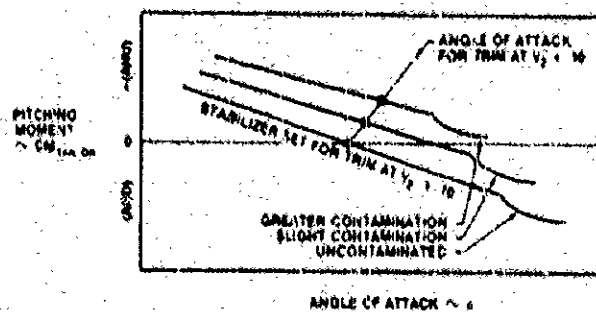
Figure 4. Effect of Wing Ice Contamination on Pitching Moment

airplane nose-up direction as the angle of attack is increased. This will result in the aircraft's pitching up more rapidly than normal during the takeoff rotation, and will require an abnormal push force to maintain the desired airspeed during climb. As with other effects, this pitch-up tendency becomes more pronounced as the amount of ice contamination increases.

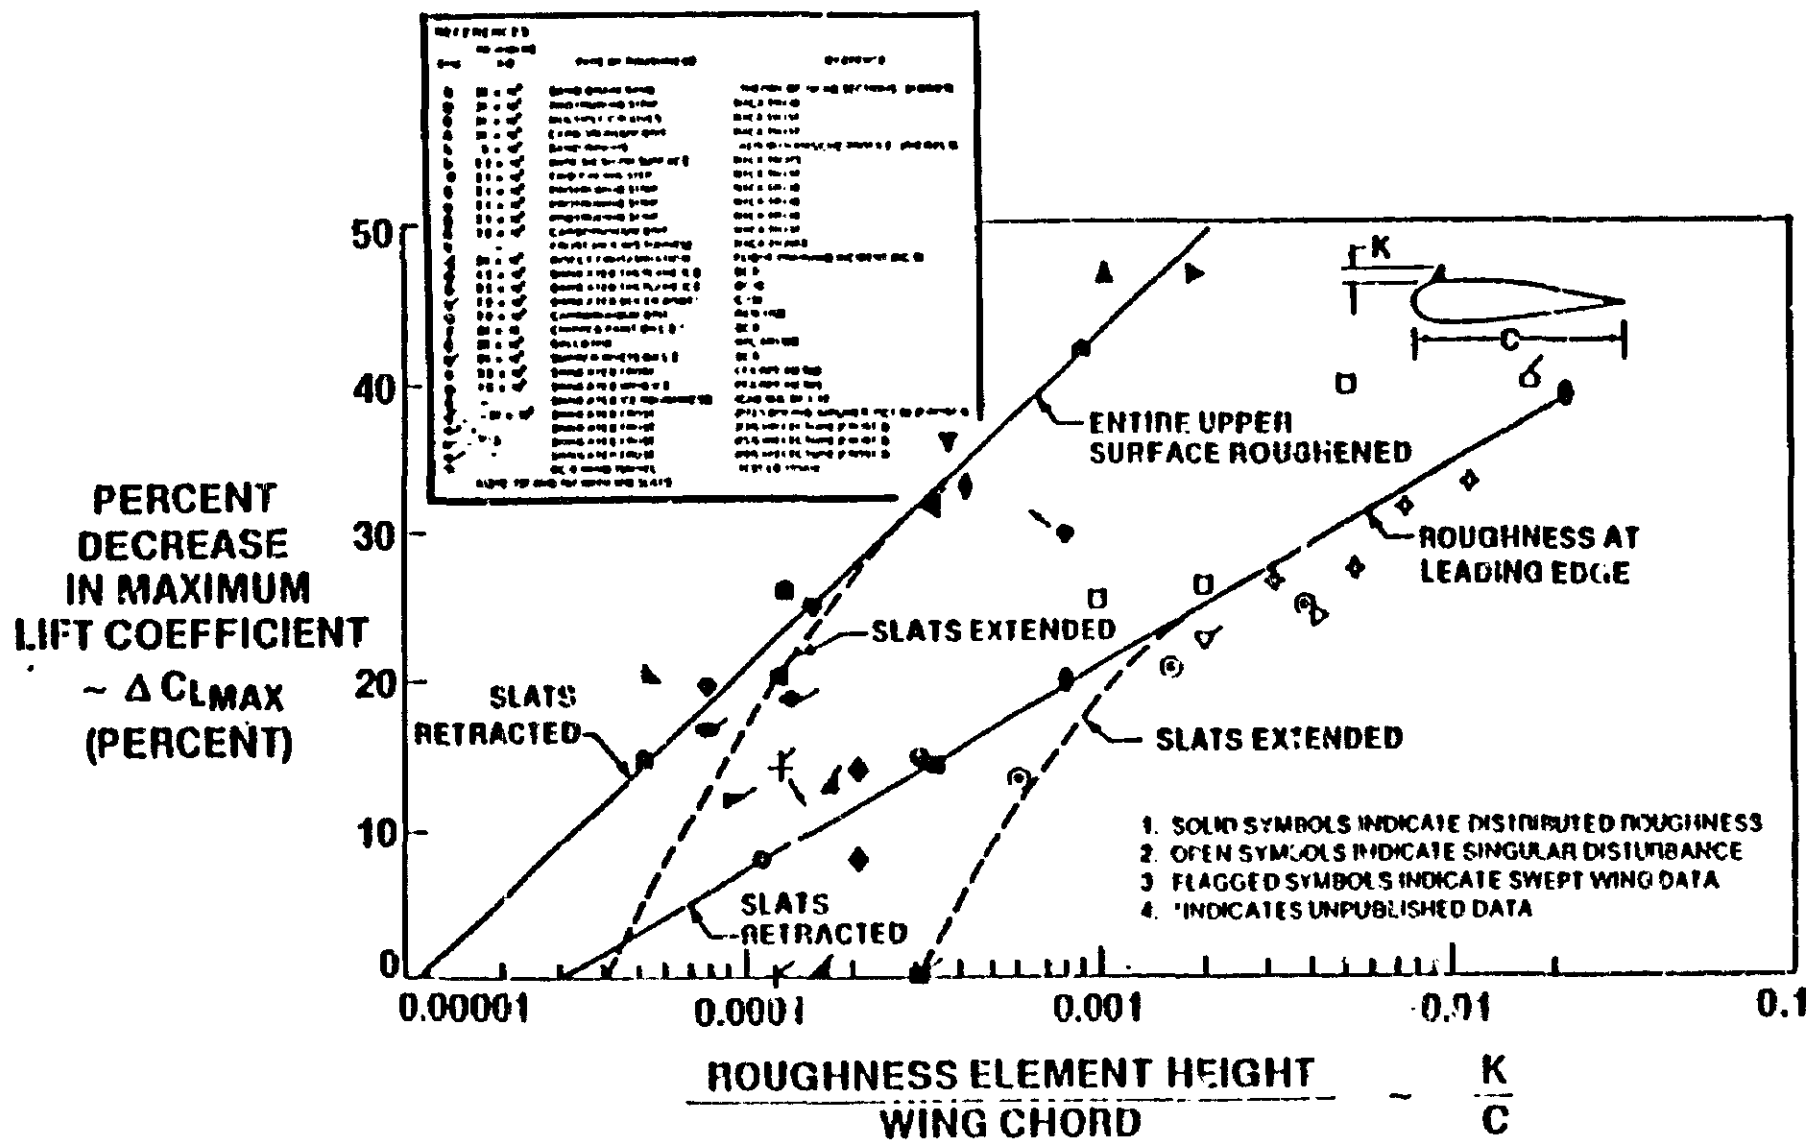
A CORRELATION OF THE EFFECT OF WING SURFACE ROUGHNESS ON MAXIMUM LIFT COEFFICIENT

Figure 6 shows an empirical correlation of lift loss due to wing surface roughness, including ice contamination. It is interesting to note that this simple correlation encompasses data representing a Reynolds Number range from 6×10^7 up to 29×10^7 and airfoil shapes ranging from simple symmetrical sections to those representative of second generation turbojet aircraft (see Table 3).

The lower line in Figure 6 shows the lift loss due to a localized strip or narrow band of contamination on the leading edge. Much of the data for the lesser amounts of contamination have been obtained from maintenance or flight training experience where some form of contamination such as insect debris, chipped paint, or buried rivets caused premature stall when the slats were retracted, but caused little or no noticeable effect when the slats were extended. Wind tunnel data indicate that as the contamination on the leading edge becomes larger, such as for in-flight ice

The upper line in Figure 6 shows the lift loss due to roughness on the entire upper surface of the wing, such as might be caused by frost, snow, or freezing drizzle while the aircraft is on the ground. Of particular note is the very large degradation for even the smaller amounts of contamination. Also of interest are the relatively recent data developed by Boeing during flight testing of second- and third-generation transport aircraft with slats extended. These data suggest that with essentially the entire wing upper surface covered with even small amounts of contamination, slat extension provides little or no recovery of lift losses.

Although Figure 6 shows a significant difference in lift loss between a narrow band of roughness at the leading edge and roughness over the entire upper surface, it is worthy to note that recent unpublished data for slight roughness extending aftward from the leading edge to about 7 percent chord on both the upper and lower surfaces (as might occur during a mild icing encounter) can cause lift losses similar to those caused by a fully roughened upper surface.
