AIRCRAFT ACCIDENT REPORT

RUNWAY DEPARTURE FOLLOWING LANDING
AMERICAN AIRLINES FLIGHT 102
McDONNELL DOUGLAS DC-10-30, N139AA
DALLAS/FORT WORTH INTERNATIONAL AIRPORT, TEXAS
APRIL 14, 1993

Notation 6109B

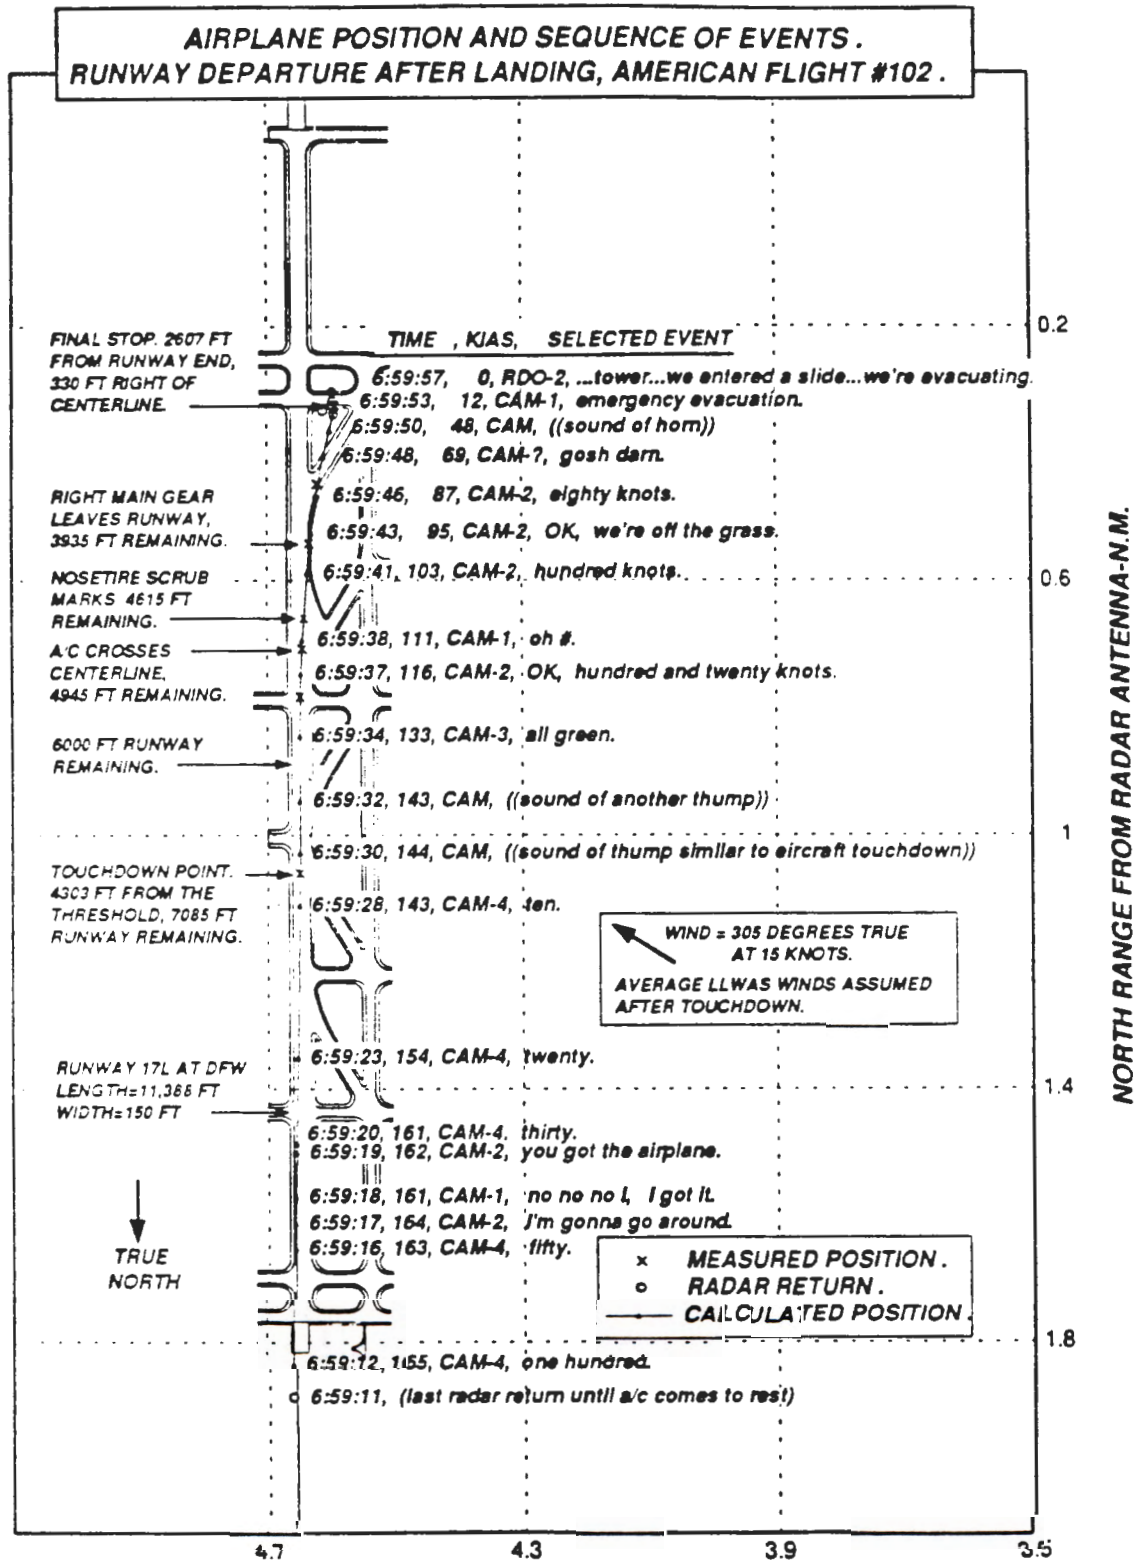
Investigators examined the landing runway after the accident and found three long sets of lightly shaded tire traces that paralleled the centerline but then angled to the right and departed the runway. The tracks from the right main landing gear continued as furrows in the soil.

Then the airplane traveled across high speed taxiway 3S before returning to the soft soil. The airplane came to rest, upright, about 2,607 feet from the departure end of 17L and about 250 feet from the right edge of the runway, with the nose on perpendicular taxiway 31. (See figures 2, 3 and 4).

The first tire marks found on the runway were traced to the left and right main landing gear, and started at 4,303 feet from the beginning of the runway. The tracks approximately paralleled the runway centerline for about 1,700 feet, then turned gradually to the right until they departed the runway.

Figure 2.--Approach and landing.
History of airplane motion and events.

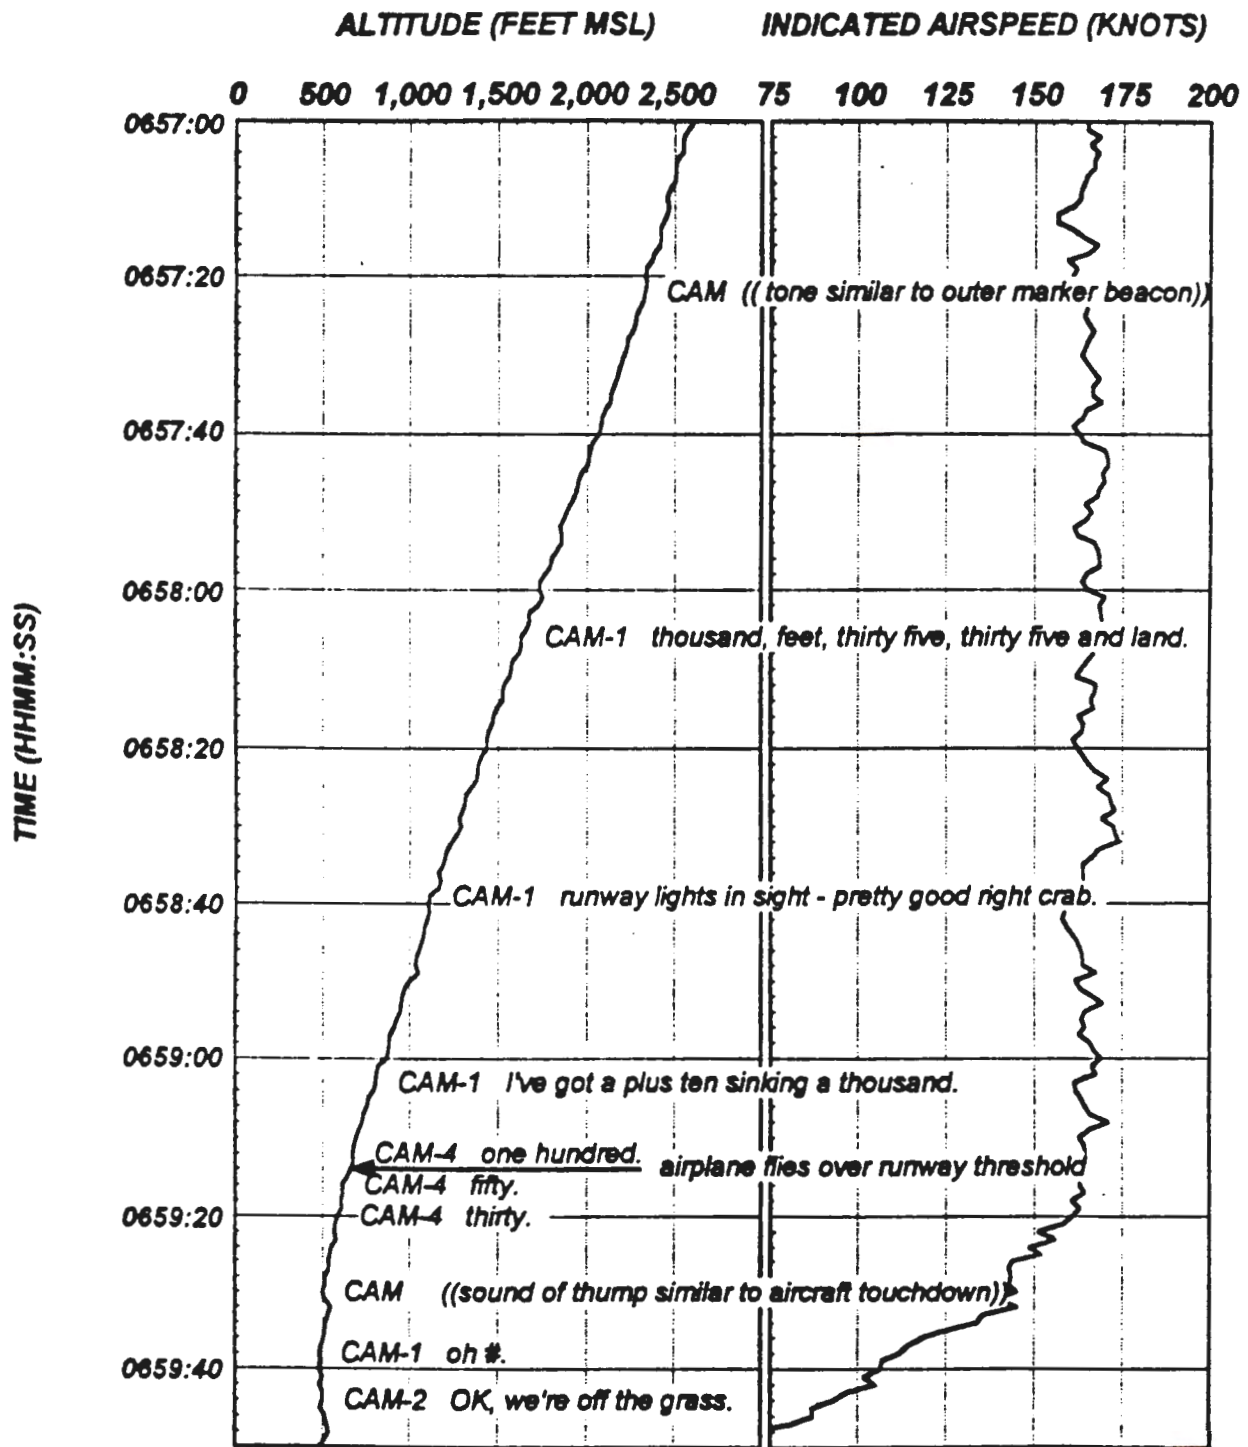
Data from ATC radar, weather, CVR, FDR, and information from the examination of the aircraft wreckage and the accident runway were used to develop a time history of the accident flight's motion during the approach and landing. (See figure 10 for airspeeds and altitudes during the landing sequence). Calculations were made of the crosswind component during the final 2 1/2 minutes before landing. A composite plot was developed that shows, in a graphical format, the flight control positions and airplane headings when key events occurred during the landing sequence. (See figures 11a and 11b).

Figure 10.--Airplane airspeeds and altitudes versus time.

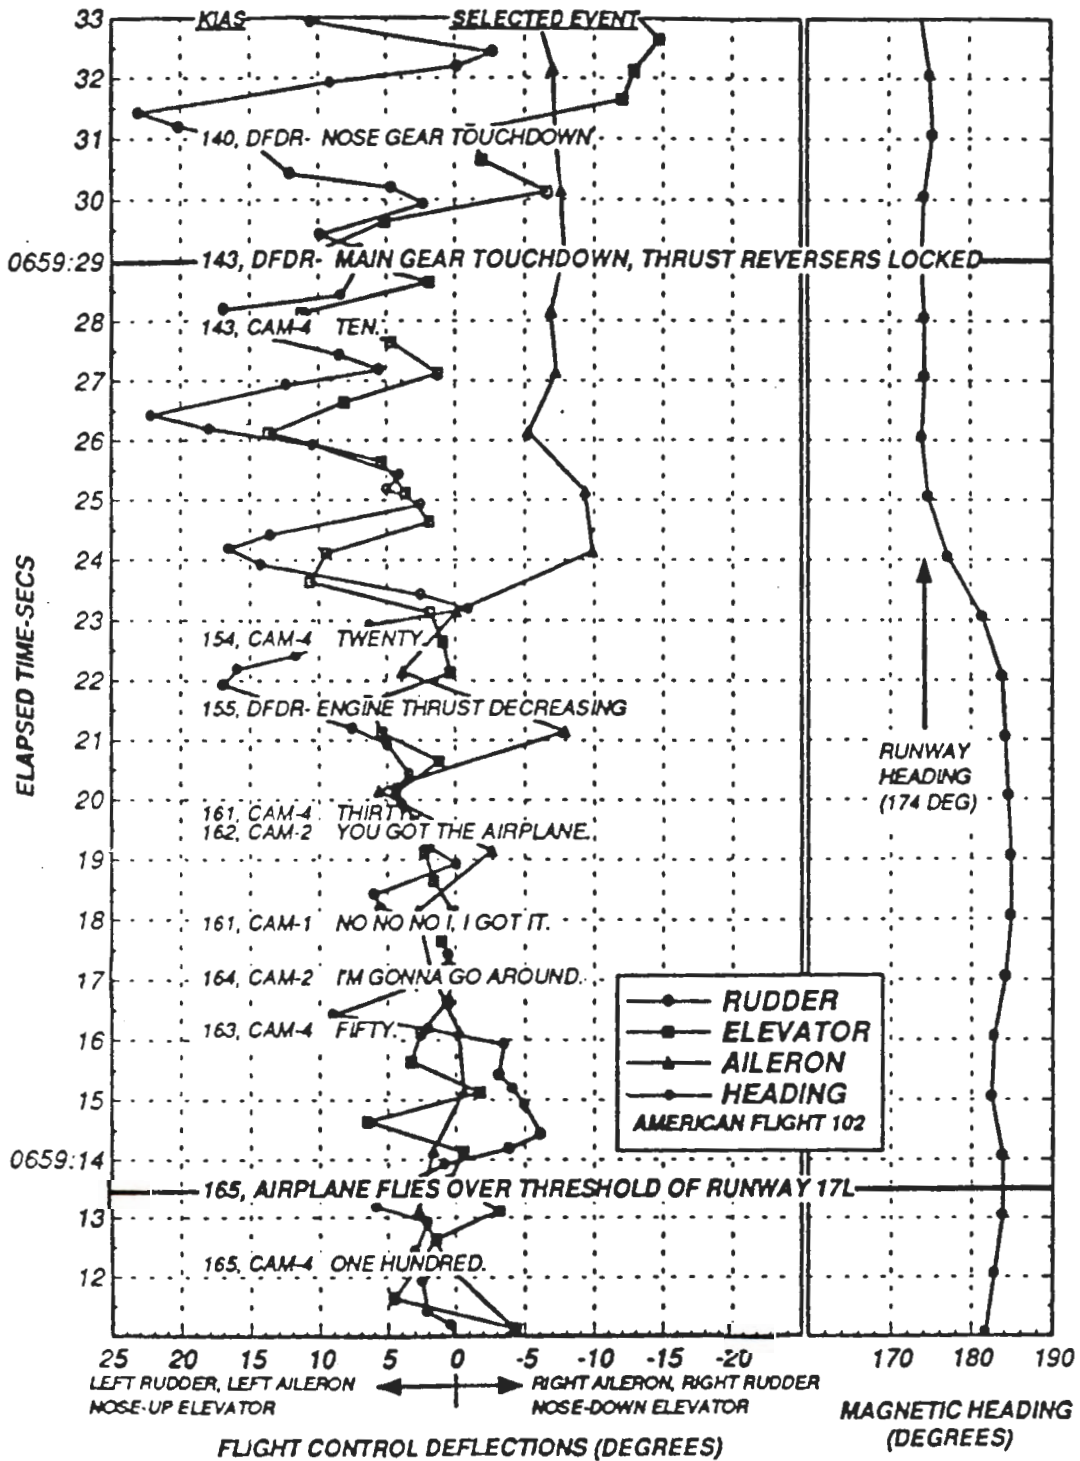
Figure 11a.--Flight control positions and airplane headings during landing sequence.

Prior to touchdown, the airplane transitioned from a 10-degree right crab to a 2-degree right-wing-down (RWD) roll and a 10-degree airplane-nose-left (ANL) rudder deflection. The data show that the airplane touched down at 0659:29 and tracked near the centerline of 17L for about 8 seconds, averaging an 8-degree ANL rudder deflection. During the 8 seconds after touchdown, the airplane decelerated to 116 knots indicated airspeed (KIAS), while the rudder was deflected on average about 8 degrees ANL, the aileron position averaged 5 degree RWD, and the elevator averaged 7 degrees airplane nose down (AND).

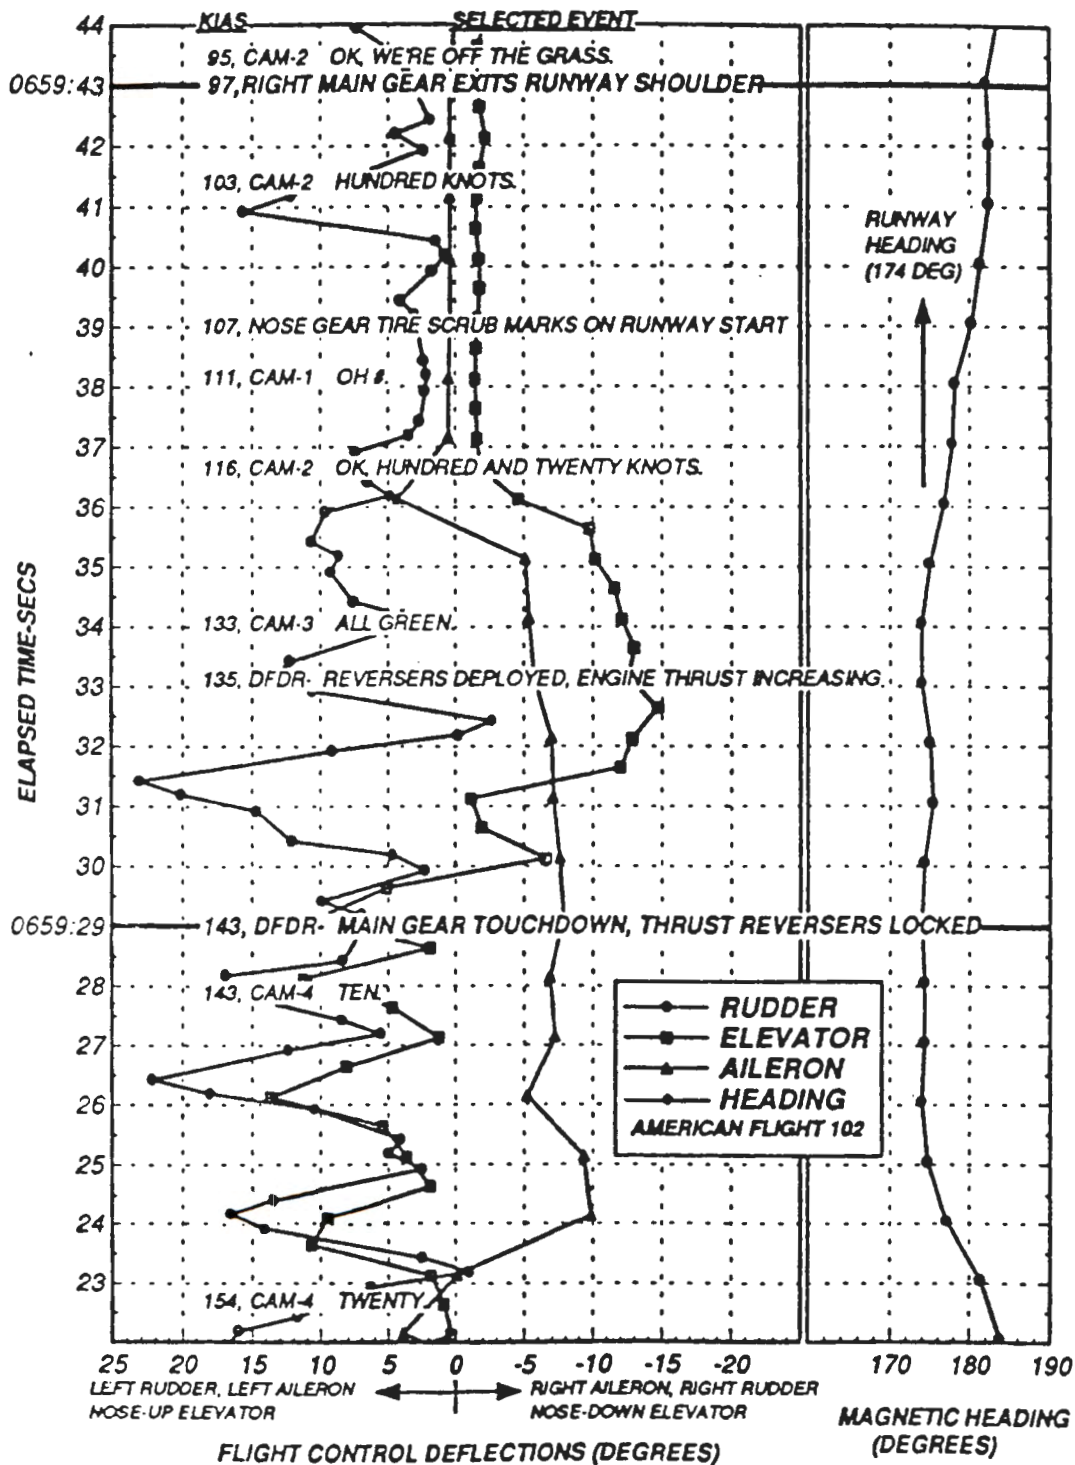
Figure 11b.--Flight control positions and airplane headings during landing sequence.
