**NTSB** National Transportation Safety Board

*Office of Railroad, Pipeline &  
Hazardous Materials Investigations*

**Macdona, Texas**

Operations

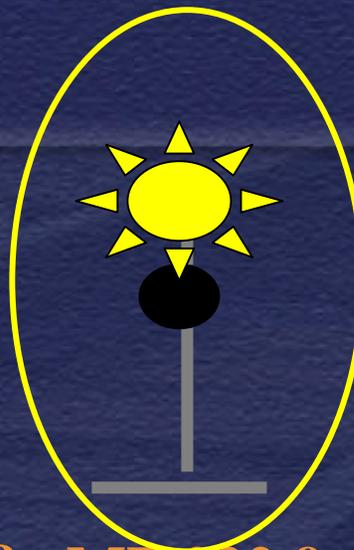
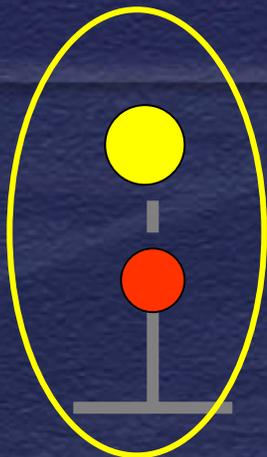
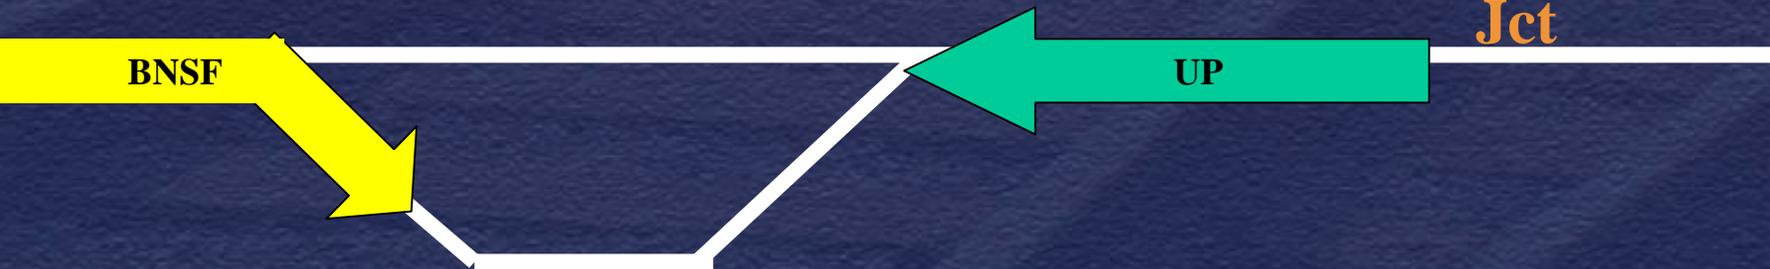
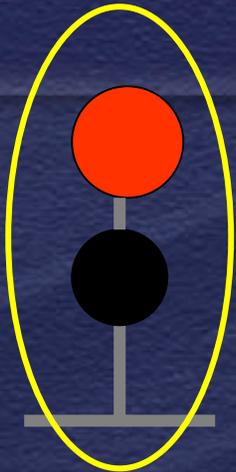
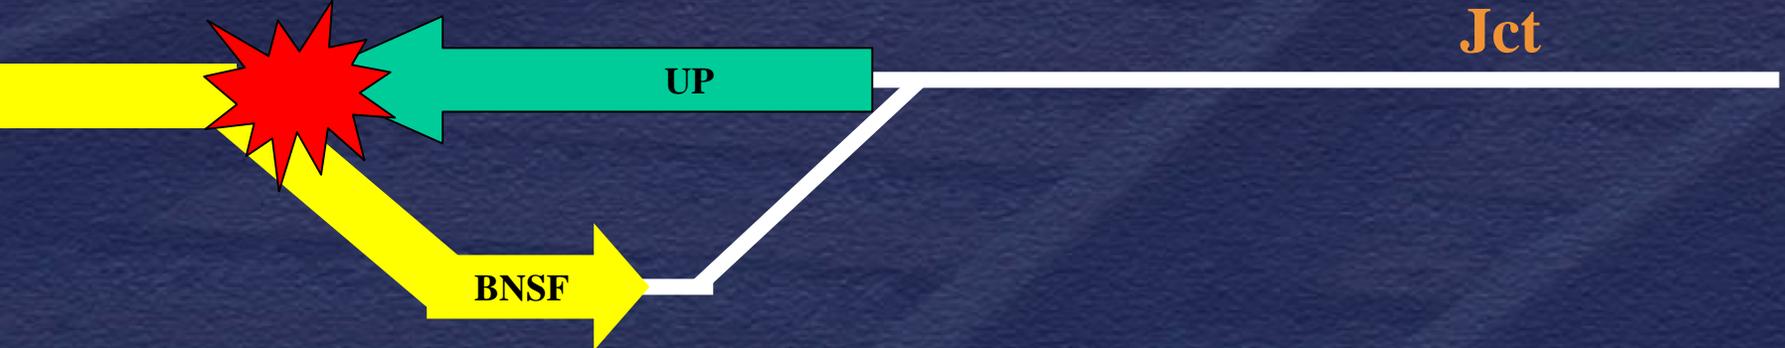
## Centralized Traffic Control

- Train dispatcher controlled
- Wayside signals
- Power switches

On the day of the accident, the crew of the accident Union Pacific train failed to operate their train in accordance with operating rules and in compliance with wayside signal indications, to include failing to take any action in response to the *stop* signal at the west end of the Macdona siding.
