National Transportation Safety Board

Aviation Accident Brief

Accident Number: SEA05MA199
Operator: Heli-USA Airways, Inc.
Aircraft and Registration: Aerospatiale AS350BA, N355NT
Location: Haena, Hawaii
Date: September 23, 2005
Adopted On: March 5, 2007

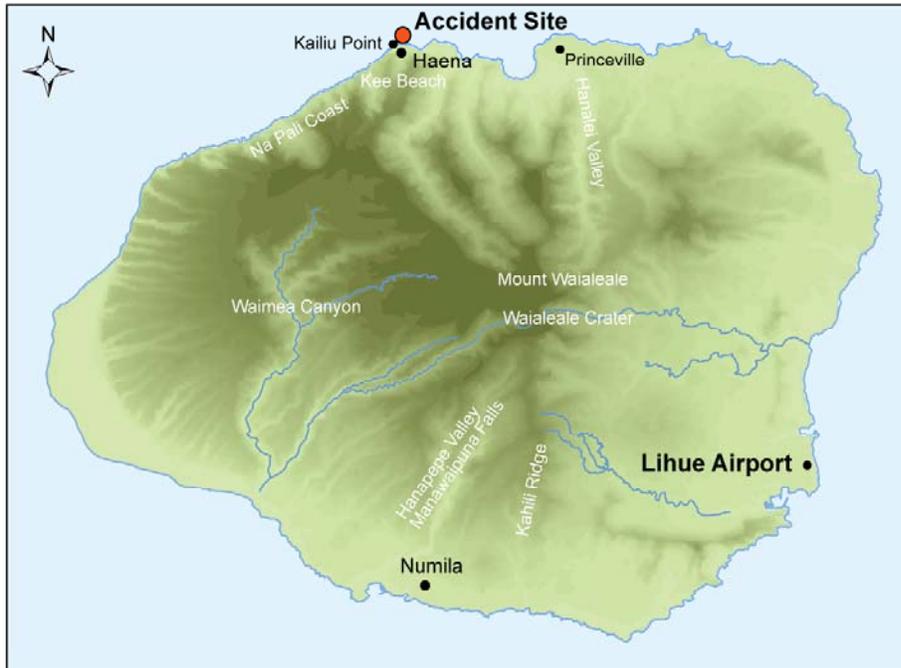
Figure 1. Map of Kauai.

The flight was operated under Special Federal Aviation Regulation (SFAR) 71, "Special Operating Rules for Air Tour Operators in the State of Hawaii,"² and in accordance with a certificate of waiver or authorization approved for Heli-USA by the Federal Aviation Administration (FAA) Honolulu Flight Standards District Office (FSDO) in Honolulu, Hawaii.³ The flight proceeded westbound from LIH, which is on the southeastern part of the island, on the operator's standard clockwise tour route around the island (see figure 1).⁴

⁴ The operator reported that the intended tour route was to depart from LIH and proceed west, which is the standard harbor departure, to the first tour site, Hanapepe Valley. From there, the tour was to proceed northwest to Waimea Canyon, then north to the Na Pali Coast, then northeast along the coastline to the northern end of the island to Kailiu Point. The tour was then to proceed south to Hanalei Valley and then to Waialeale Crater before returning to LIH.
