National Transportation Safety Board
Washington, D.C. 20594

Marine Accident Brief

Vessel No. 1: U.S. Towboat *Christine Cenac*, 53 feet long, O.N. 523261, 69 gross tons, built 1969, uninspected.

Location: Mile 179.5 AHP, Lower Mississippi River, near Donaldsonville, Louisiana.

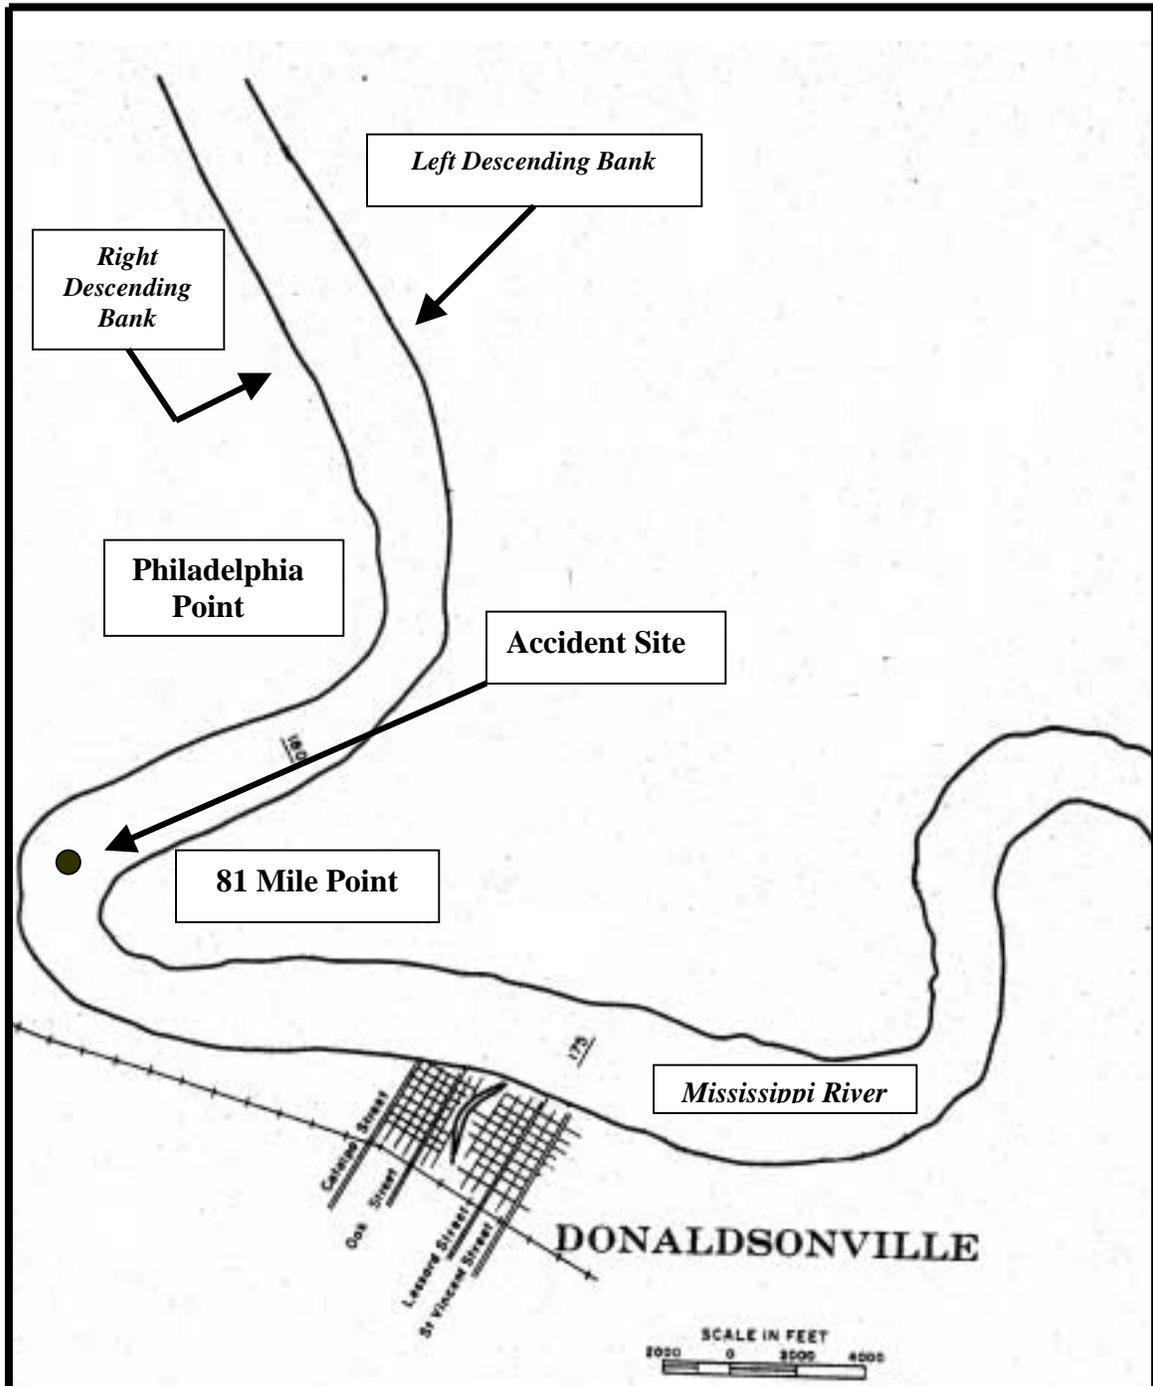
Figure 1. Chart of Lower Mississippi River Near Donaldsonville, Louisiana Showing Approximate Location of Accident Site

During the subsequent attempt by the operator of the *Christine Cenac* to pass between the *American Heritage* and the left descending bank of the river, the port side of CTCO 211 struck the stern of the *American Heritage*. The force of the impact ruptured the No. 3 port cargo tank⁴ of CTCO 211 causing crude oil to spill into the river. It also caused the lead tank barge, CTCO 210, to break free of the tow. The *Christine Cenac*, still pushing the damaged and leaking CTCO 211, was able to catch up with the drifting CTCO 210 and push it against the left descending bank. (See Figure 1.)
