Introduction of Glass Cockpit Avionics into Light Aircraft

Safety Study

NTSB/SS-10/01
PB2010-917001
Notation 7954A
Adopted March 9, 2010

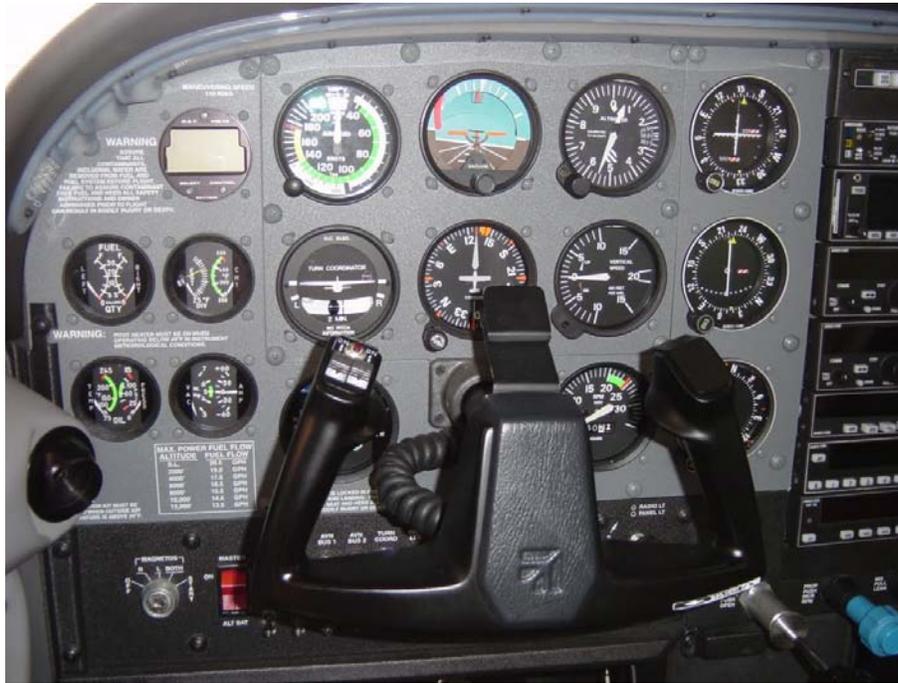
Figure 1. Example of a light aircraft conventional cockpit.

Changing from conventional instruments to glass cockpit displays has created new challenges for interface and display design with implications for the way pilots monitor information in the cockpit. However, the differences between conventional and glass cockpit displays extend beyond appearance (figures 1 and 2). Each of the conventional round-dial instruments relies on electromechanical, pneumatic, or pressure-sensitive components to generate and display specific aircraft performance and control parameters, such as airspeed, altitude, heading, pitch and bank attitude, rate of climb, and rate of turn. In contrast, glass cockpit displays rely on computerized systems that integrate multiple data inputs and controls. Glass cockpit displays can present more information in the space required for conventional instrument panels, but the increase in information places greater demands on pilot attention and creates a risk of overloading pilots with more information than they can effectively monitor and process. The complexity of the integrated computerized systems that drive glass cockpit displays may also limit pilots' understanding of the functionality of the underlying systems.

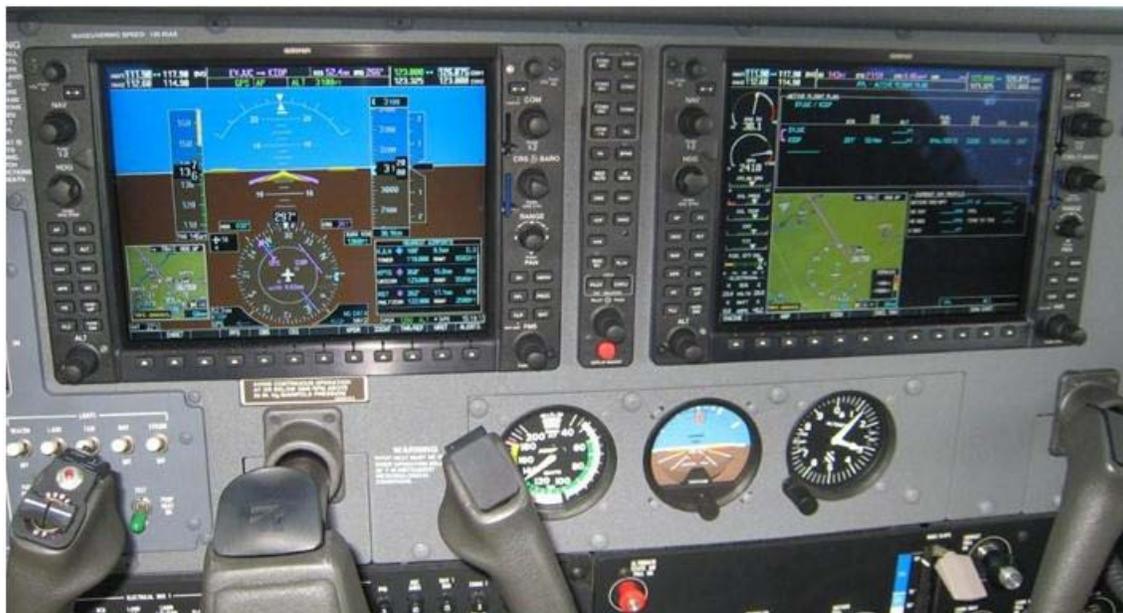
Figure 2. Example of a light aircraft glass cockpit.

The typical light aircraft glass cockpit consists of at least two displays: a primary flight display, or PFD, and a multifunction flight display (MFD). A PFD replaces individual flight instruments to display the airspeed, altitude, attitude, and rate information that pilots use for aircraft control.⁶ As the name "multifunction" suggests, a wide range of supplementary and status information can be selected for display on an MFD. Typical MFDs supplement or replace discrete navigation, communication, weather displays, and system status information, such as engine and fuel gauges. They can also display navigational charts, airport diagrams, and electronic checklists. For this study, a glass cockpit aircraft is defined as having at least a PFD.⁷

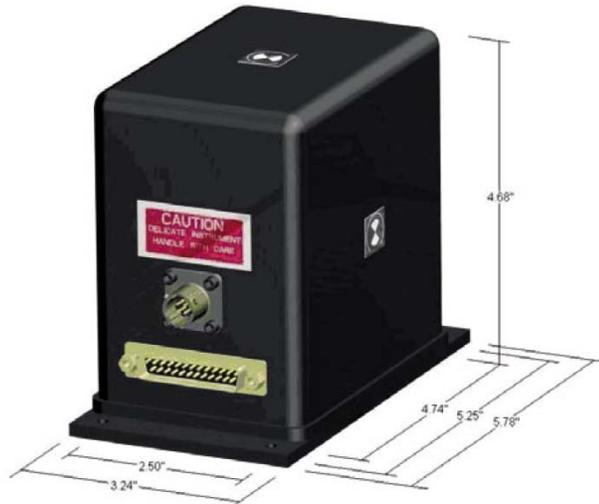
Unlike the relatively simple system of gyros and linkages that drives analog instruments, very little information is available to pilots about the glass cockpit display equivalent. The computerized systems at the heart of electronic PFDs are combinations of electronic components and software that are both unique to the manufacturer and equipment, and that are subject to change with any future system software revision. In contrast to the cutaway illustrations for analog instruments, illustrations of digital instruments do not lend themselves to the same amount of detail. Figure 24, for example, shows an AHRS, which drives the attitude and heading indicator displays of a PFD. As this illustration shows, the system is both figuratively and literally a “black box.” Although the FAA *Pilot's Handbook of Aeronautical Knowledge* includes more than five pages of text and illustrations to describe the design and function of the analog gyroscopic instruments, it includes only four sentences describing the design of an AHRS. Rather than being indicative of an incomplete manual, this difference reflects the nature of the design of electronic display systems.

Figure 24. Illustration of an AHRS, copied from the FAA *Pilot's Handbook of Aeronautical Knowledge*.

Figure 24. Illustration of an AHRS, copied from the FAA *Pilot’s Handbook of Aeronautical Knowledge*..... 54
