GROUP CHAIRMAN'S FACTUAL REPORT OF INVESTIGATION

DCA06MA022

**Group Chairman's Factual Report
By Erin Gormley**

Location: Philadelphia, PA
Date: February 7, 2006, 23:59 EST*
Aircraft: DC-8-71, N748UP
Operator: UPS Airlines, Flight 1307
NTSB Number: DCA06MA022

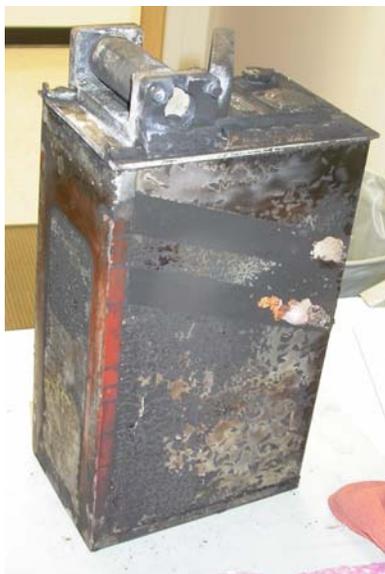
Figure 1: CVR Exterior

Upon arrival at the audio laboratory, it was evident that the exterior of the CVR had sustained heat damage. The outer case was removed and the interior crash-protected case did not appear to have any heat or structural damage (see Figures 1 and 2). The magnetic tape was retrieved from within the crash-protected case and was successfully downloaded.
