PRELIMINARY REPORT

HIGHWAY

HWY18MH007

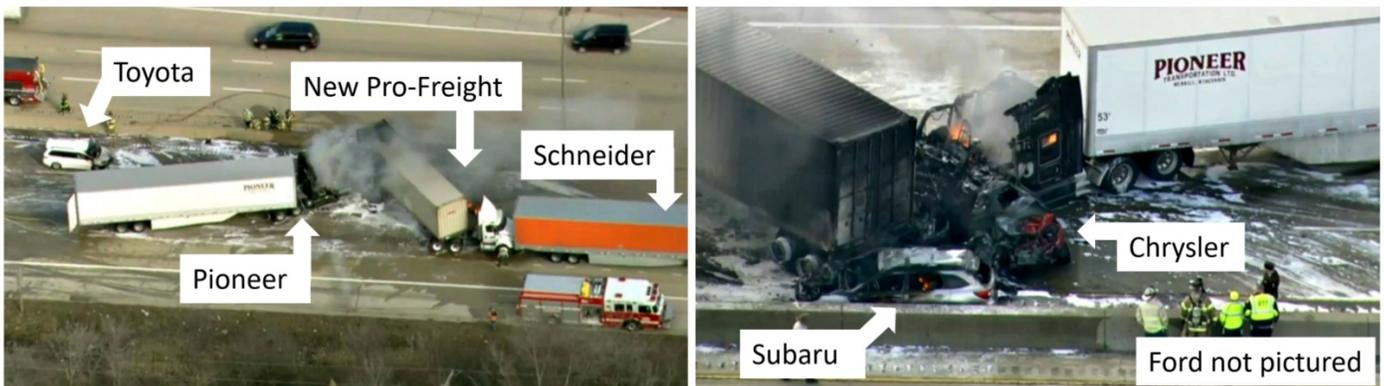
The Chrysler came to rest in the center lane between the New Pro-Freight semitrailer and the Pioneer truck-tractor, where a postcrash fire ensued, which consumed the Chrysler (see figure below). The New Pro-Freight semitrailer, Pioneer truck, Subaru, and Toyota also sustained fire damage. Each of the seven vehicles was occupied by a driver only. The driver of the Chrysler died, while the remaining six drivers sustained minor injuries.

Scene views of six of the vehicles at final rest on eastbound I-290.
