PRELIMINARY REPORT

Long Island Rail Road Passenger Fatality

Lynbrook, New York

RRD18LR005

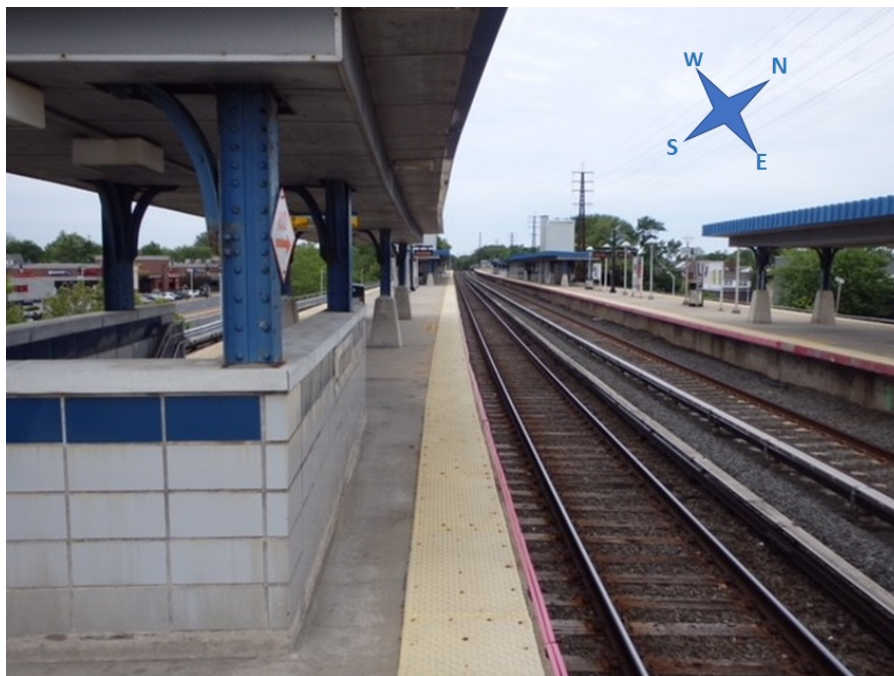
Figure 1. Lynbrook Station.

On April 5, 2018, about 8:12 p.m. eastern daylight time, a passenger who was walking eastward on the Long Island Rail Road (LIRR) Lynbrook Station platform came into contact with the side of train 884, fell, and died as the train was leaving the station.¹ (See Figures 1 and 2.) The accident happened in Lynbrook, New York on the LIRR Long Beach Branch. At the time of the accident, the sky was clear, wind was 19 mph from the south, and the temperature was 42°F.
